**SUBJECT: South Yuba Canal Condition Assessment Report (Project #2419)**

# South Yuba Canal 2021 Condition Assessment

Final Report  
South Yuba Canal  
2021 Condition Assessment

Nevada Irrigation District

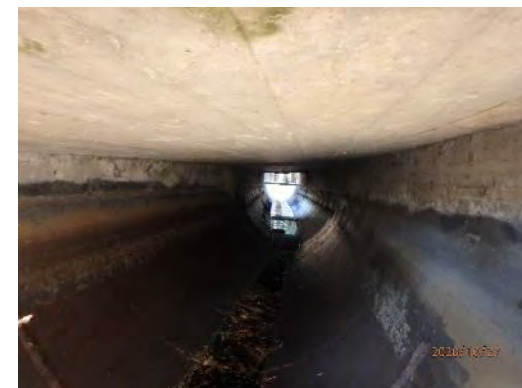
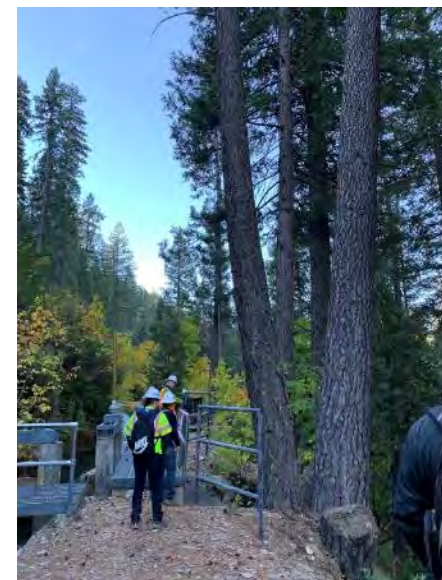
- Access Points
  - Limited access to Chalk Bluff Canal (Segments 20 through 22) and Telephone House Flume (Segment 4)
- Freeboard
  - Generally sufficient, i.e. greater than 12 inches
- Critical Location at Highway 20 (Segment 1)
- Vegetation
  - Generally minor hazards observed
  - Lowest rating at 9 Mile Spill (Segment 10)

1 <6"	High Risk	None
2 6"-12"		<b>Hwy 20 Crossing</b>
3 12"-18"		Majority of Canal
4 18"-24"		
5 >24"	Low Risk

- Freeboard
  - Critical location at Highway 20 - modify flume to provide additional freeboard
- Vegetation
  - Remove hazard trees, monitor embankments
- Liner, Superstructure, Substructure, and Foundation
  - Robust Maintenance Program with Targeted Replacements
- Foundation Stability and Erosion
  - Monitor for additional erosion
- Slope Stability
  - Monitor for further movement
- Rock Fall
  - Continue to monitor potential rockfall locations
- Spillways
  - Stabilization of spillway chutes/discharge points
- Rough order of magnitude CIP estimates for critical sites

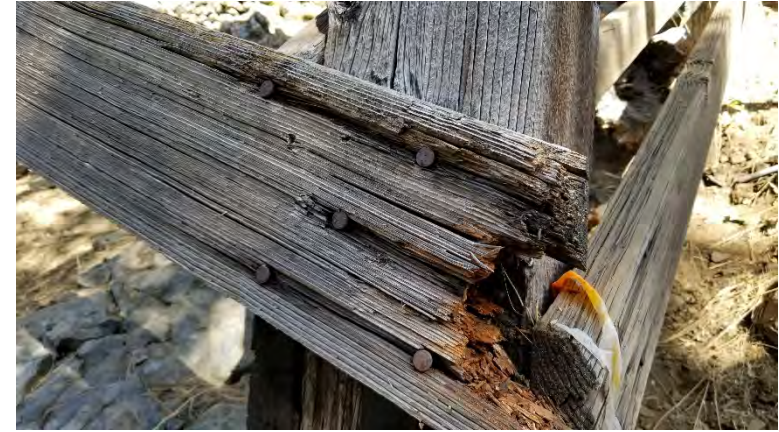
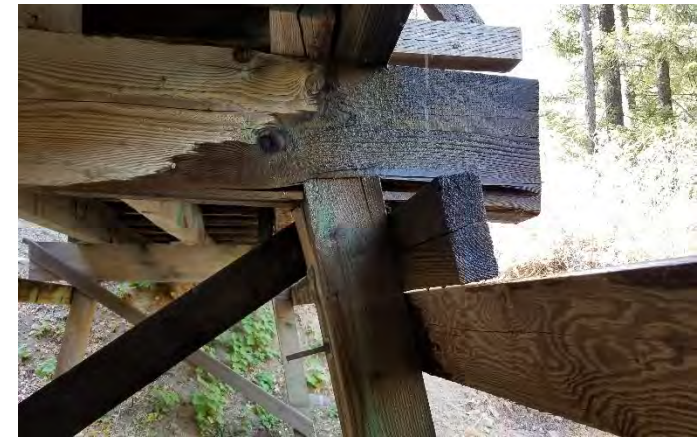
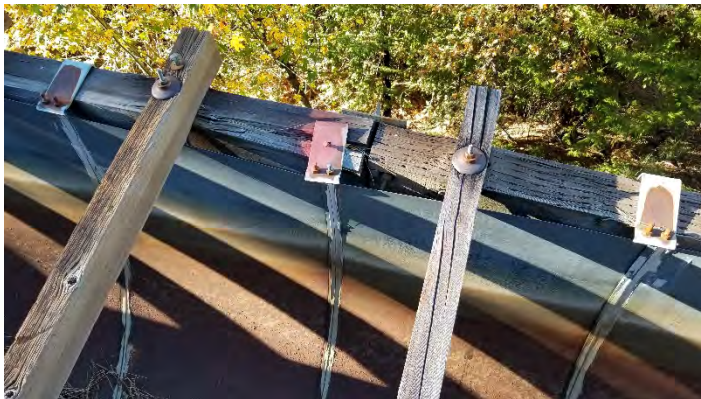
- Superstructure and Substructure
  - Most timber members are exceeding their useful life.
  - Insufficient connections
- Foundation
  - Minor cracking of concrete
  - Loss of support within Segment 3
- Liner
  - Liner of elevated Lennon flume missing brackets and adequate connections

- Hazard trees should be removed from the System footprint. Dense vegetation near the timber structures should be minimized to reduce fire danger.
- Required repairs for the timber superstructure and substructure include replacing split timber members, tightening bolts in hardware clips that are not fastened down, replacing hardware that does not fit with proper fitting hardware and replacing beams with splits through connectors.

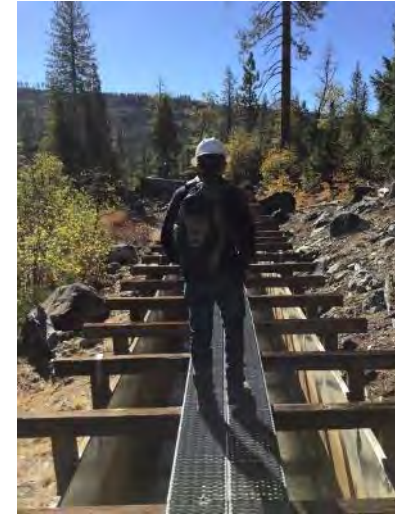
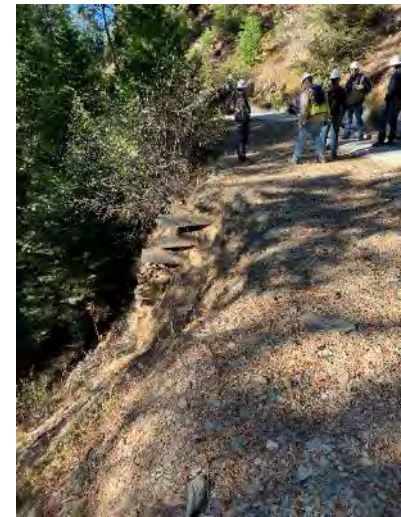
- Foundation Stability
  - Portion of flume out of plumb in Segment 4
- Erosion
  - Minor erosion and scour, critical section at Hickman Spill (Segment 12)
- Slope Stability
  - Sporadic separation of bench from canal liner in select locations
  - History of instability and landslides in several segments
  - Most notable location at Hickman Spill (Segment 12)
- Rock Fall
  - Minor observations within Segment 1

- Areas where instability is observed should be monitored and repaired as needed to maintain stability of the System.
- Potential landslide areas should be monitored for future movement and repaired as required. 8.1.8

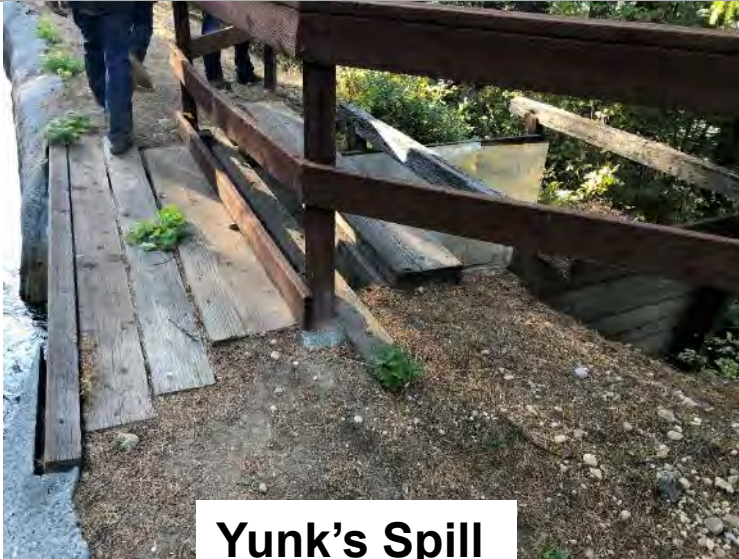
**Yunk's Spill**

- Majority of timber members are deteriorated, a great many are split, dry-rotted, and lack competent connections.
- Segment 1 – Erosion of the foundation and freeboard limitations at Highway 20
- Segment 9 – Erosion at the downslope side of the flume
- Segment 12 – Erosion and slope stability at Hickman Spill
- Segment 15 – Deteriorated timber flume and upslope landslide
- Big Tunnel Spill – Erosion and structural condition of the spillway chute
- Yunk's Spill – Wood box flume through the right bank of the canal failing

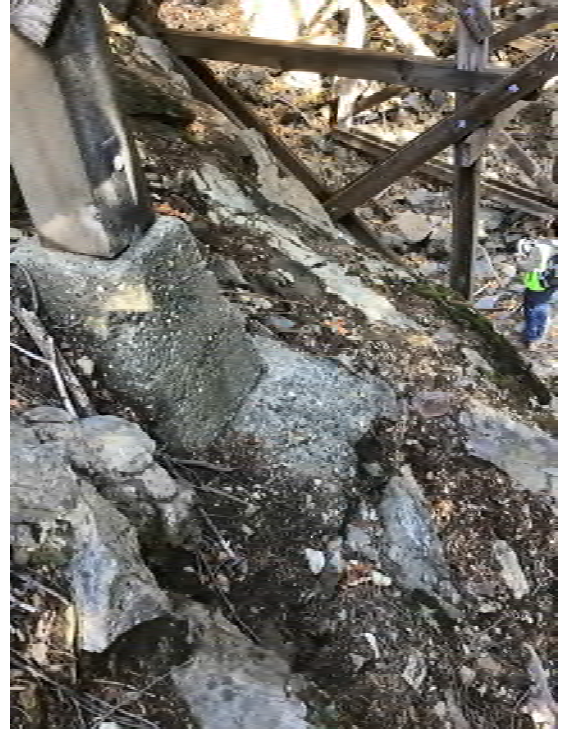
Photo 2 Minor Erosion at Foundation

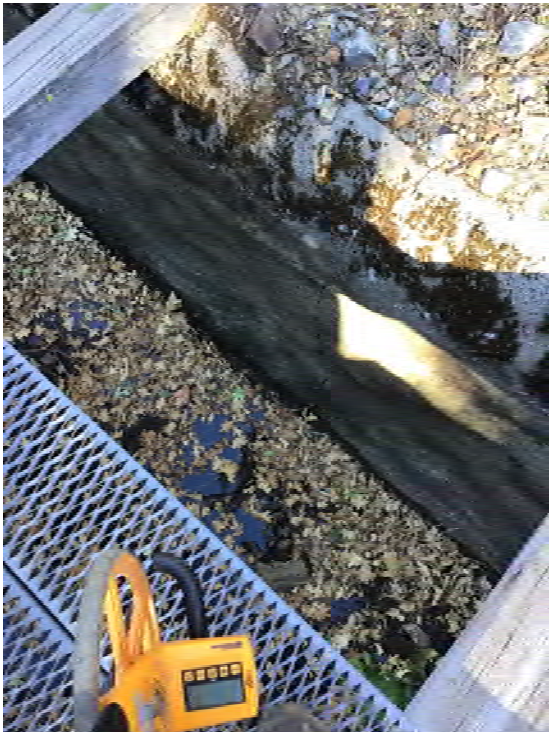
Photo 3 Cracking in Liner

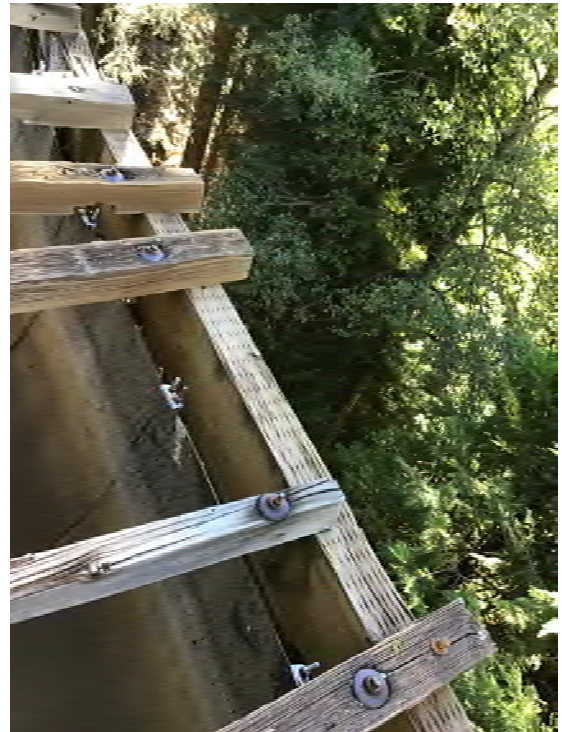
Photo 4 Separation in Liner on Lennon Flume

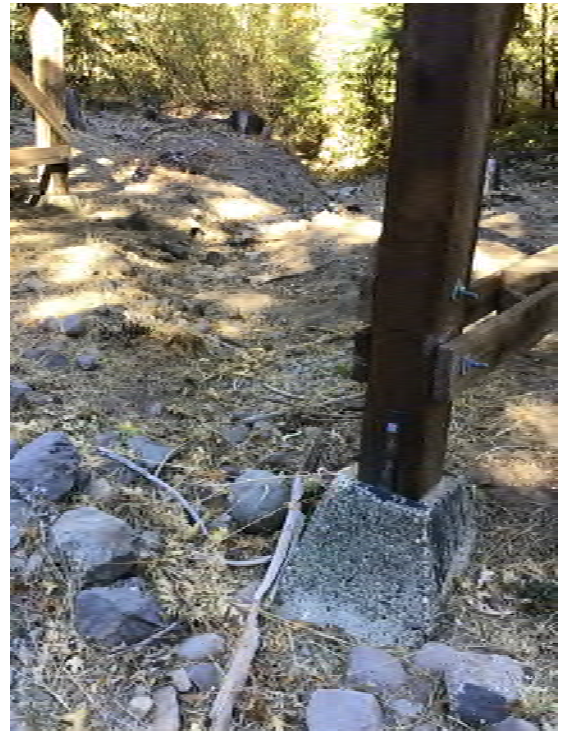
Photo 9 Minor Erosion at Foundation

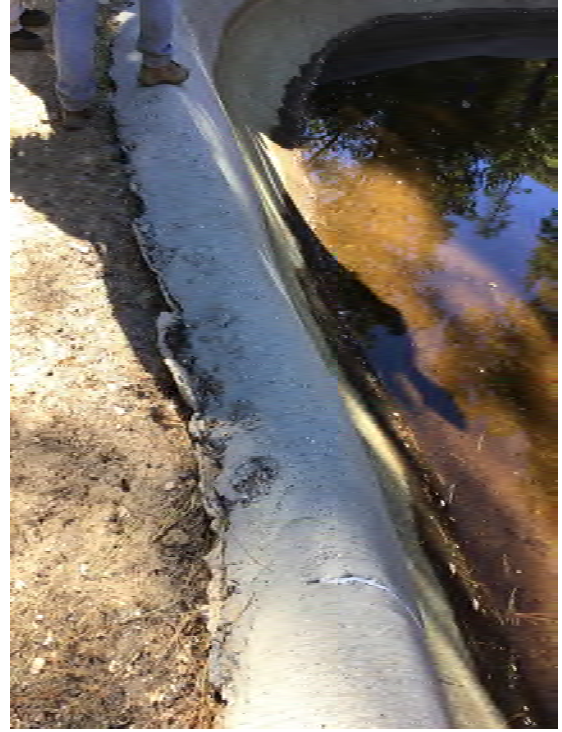
Photo 13 Minor Cracking in Liner

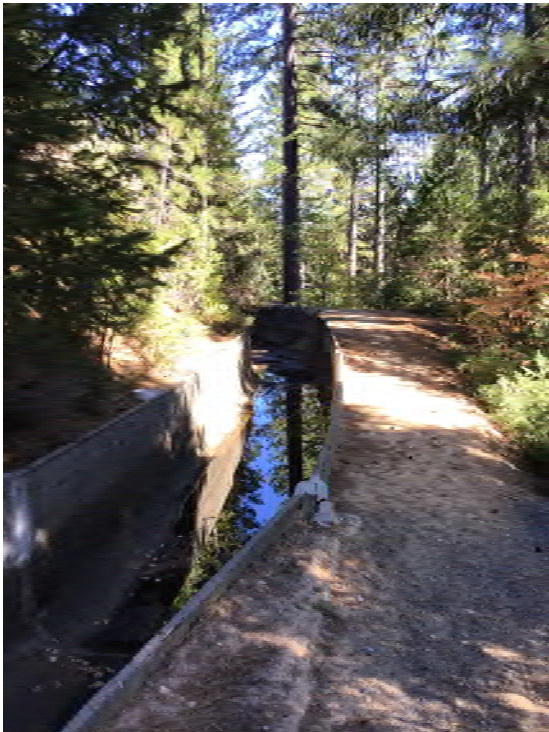
Photo 14 Separation of Bench from Canal with Lateral Offset

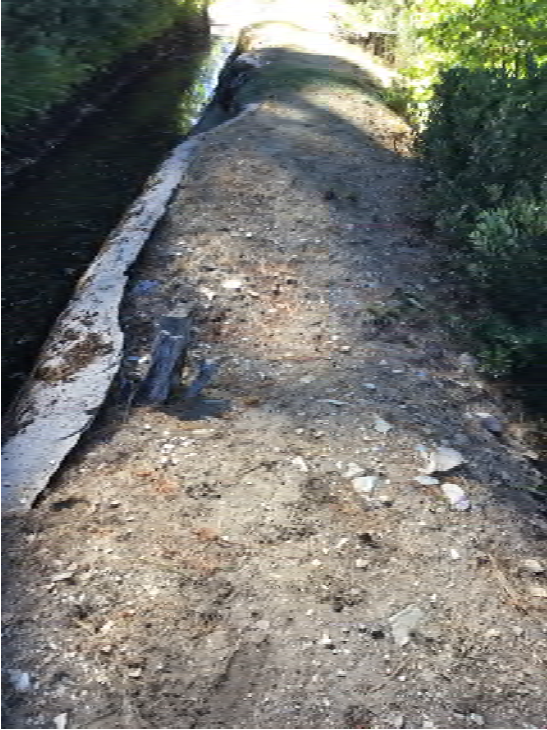
Photo 18 Slump in Bench with Cracking in Canal

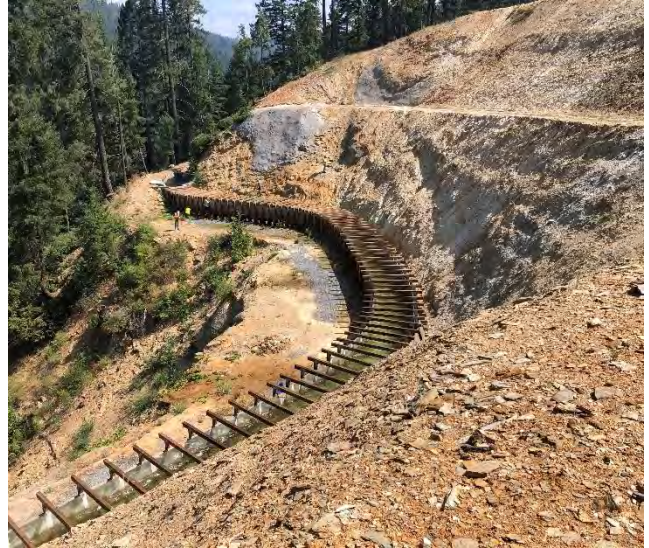
Photo 19 Landslide Repair

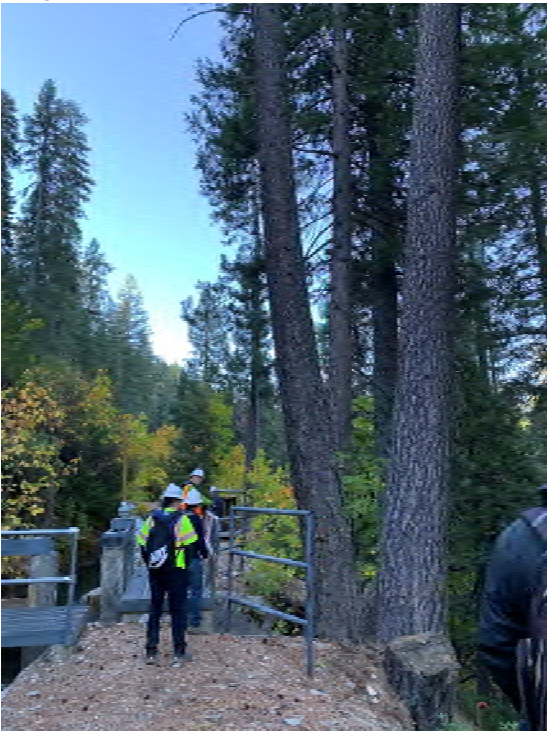
Photo 20 Hazard Trees

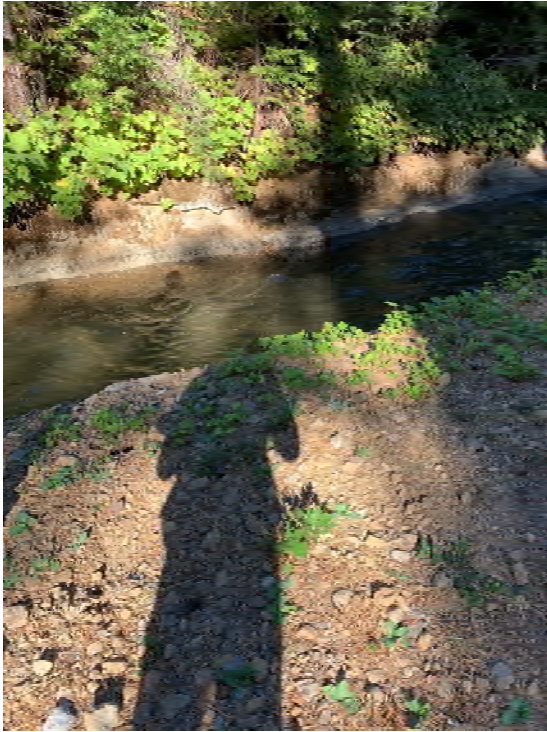
Photo 22 Cracking in Liner

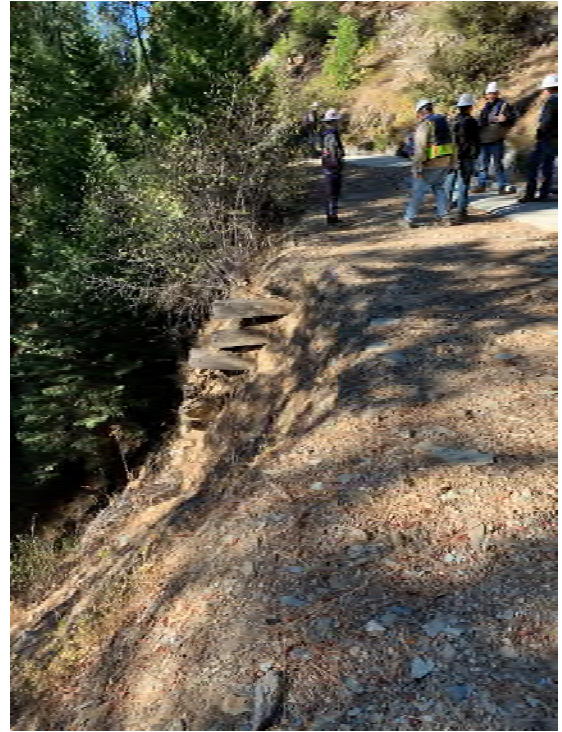
Photo 23 Potential Slope Distress at Hickman Spill

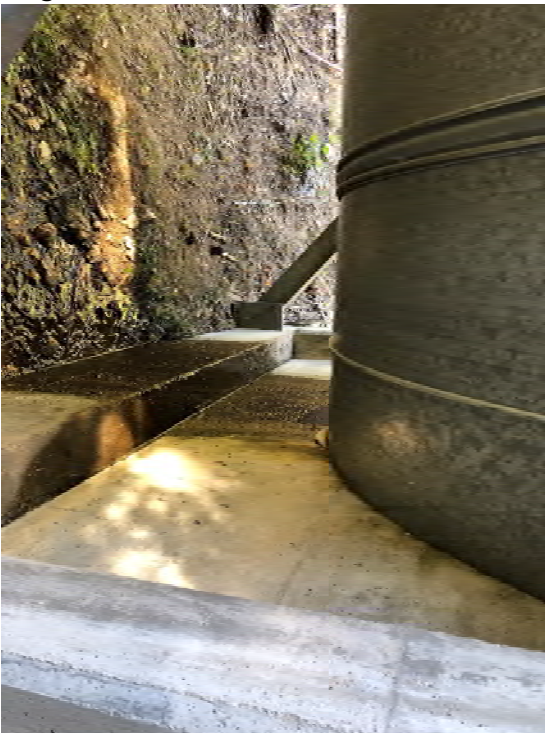
Photo 32 Leakage in Liner at Transition

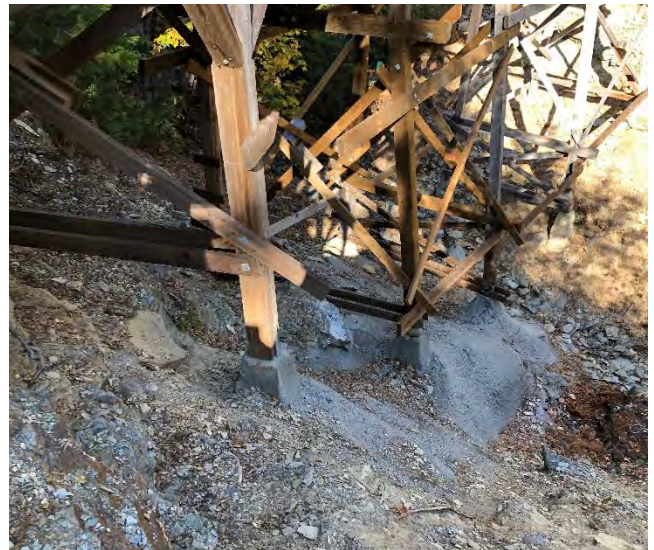
Photo 33 Shotcrete Repair at Flume Abutment

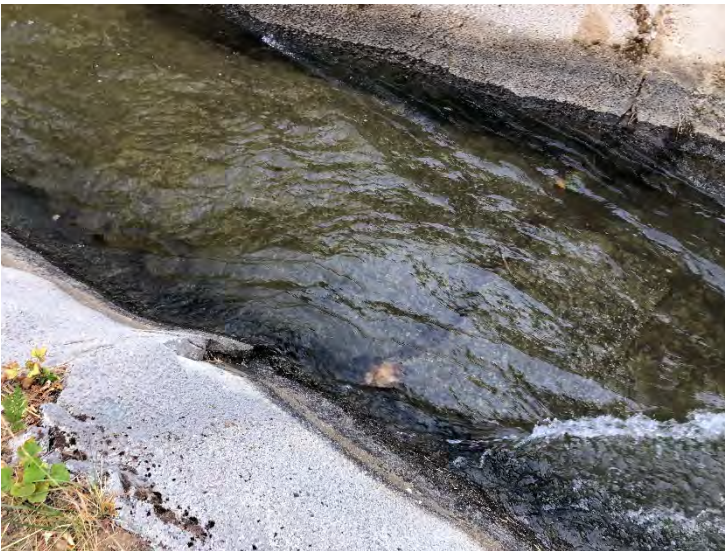
Photo 36 Potential Leak in Liner
