SUBJECT: Lower Cascade Canal and Upper Grass Valley Canal Long Term Canopy Cover Study, Tree Health Assessment Report-Monitoring Year 6 (FATR #6593-2)

Informational item to review and file the Lower Cascade Canal (LCC) and Upper Grass Valley Canal (UGVC) Long-term Canopy Cover Study, Tree Health Assessment Report – Monitoring Year 6.

**LOWER CASCADE CANAL AND UPPER GRASS VALLEY CANAL LONG TERM CANOPY COVER STUDY,
TREE HEALTH ASSESSMENT REPORT- MONITORING YEAR 6**

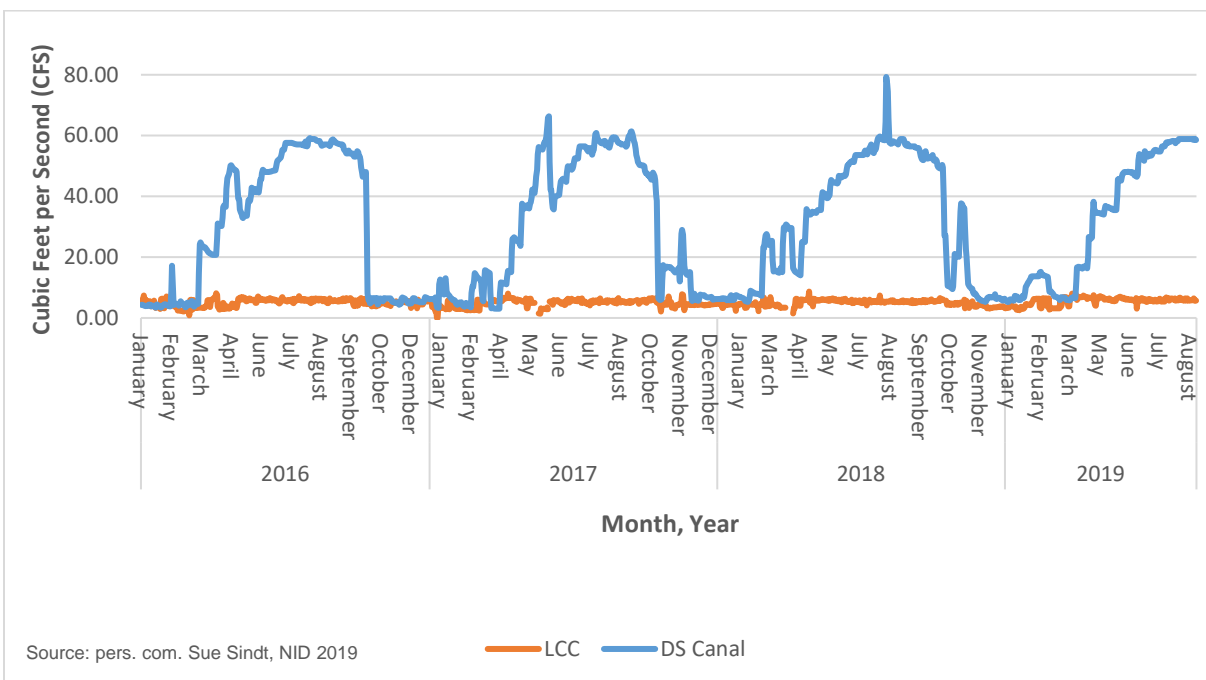
Figure 2.1 Canal Flow in LCC and DS Canal, 2016-2019

Flows in LCC were reduced from approximately 45 to 5 cubic feet per second (CFS) as part of the Project. Branching from LCC, flows in the UGVC were reduced from 12 to 1 CFS as part of the Project. Flows in DS Canal have continued per normal operating conditions at rates averaging approximately 50 CFS during the summer (May-September) and 15 CFS during winter months (October-April) (pers. com. Sue Sindt, NID 2019b) (Figure 2.1).

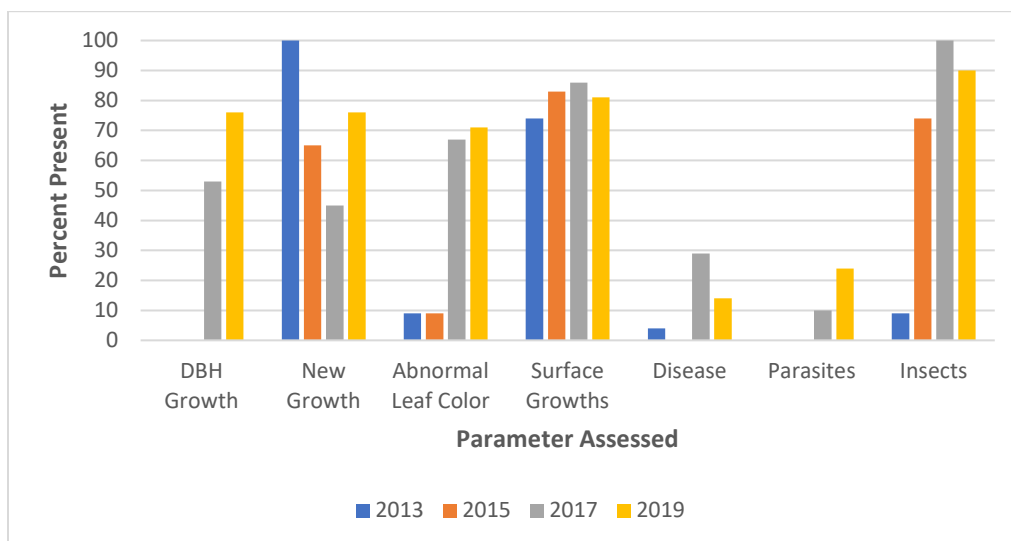
Figure 4.1 LCC Site 1 Tree Health Assessment Data

In Monitoring Year 6, 21 riparian trees were surveyed at Site 1 on LCC on September 20, 2019, including bigleaf maple, Pacific dogwood, and gray alder. No new dead trees were found. Most trees surveyed had full to partial canopy cover and good bark health, and exhibited DBH growth, new growth, surface growths, foliage discoloration, and insect damage. Disease was minimal at this site, but a few trees'

Since Baseline Year 0, trees at Site 1 improved from partial to medium canopy cover, and bark health remained good. However, presence of abnormal leaf color and insects increased from barely present at Site 1 to present in most trees. Presence of new growth greatly decreased from Baseline Year 0 to Monitoring Year 4 but made a substantial recovery in Monitoring Year 6. Surface growth remained highly prevalent and diseases and parasites remained minimal across monitoring years, though honeysuckle and other parasitic plants were observed in increasing quantity at Site 1. Two tree deaths were observed at Site 1 since Baseline Year 0, but no new trees were confirmed dead in Monitoring Year 6. In comparison with Monitoring Year 4, trees surveyed in Monitoring Year 6 exhibited improvements in presence of DBH and new growth, as well as less disease and insects. Overall tree health at Site 1 remains good since Baseline Year 0, oscillating on health between Monitoring Years 2 through 6 (Table 4.1, Figure 4.1).

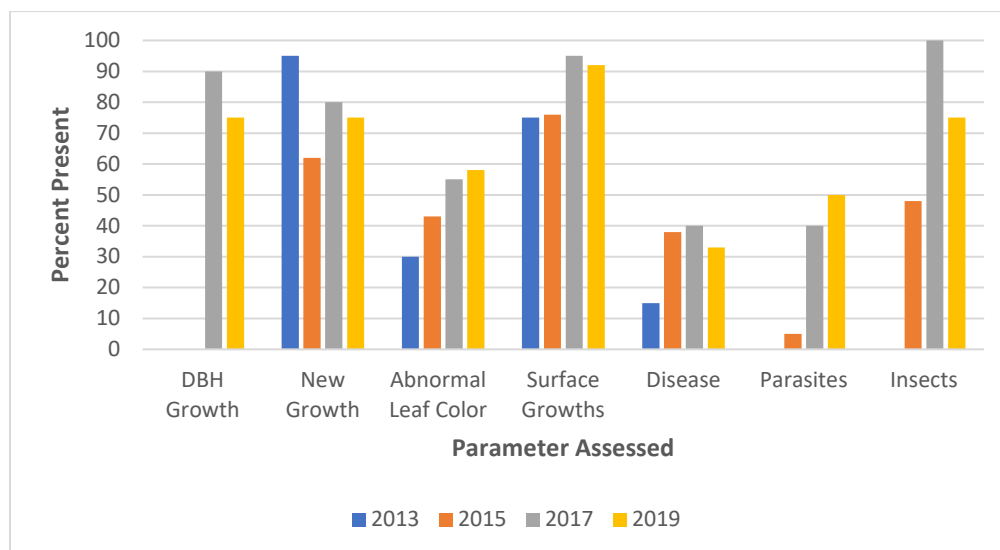
Figure 4.2 LCC Site 2 Tree Health Assessment Data

During Year 6 monitoring, 12 riparian trees were surveyed at Site 2 on LCC on October 17, 2019. Tree species surveyed include bigleaf maple, gray alder, and Pacific dogwood. No new trees were found dead, but some trees were inaccessible for evaluation due to new private property fencing. Most trees surveyed had full to partial canopy cover and poor bark health, and exhibited new growth, surface growths, and insect damage and infestation. Disease was minimal at this site, but approximately half the trees surveyed exhibited foliage discoloration and parasites such as honeysuckle and Himalayan blackberry (*Rubus armeniacus*) on trunks and branches. Overall tree health at Site 2 is good, with a range of health scores from 6 to 12 and an average health score of 8 (Table 4.2, Figure 4.2).

Since Baseline Year 0, canopy cover of trees at Site 2 remained consistent, and bark health declined from good to fair in Monitoring Year 6. DBH growth and new growth also declined since Baseline Year 0, and abnormal leaf color, surface growths, diseases, parasites, and insect presence increased, though prevalence of diseases and insect damage dropped in Monitoring Year 6. Only one tree death was observed at Site 2 since Baseline Year 0, and no new trees were confirmed dead in Monitoring Year 6. In

comparison with Monitoring Year 4, trees surveyed in Monitoring Year 6 exhibited improvements in the presence of insects and insect damage, but also exhibited poorer bark health, greater presence of parasites, and less evidence of DBH growth and new growth. Overall tree health at Site 2 remains good since Baseline Year 0, with a slight decrease between Monitoring Years 2 through 6 (Table 4.2, Figure 4.2).

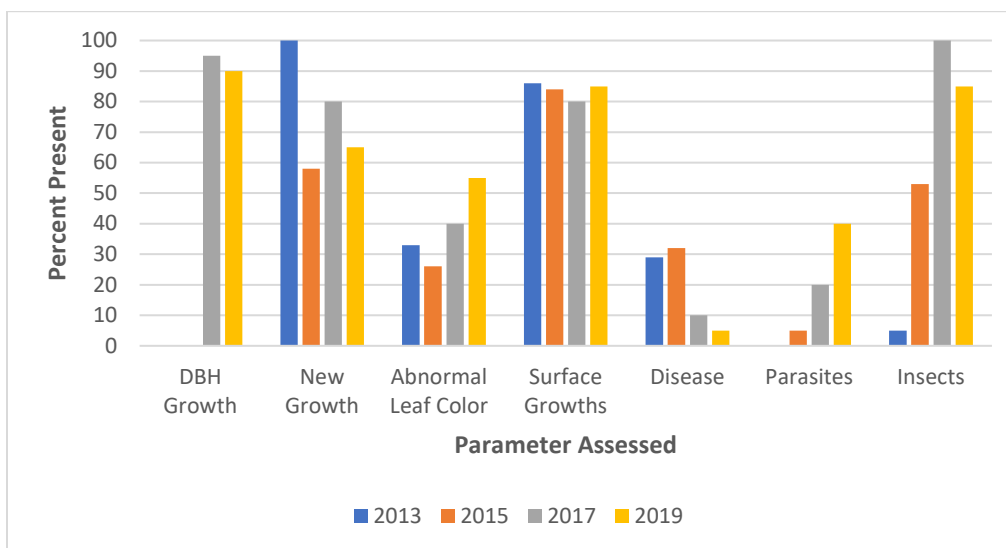
Figure 4.3 LCC Site 3 Tree Health Assessment Data

During Year 6 monitoring, 20 riparian trees were surveyed at Site 3 on LCC on October 17, 2019. Tree species surveyed include bigleaf maple, gray alder, and Pacific dogwood. No new trees were found dead. Most trees surveyed had full to partial canopy cover and fair bark health and exhibited surface growths and insect damage and infestation. Over half the trees surveyed exhibited new growth and foliage

discoloration. Very little disease was observed at this site, but parasites such as California wild grape and english ivy were present on several trees' trunks and branches. Overall tree health at Site 3 is good, with a range of health scores from 4 to 13 and an average health score of 8 (Table 4.3, Figure 4.3).

Since Baseline Year 0, trees at Site 3 improved from partial to medium canopy cover, as well as fair to good bark health, and the prevalence of disease greatly decreased. However, presence of new growth declined and abnormal leaf color and parasites steadily increased. Presence of insects also increased from barely present at Site 3 to present in most trees, though the prevalence of insect damage dropped in Monitoring Year 6. Surface growths remained highly and consistently prevalent. No tree deaths were observed at Site 3 since Baseline Year 0. In comparison with Monitoring Year 4, trees surveyed in Monitoring Year 6 exhibited improvements in the presence of disease and insect damage, but also exhibited greater presence of abnormal leaf color and parasites, as well as less evidence of DBH and new growth. Overall tree health at Site 3 remained consistently good, though it decreased slightly in Monitoring Year 6 (Table 4.3, Figure 4.3).

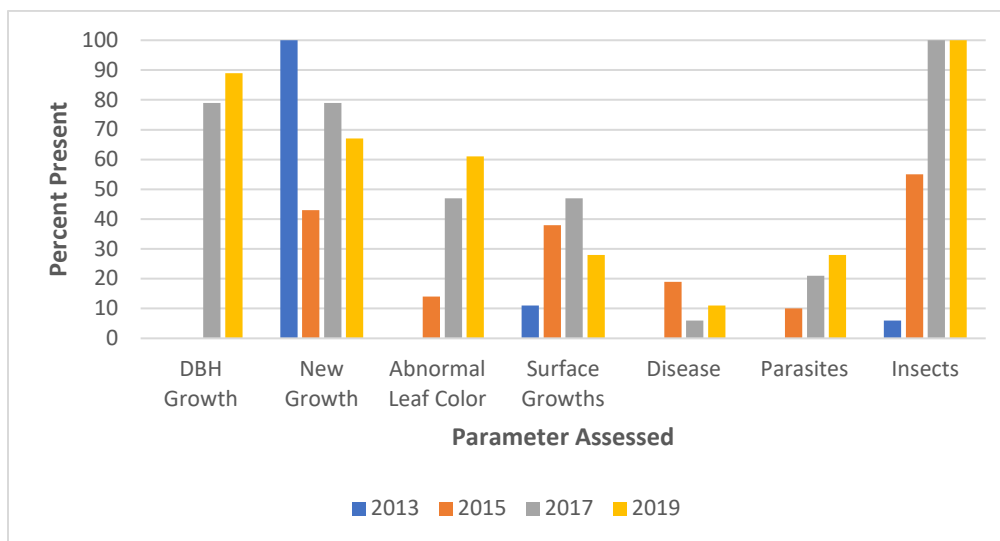
Figure 4.4 LCC Site 4 Tree Health Assessment Data

During Year 6 monitoring, 18 riparian trees were surveyed at Site 4 on LCC on September 20, 2019. Tree species surveyed include bigleaf maple, gray alder, tanoak, and Oregon ash. One tree had been crushed under another fallen tree and was noted as dead. All trees surveyed exhibited insect damage and infestation. On average, trees surveyed had full to partial canopy cover and fair bark health, and over half the trees surveyed exhibited new growth and foliage discoloration. Disease, surface growth, and parasites were minimal at this site, though english ivy and root rot was present on some trees' trunks. Overall tree health at Site 4 is good, with a range of health scores from 6 to 12 and an average health score of 9 (Table 4.4, Figure 4.4).

Since Baseline Year 0, trees at Site 4 remained consistent in canopy cover (medium) and bark health (good). However, presence of new growth declined, and abnormal leaf color and insects increased from barely present at Site 4 to present in most to all trees. Surface growths, diseases, and parasites remained low but also generally increased since Baseline Year 0, though the prevalence of surface growths dropped in Monitoring Year 6. One tree death was observed at Site 4 in Monitoring Year 6. In comparison with Monitoring Year 4, trees surveyed in Monitoring Year 6 exhibited improvements in the presence of DBH growth and surface growths, but also exhibited greater presence of abnormal leaf color, disease, and parasites, as well as less evidence of new growth. Overall tree health at Site 4 decreased from

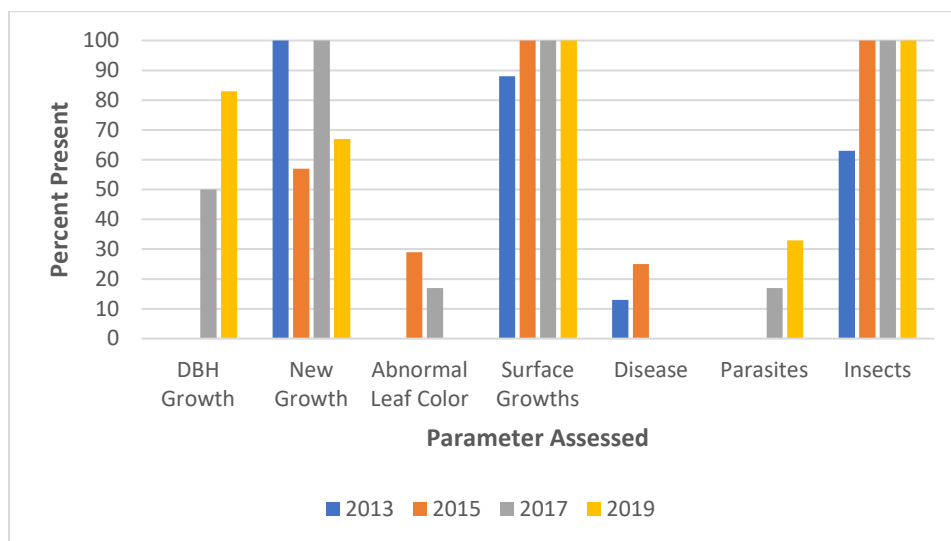
Figure 4.5 UGVC Site 4 Tree Health Assessment Data

During Year 6 monitoring, six riparian trees were surveyed at Site 5 on UGVC on October 17, 2019. Tree species surveyed include bigleaf maple, Pacific dogwood, and white alder. No new dead trees were observed. All trees surveyed exhibited insect damage and infestation, as well as surface growths. Most trees surveyed exhibited new growth, largely of epicormic stems, full to partial canopy cover, fair bark health, and no abnormal foliage discoloration nor disease. Parasitic honeysuckle was present on some trees' trunks and adjacent saplings. Mechanical damage to trees from roadside tree-trimming was observed, as well as new growth of various riparian tree species saplings within the site. Overall tree

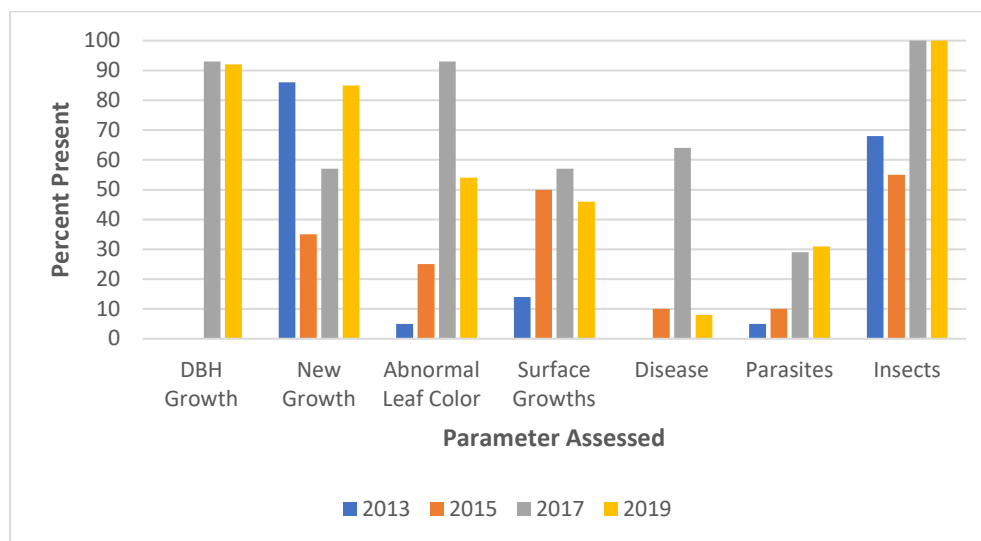
Figure 4.6 DS Canal Site 6 Tree Health Assessment Data

During Year 6 monitoring, 13 riparian trees were surveyed at the reference site, Site 6, on DS Canal on October 18, 2019. Tree species surveyed include bigleaf maple, gray alder, and Pacific dogwood. Two new trees were found dead. All trees surveyed exhibited insect damage and infestation, though new growth, full to partial canopy cover, and fair bark health was also observed in most trees. Foliage discoloration and surface growth was observed on approximately half of the trees surveyed. Little disease or parasitic presence was observed, though there was some root rot and parasitic honeysuckle was present on some trees’ trunks and branches. Overall tree health at Site 6 is good, with a range of health scores from 7 to 12 and an average health score of 10 (Table 4.6, Figure 4.6).

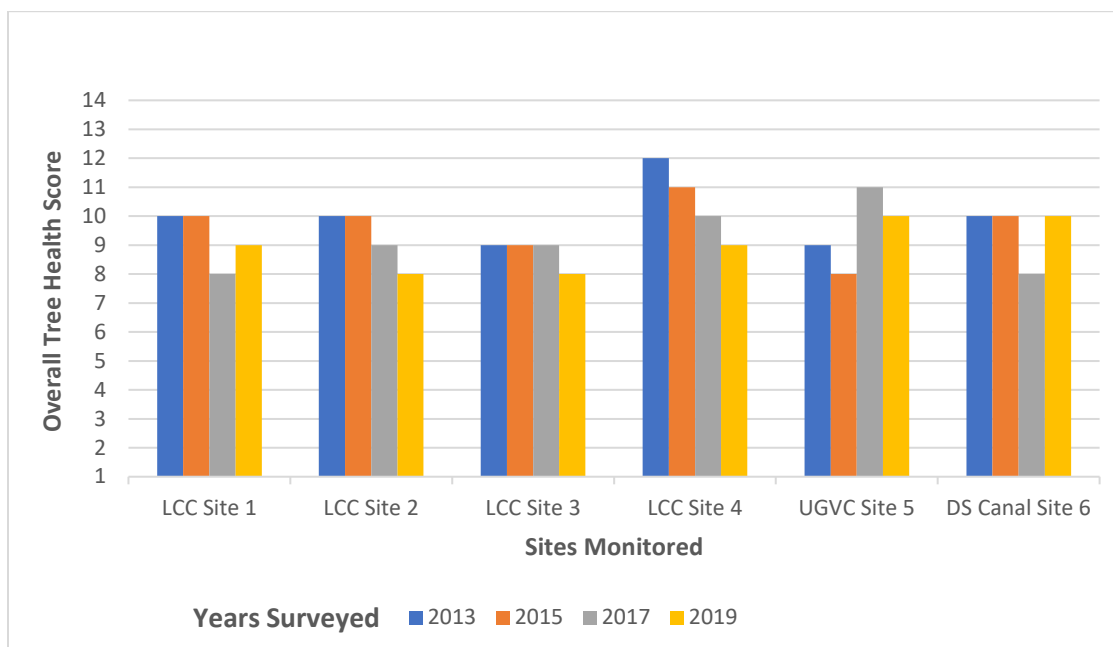
Figure 4.7. Average Overall Tree Health Scores³ by Study Site

Overall tree health at Sites 2, 3, and 4 on LCC decreased, and increased at Site 1 on LCC, from Monitoring Years 4 to 6 (Figure 4.7). Overall tree health at all four sites on LCC was lower than sites on the other two canals. Increased parasite presence (e.g., honeysuckle and blackberry) and abnormal leaf color, as well as decreased observations in new growth, were drivers in leading to lower overall health scores at the study sites along LCC. Canopy cover remained consistent at all sites, so it can be concluded that associated riparian shade canopy remains intact. There was also minimal loss of riparian tree species along the LCC study sites, with four total confirmed tree deaths out of 84 trees total amongst the sites for the duration of the study; however, all sites had notable decreases in new growth

Overall tree health at DS Canal increased from Monitoring Year 4 to 6, recovering to baseline overall health levels (Figure 4.7). In Monitoring Year 6, overall tree health at Site 6 was better than all sites on LCC and the same as Site 5 on UGVC. Increased presence of new growth, and decrease of abnormal leaf color, disease, and surface growths on the trees are the primary drivers leading to higher overall health at Site 6. Canopy cover was similarly less from Monitoring Year 4 to 6 but generally increased from Baseline Year 0, so it may be concluded that associated riparian shade canopy remains intact. There was also moderate loss of riparian tree species at Site 6, with six total confirmed tree deaths out of 22 trees; however, there was measurable increase in new growth observations.

³ Health scores – 1-4: poor health; 5-7: fair health; 8-11: good health; 12-14: excellent health

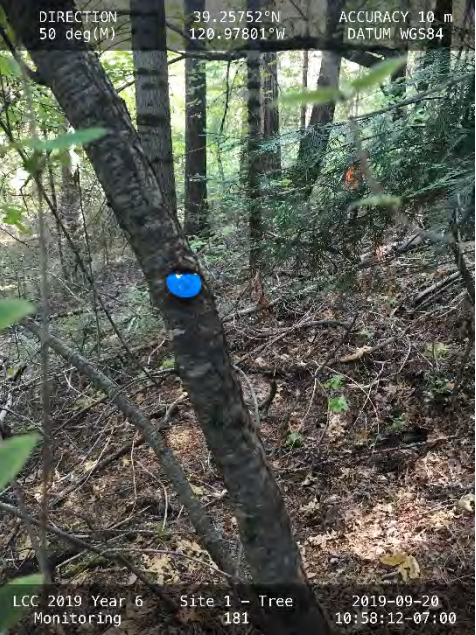
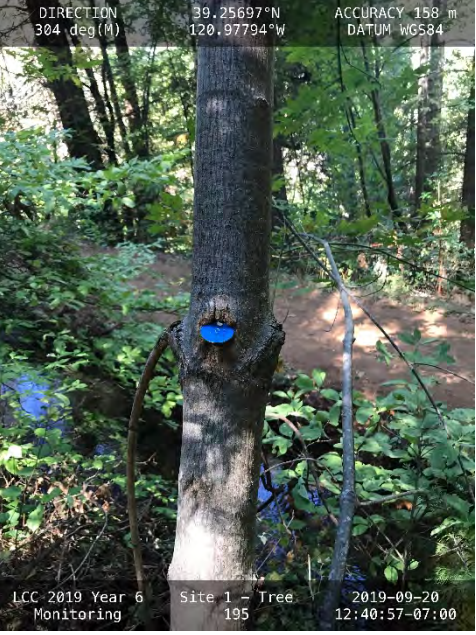
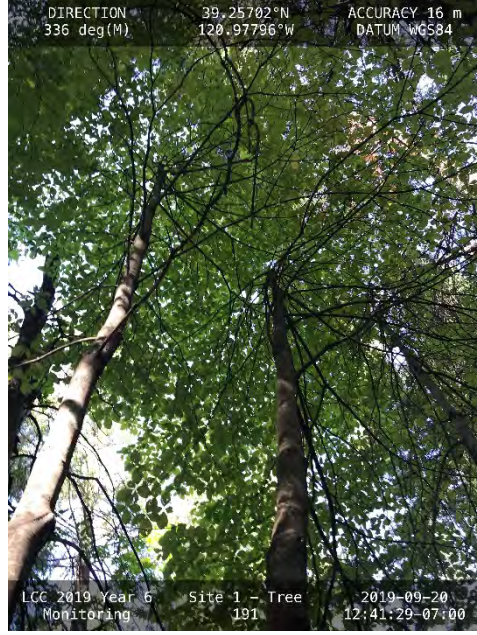
<p>LCC Site 1. Downslope; downed woody debris, thick duff, minimal understory, pink honeysuckle (<i>Lonicera hispidula</i>) vining on tree in foreground.</p>	<p>LCC Site 1. Downslope; example canopy cover of assessment tree (#186).</p>

<p>LCC Site 1. Upslope; thick duff and downed woody debris.</p>	<p>LCC Site 1. Upslope; example canopy cover of assessment tree (#191).</p>

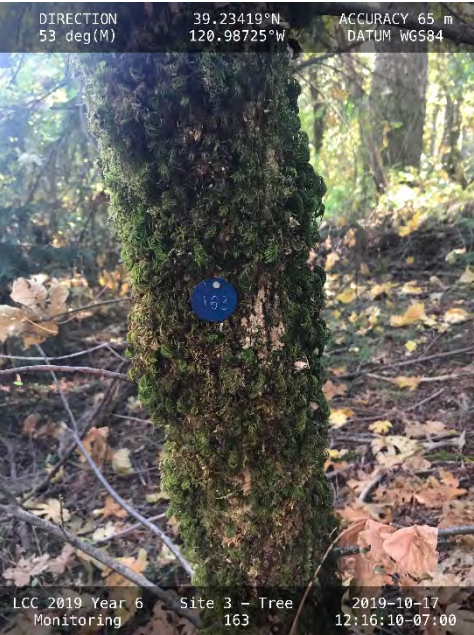
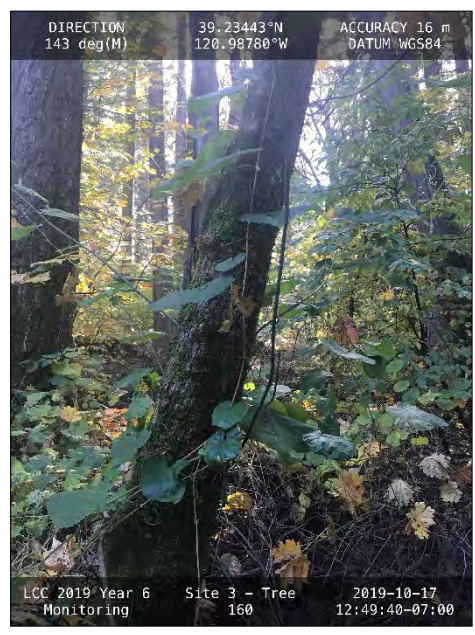
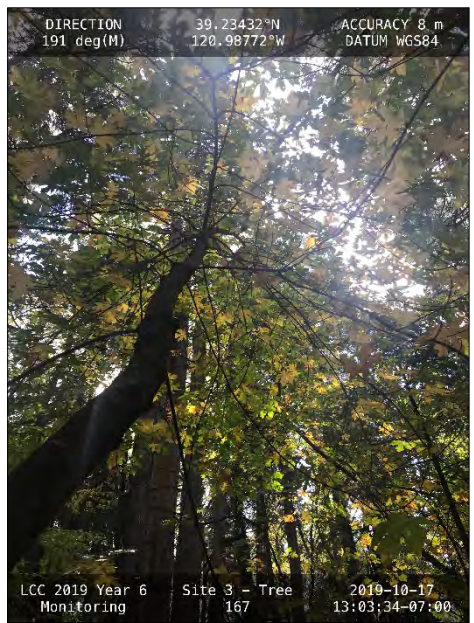
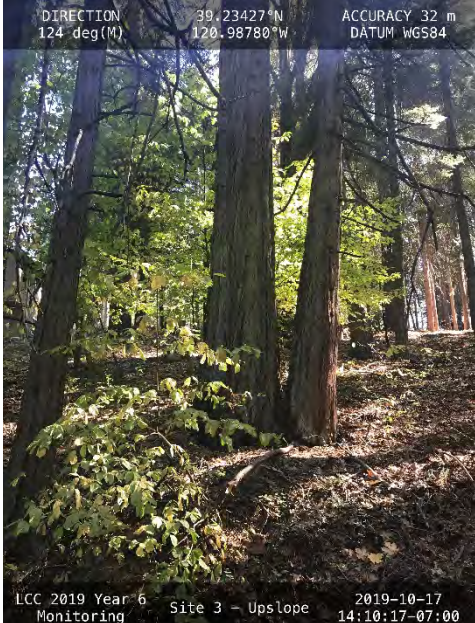
<p>LCC Site 3. Downslope; understory and downed woody debris throughout site; some areas with large fallen trees and piled debris.</p>	<p>LCC Site 3. Downslope; example assessment tree (#160), with moss surface growth and parasitic California wild grape (<i>Vitis californica</i>); English Ivy (<i>Hedera helix</i>) also present in understory and on trees.</p>

<p>LCC Site 3. Downslope; example canopy cover of assessment tree (#167).</p>	<p>LCC Site 3. Upslope; minimal understory and thick duff.</p>

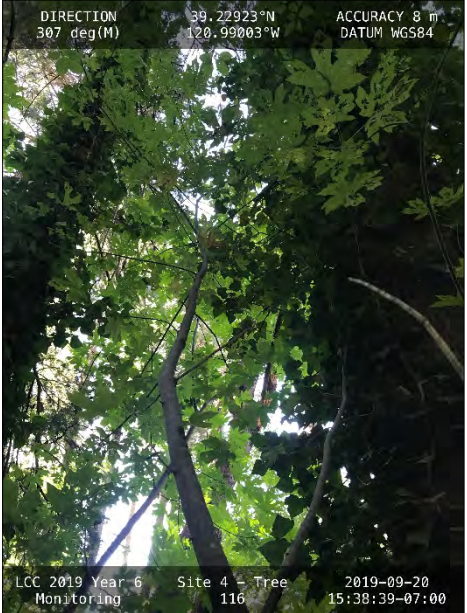
<p>DIRECTION 307 deg(M) 39.22923°N 120.99003°W ACCURACY 8 m DATUM WGS84</p> <p>LCC 2019 Year 6 Monitoring Site 4 - Tree 116 2019-09-20 15:38:39-07:00</p>
<p>LCC Site 4. Downslope; understory of English Ivy (<i>Hedera helix</i>) and downed woody debris.</p>	<p>LCC Site 4. Downslope; example assessment tree (#116), with heavy insect damage on leaves.</p>

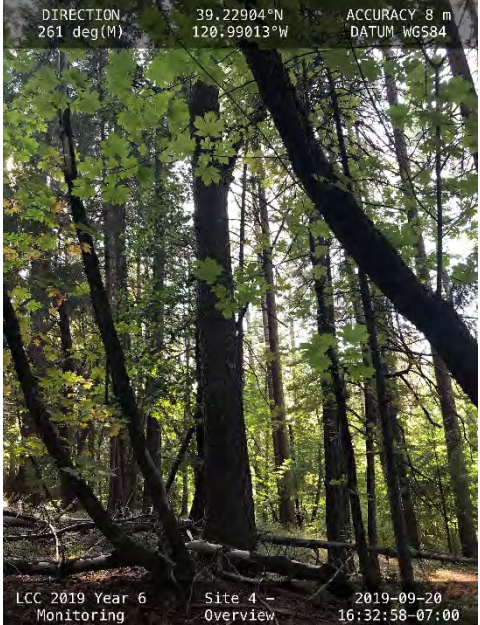
<p>DIRECTION 261 deg(M) 39.22904°N 120.99013°W ACCURACY 8 m DATUM WGS84</p> <p>LCC 2019 Year 6 Monitoring Site 4 - Overview 2019-09-20 16:32:58-07:00</p>
<p>LCC Site 4. Downslope; example canopy cover of assessment tree (#201).</p>	<p>LCC Site 4. Upslope; understory of poison oak (<i>Toxicodendron diversilobum</i>) and large downed trees.</p>

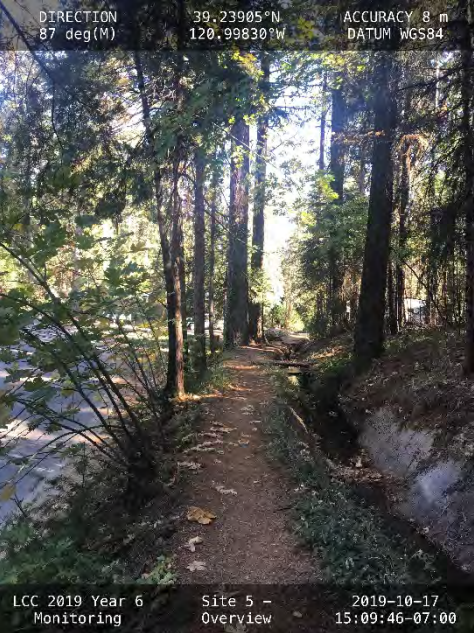
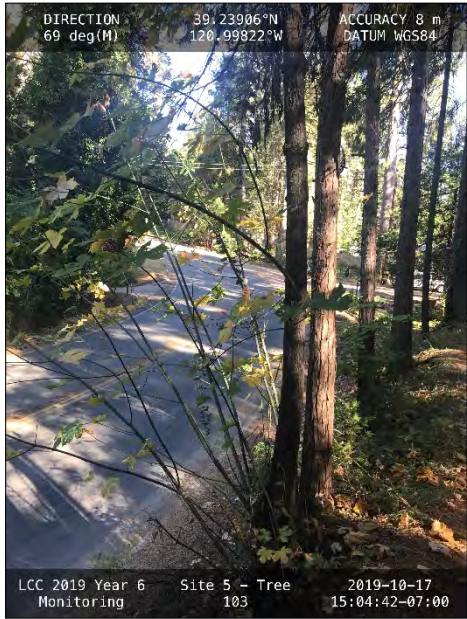
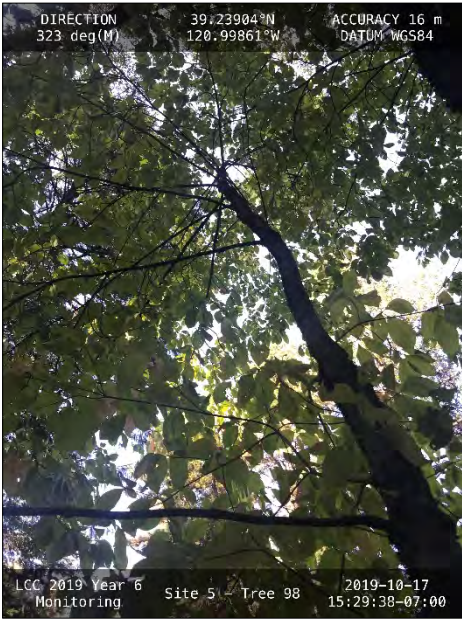
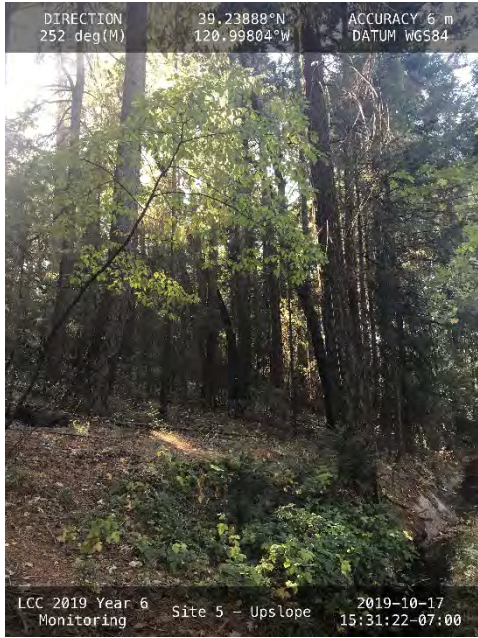
<p>UGVC Site 5. Downslope; steep and adjacent to roadside, thick duff, understory of saplings, grasses, and pink honeysuckle (<i>Lonicera hispidula</i>).</p>	<p>UGVC Site 5. Downslope; example assessment tree (#103), with epicormic growth and evidence of prior limbing for road maintenance.</p>

<p>UGVC Site 5. Downslope; example canopy cover of assessment tree (#98).</p>	<p>UGVC Site 5. Upslope; largely conifer with few deciduous trees, thick duff, understory of Himalayan blackberry (<i>Rubus armeniacus</i>).</p>
