**SUBJECT: South Yuba Canal Condition Assessment Report (Project #2419)**

# South Yuba Canal 2021 Condition Assessment

Final Report  
South Yuba Canal  
2021 Condition Assessment

Nevada Irrigation District

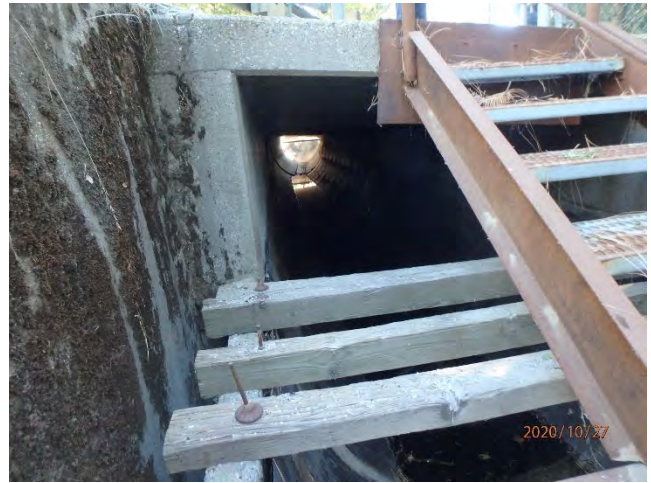
Photo 6 Culvert under Highway 20

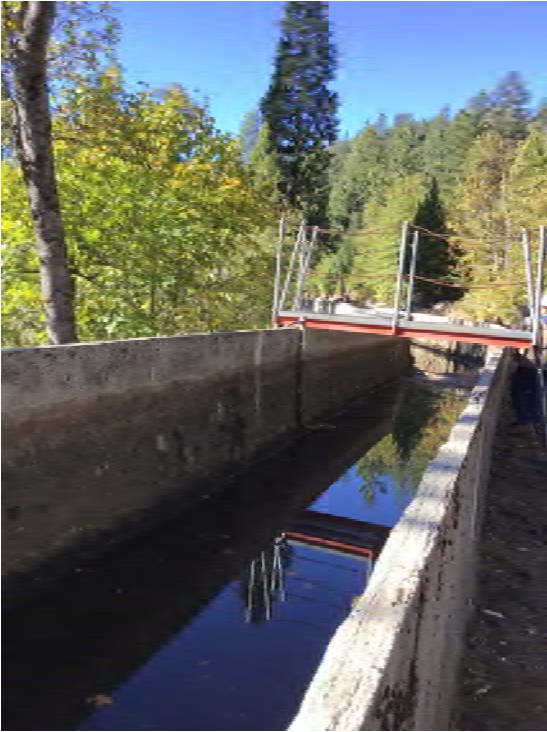
Photo 10 Typical Concrete Box

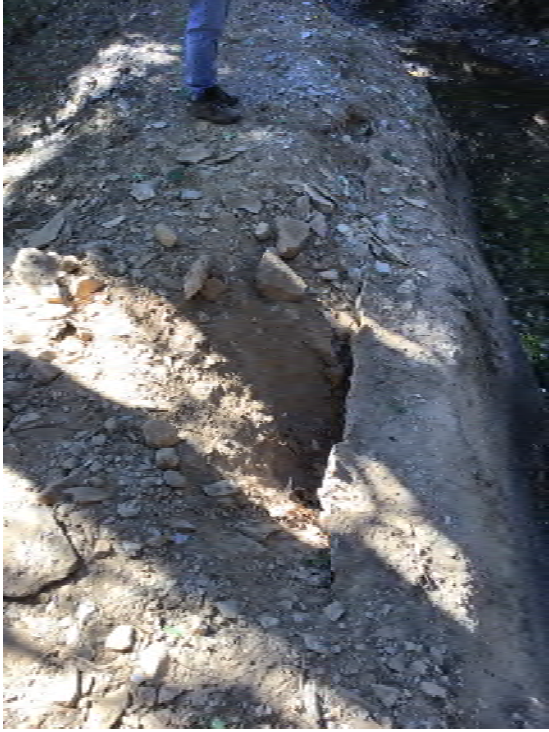
Photo 12 Minor Erosion behind Liner

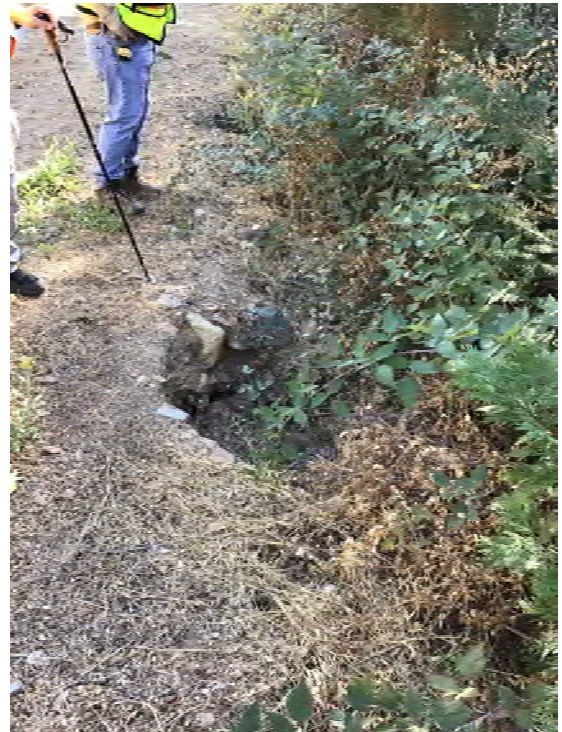
Photo 15 Erosion and Voids in Bench

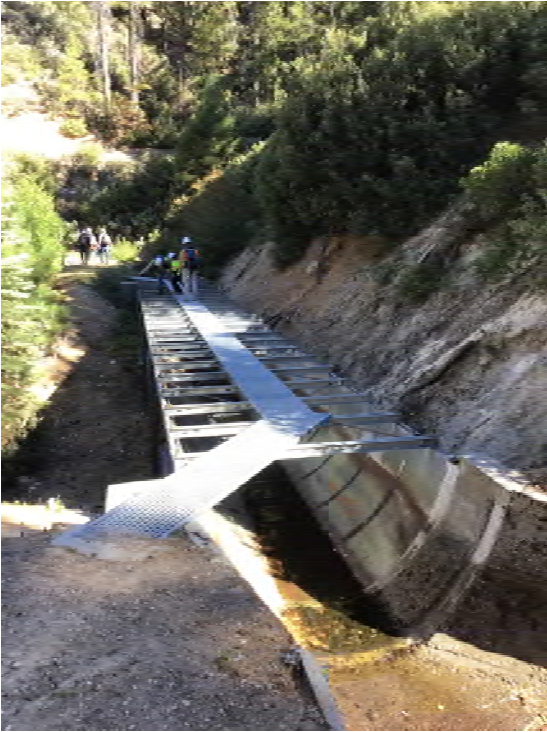
Photo 16 Historic Landslide at Flume 8/2

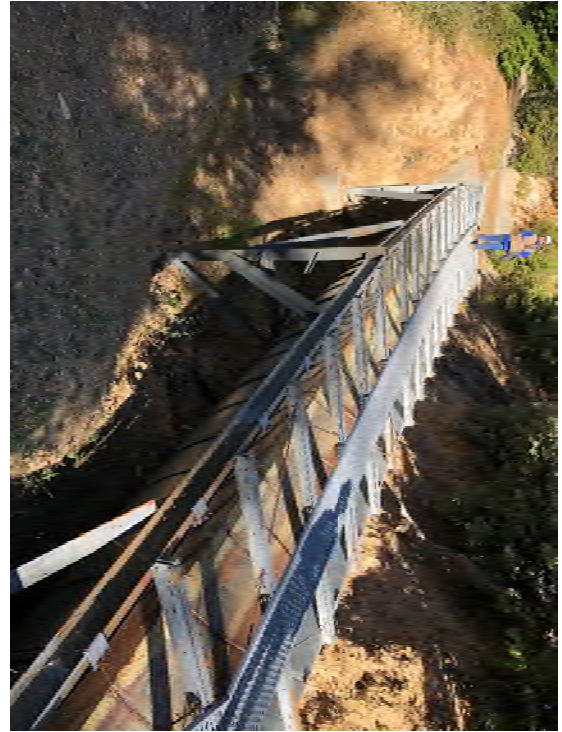
Photo 17 Historic Landslide at Flume 8/4

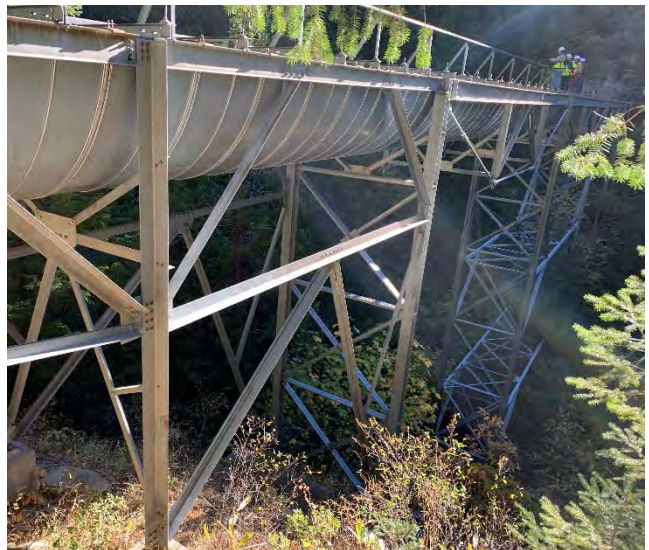
Photo 21 Steep Hollow #1 Lennon Flume

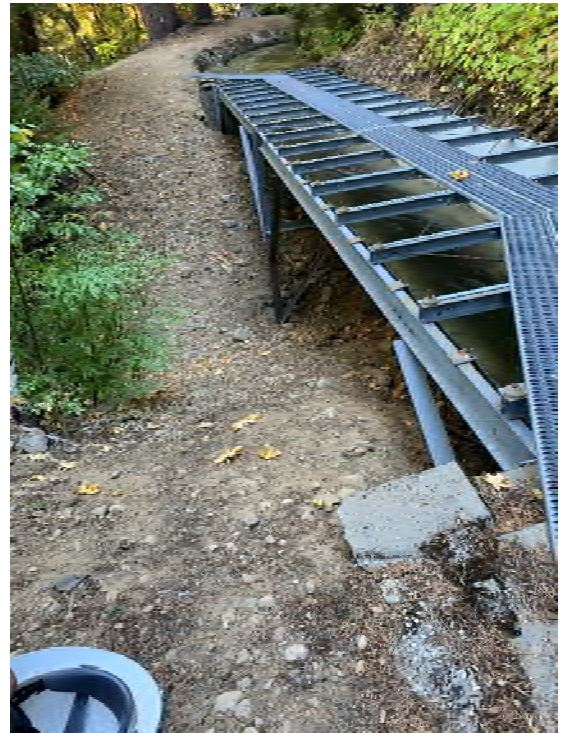
Photo 25 Historic Landslide at Flume 11/2

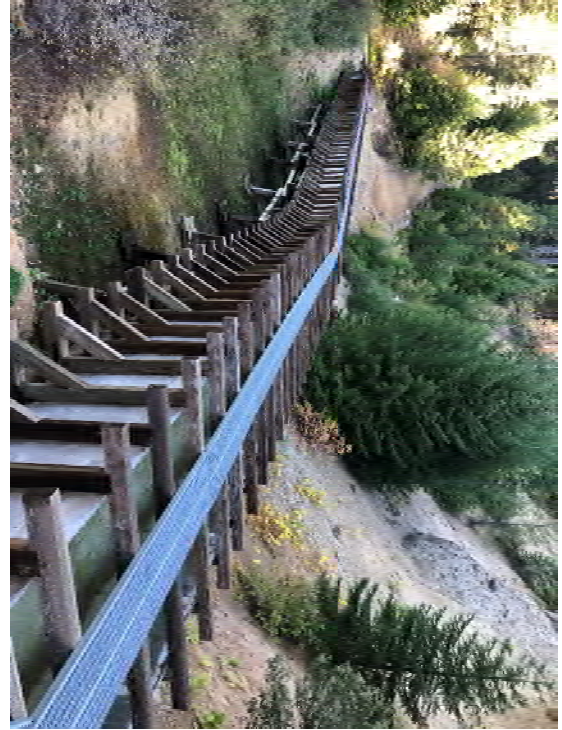
Photo 27 Wood Box Flume

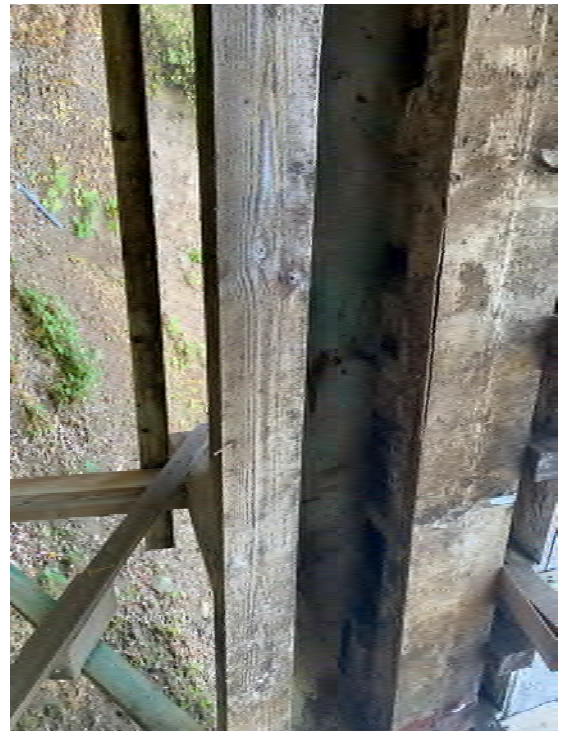
Photo 29 Split Girder in Timber Flume

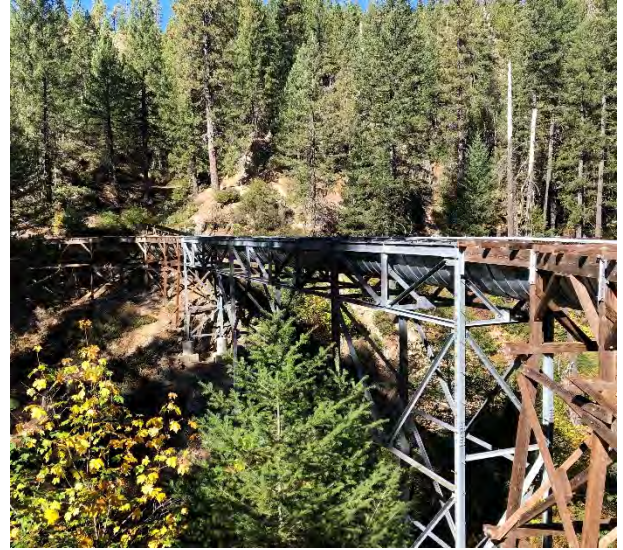
Photo 31 Steep Hollow #2 Lennon Flume

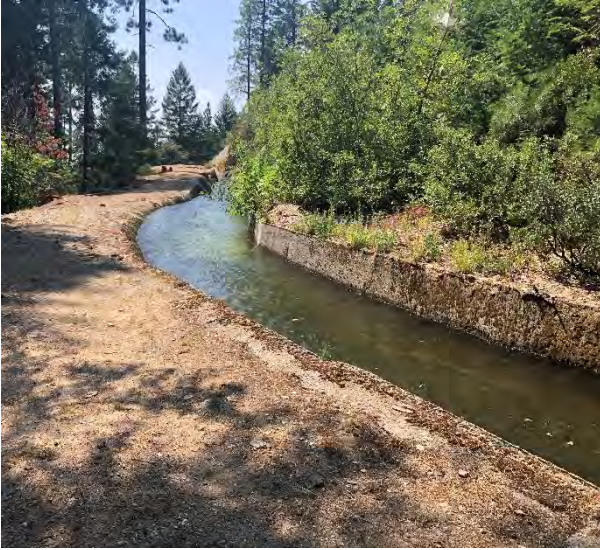
Photo 34 Slump in Bench

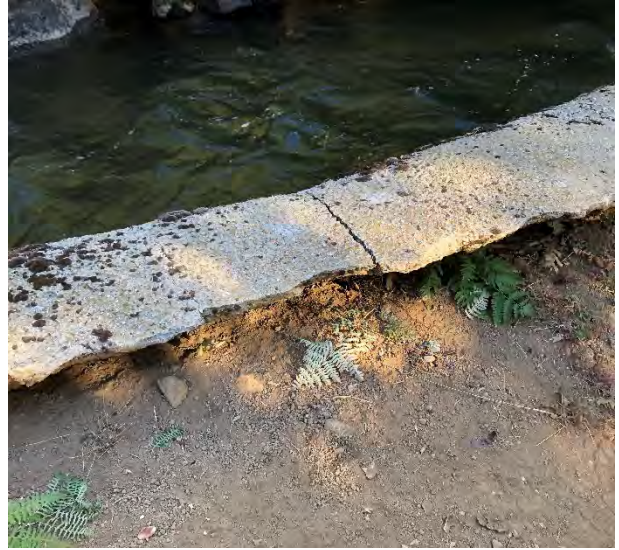
Photo 35 Void in Liner

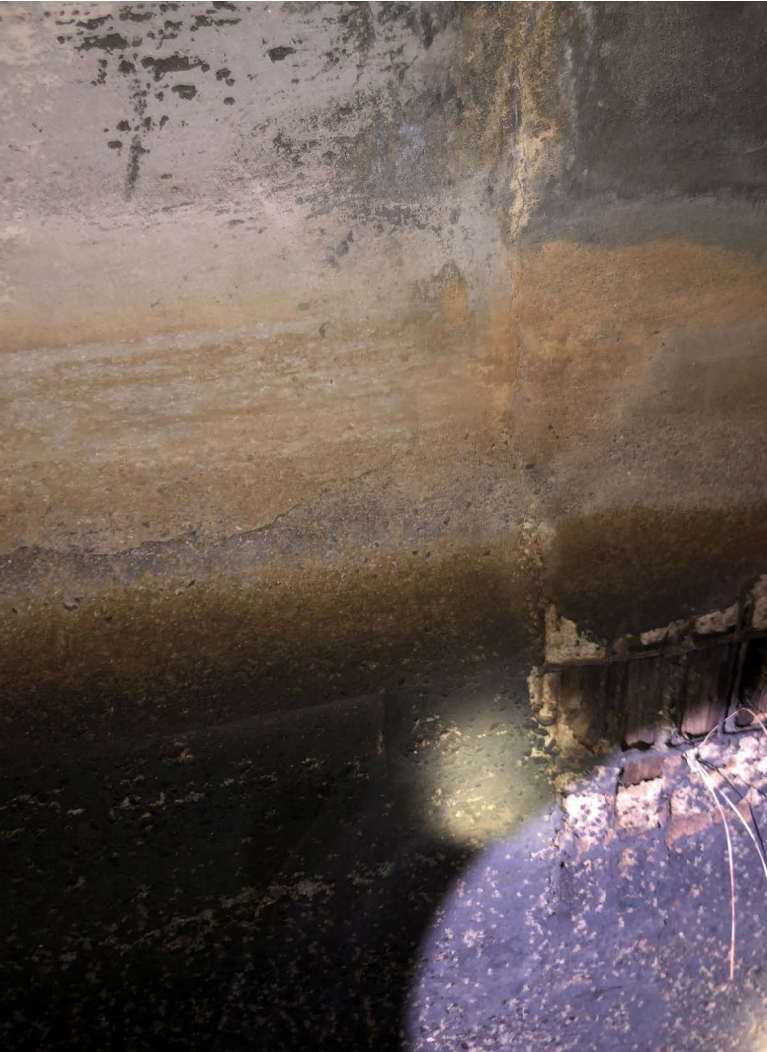
Little Tunnel Liner Thin Cover On Timber

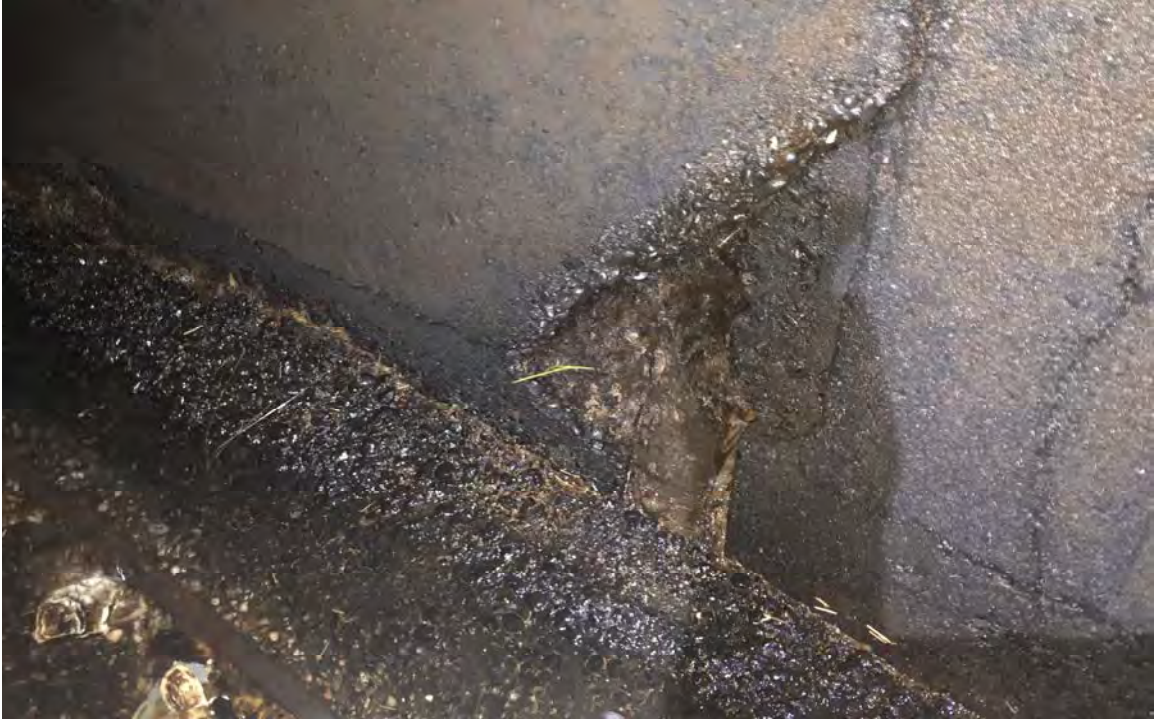
Big Tunnel 0+70 Thin Cover

GHD recommends continued monitoring of the eroded thin liner sections discussed above. The original design called for thin shotcrete cover over old timber sets.

Within approximately five years, we anticipate that "dental" localized repair work may be needed in the eroded liner sections. Other than eroded liner sections, no evidence of structural distress was observed.

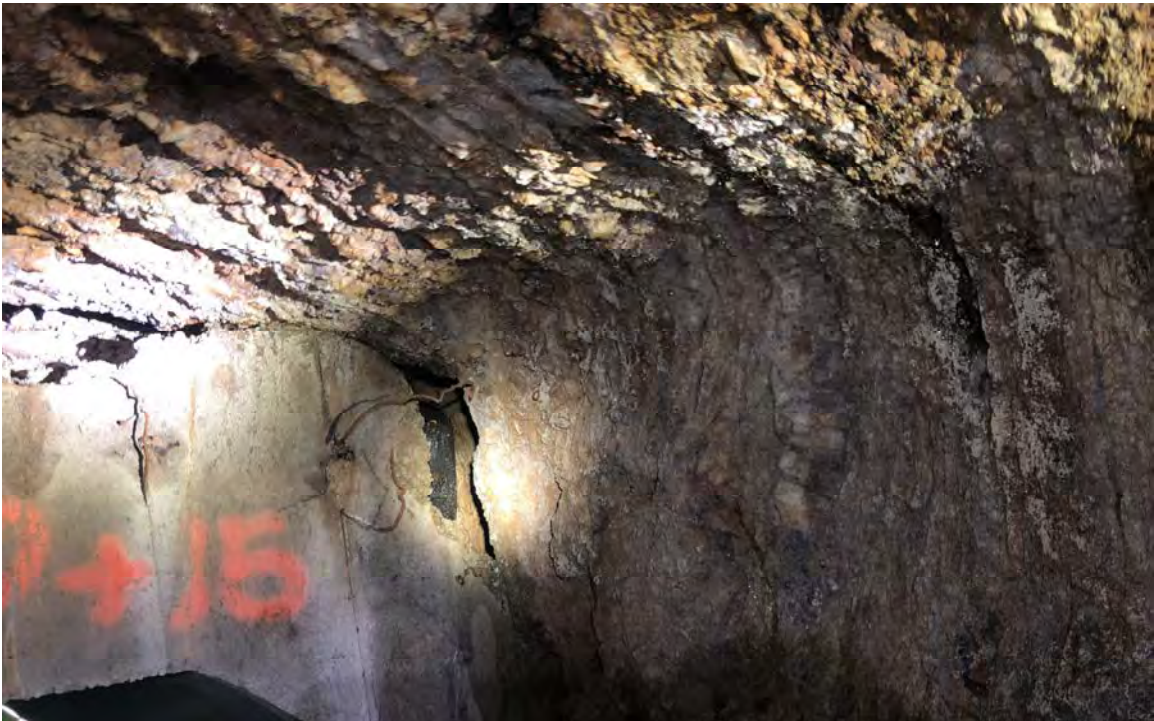
Big Tunnel 20+15

Station 20+15 begin lined section. the transition is eroded above spring line on the right rib and back has been partially filled. looks tight however from spring line down to belly on both left and right ribs. a vertical concrete transition exists at approximately 45° angle over distance of about 12 inches (chamfered edge).

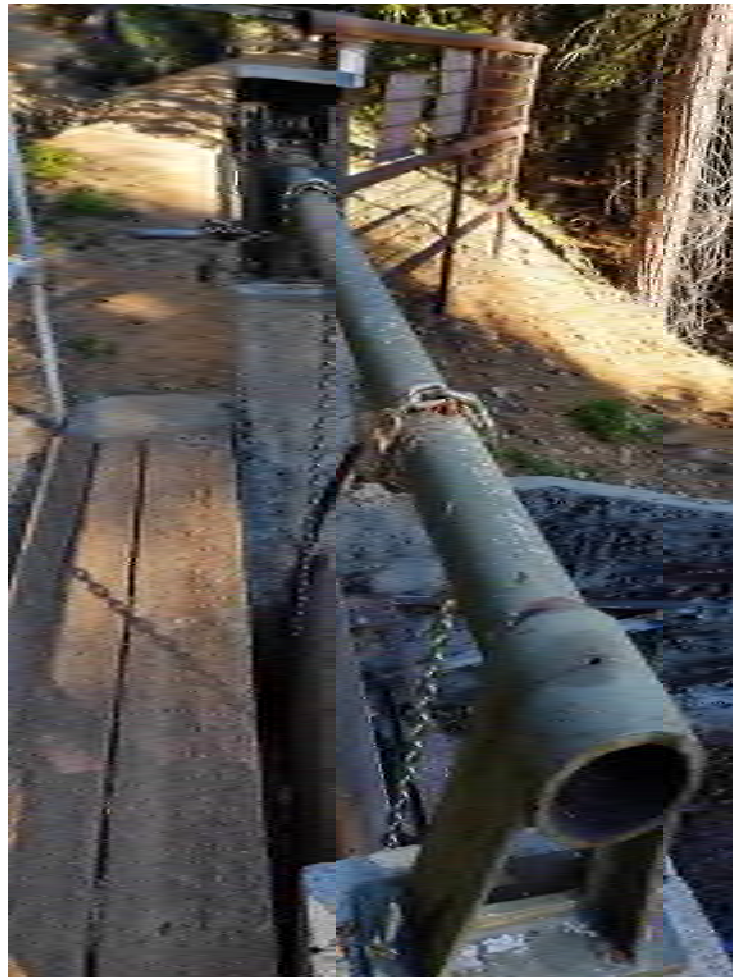
Photo 32 - View of Little Tunnel Spillway

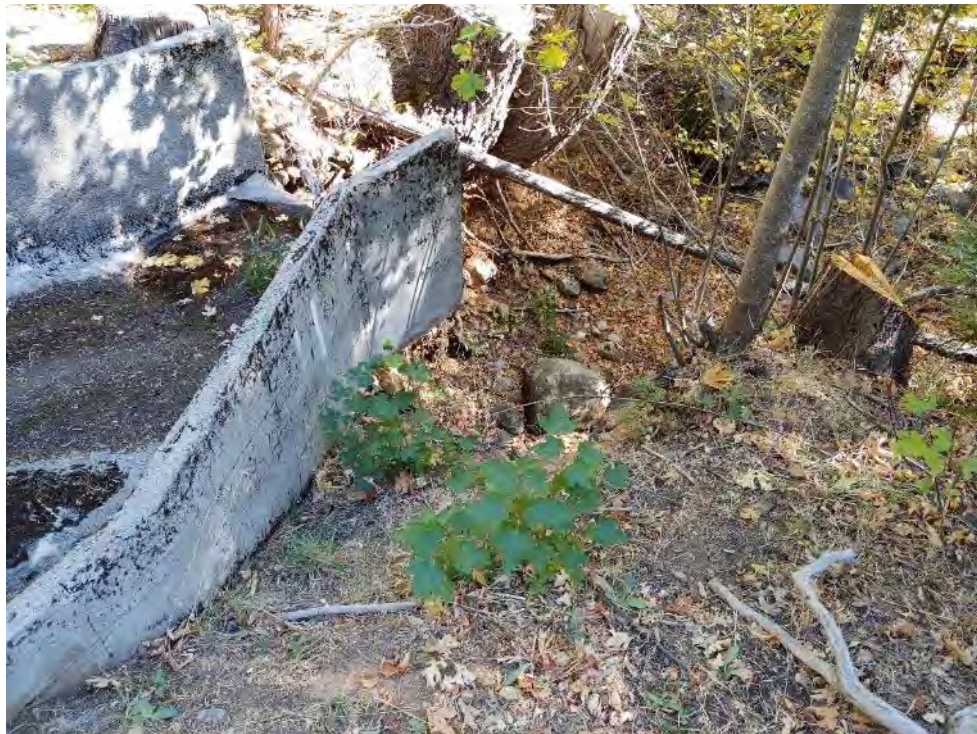
Photo 33 - View of Little Tunnel Spillway

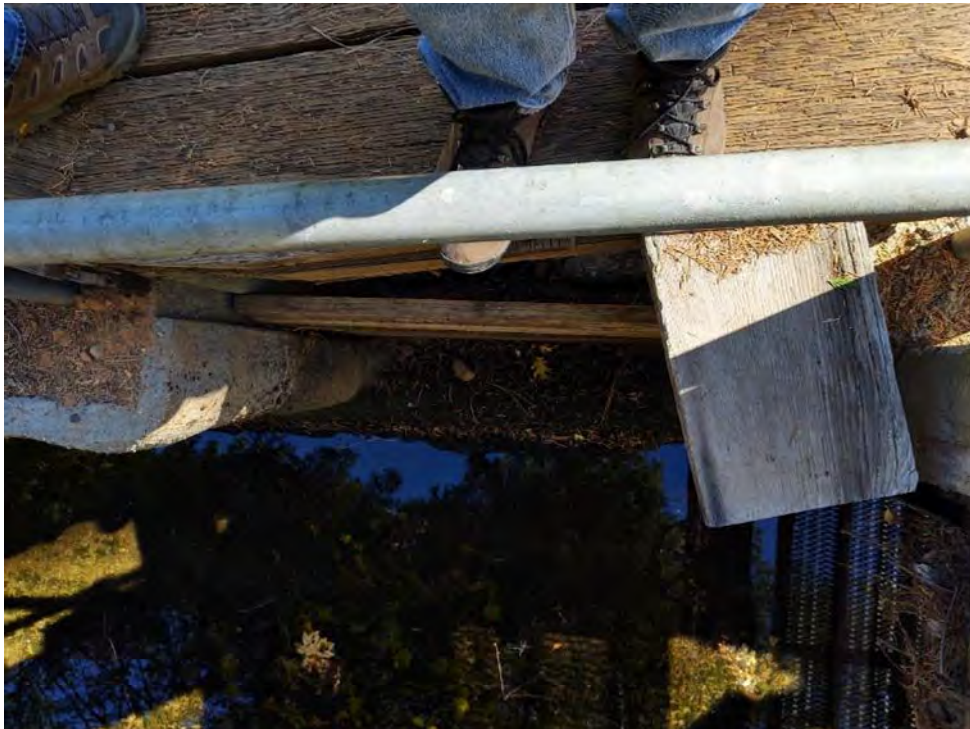
Photo 34 - View of Little Tunnel Spillway

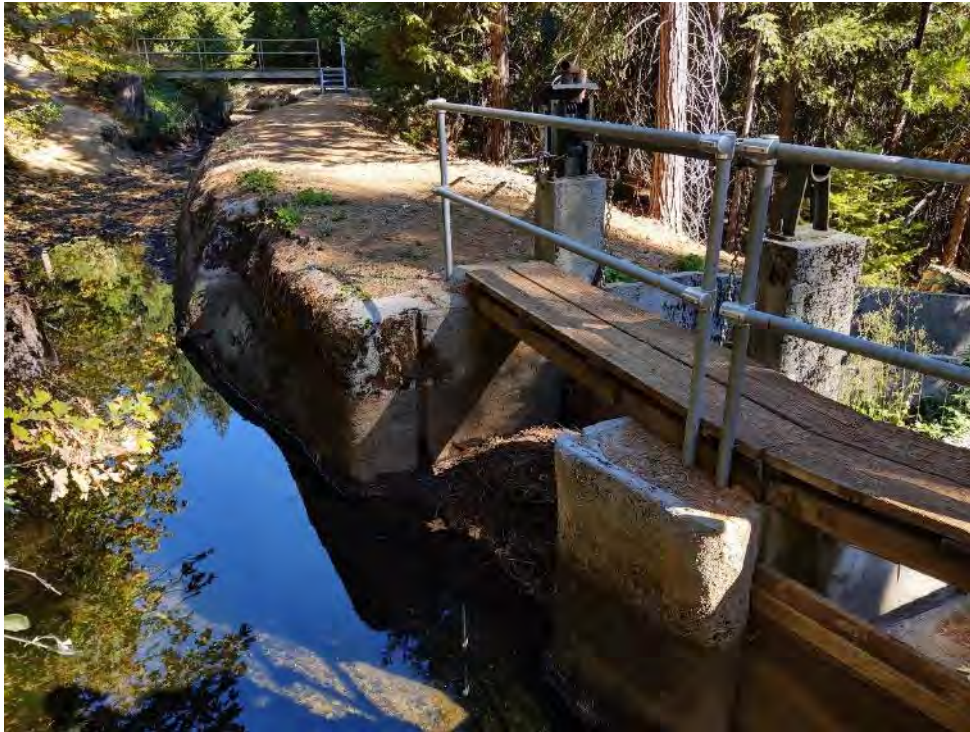
Photo 35 - View of Little Tunnel Spillway

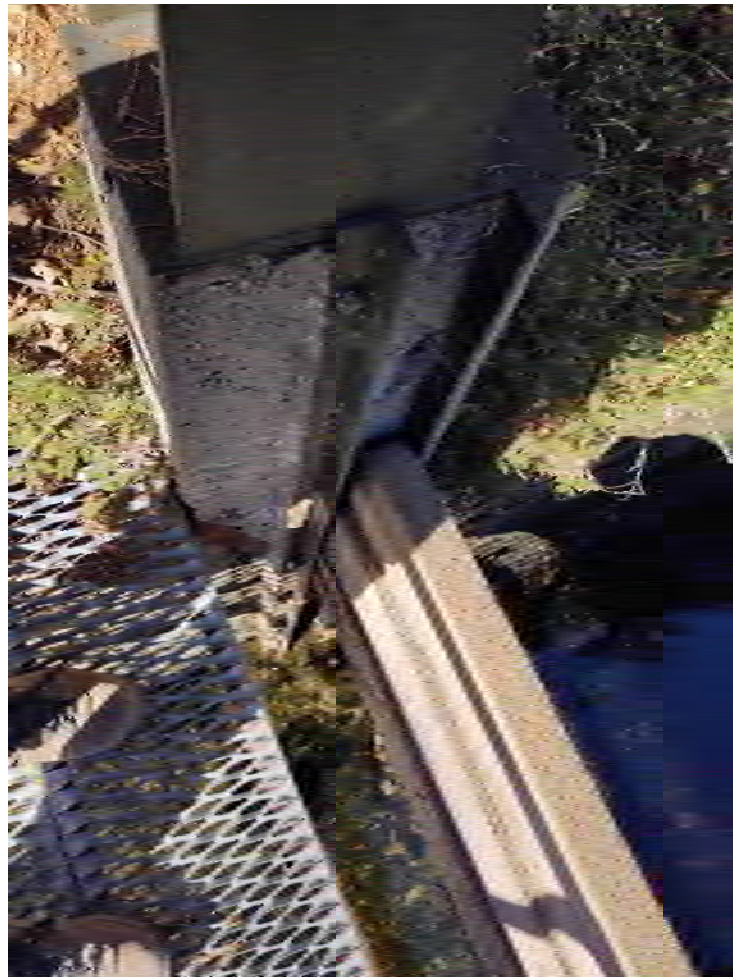
Photo 36 - View of Little Tunnel Spillway

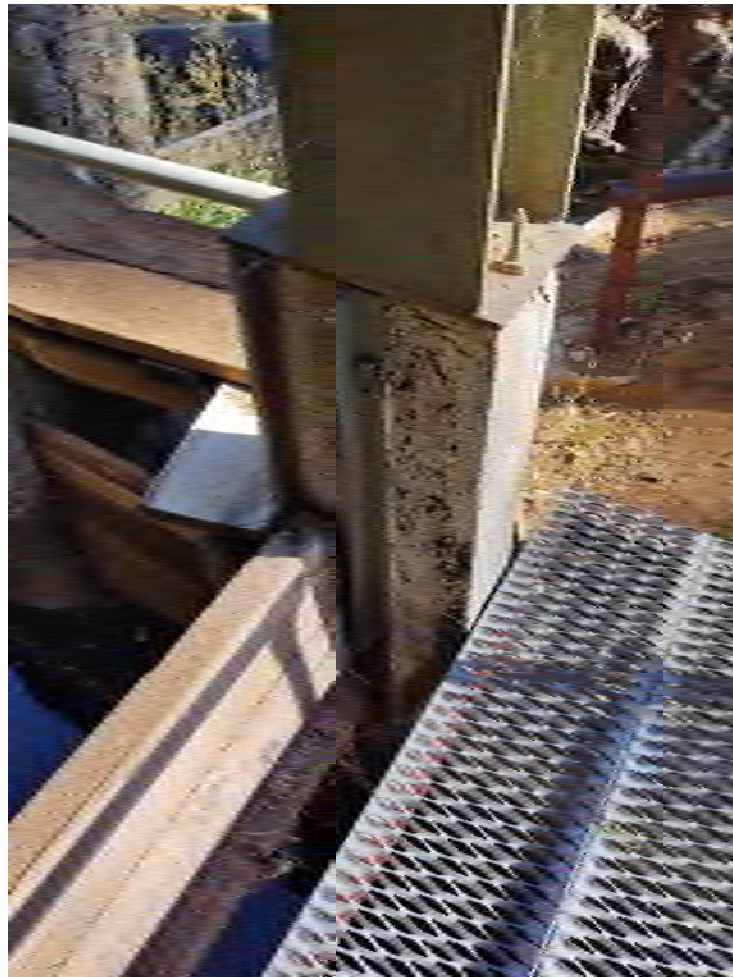
Photo 37 - View of Little Tunnel Spillway

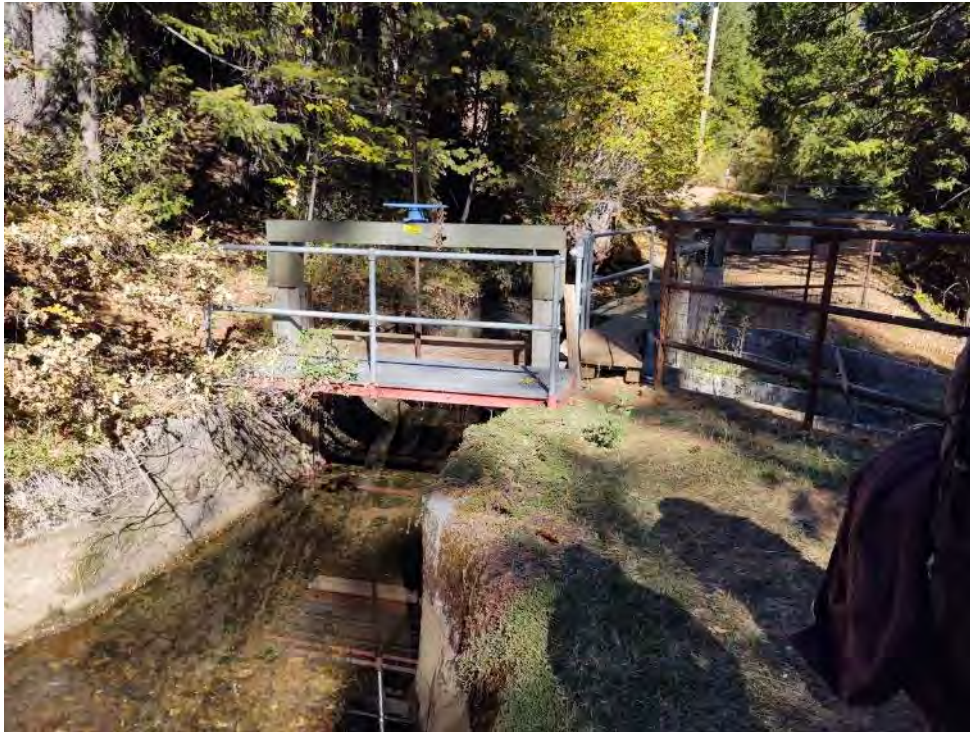
Photo 38 - View of Little Tunnel Spillway

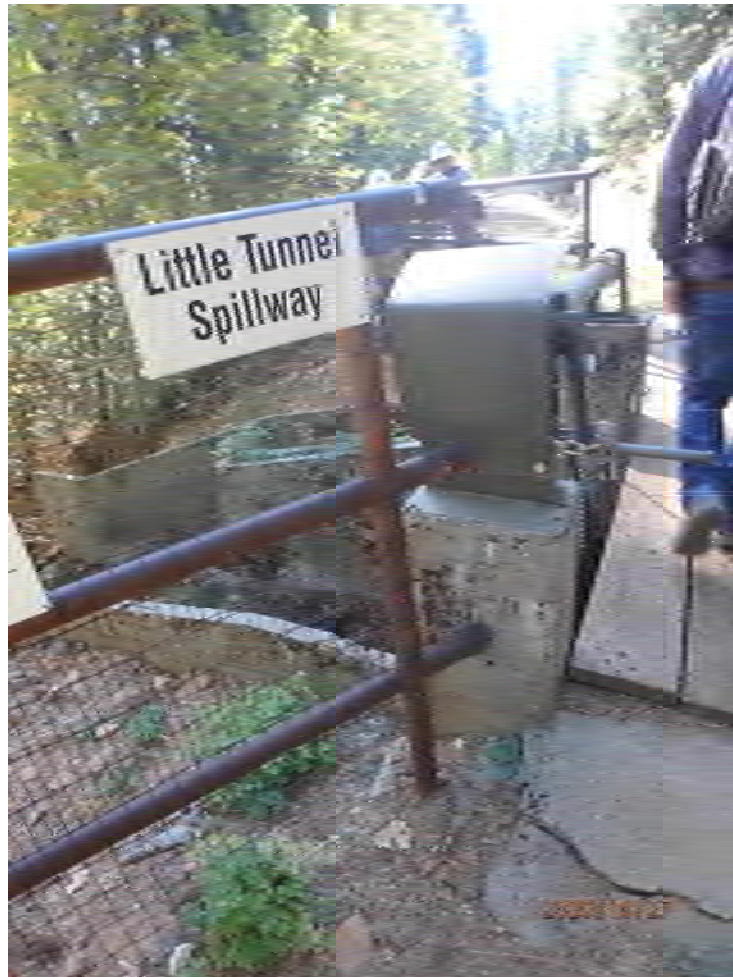
Photo 39 - View of Little Tunnel Spillway

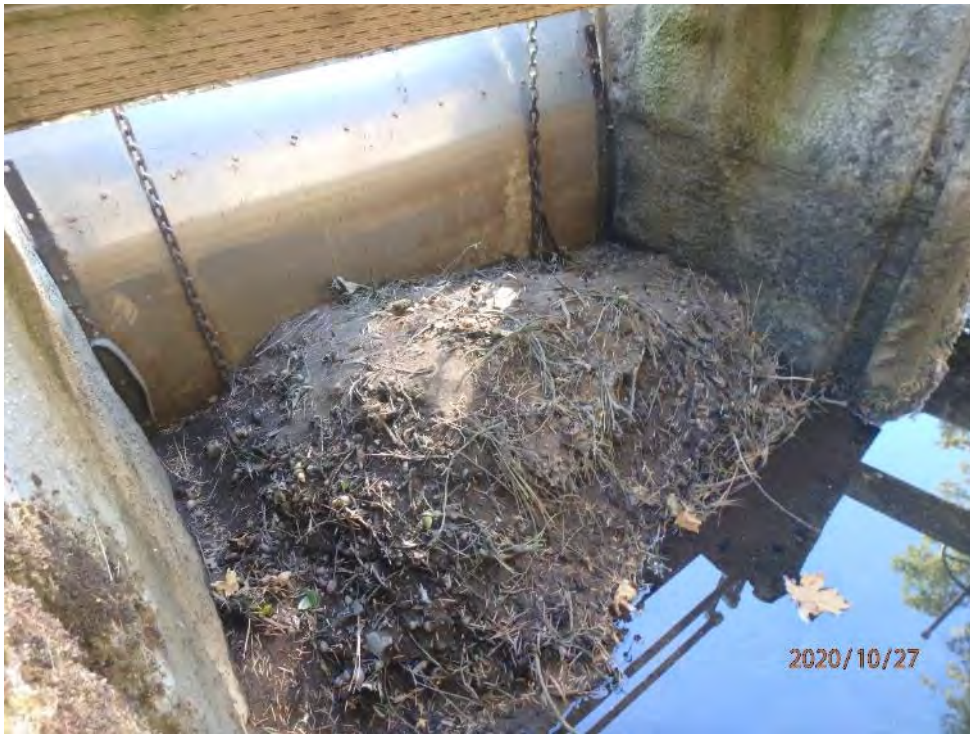
Photo 40 - View of Little Tunnel Spillway

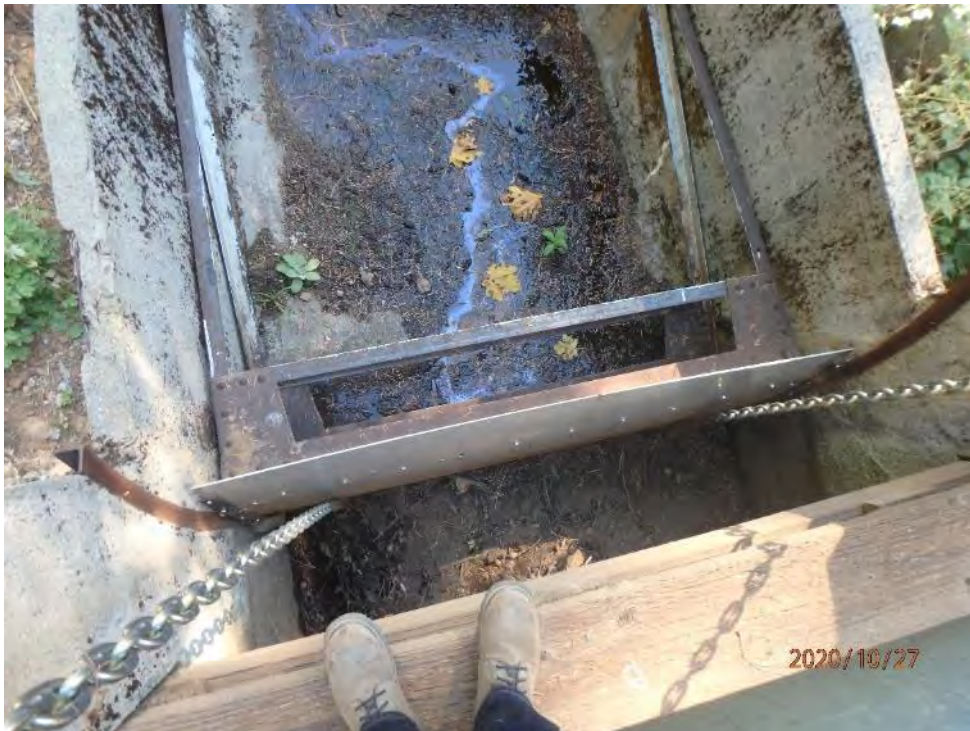
Photo 41 - View of Little Tunnel Spillway

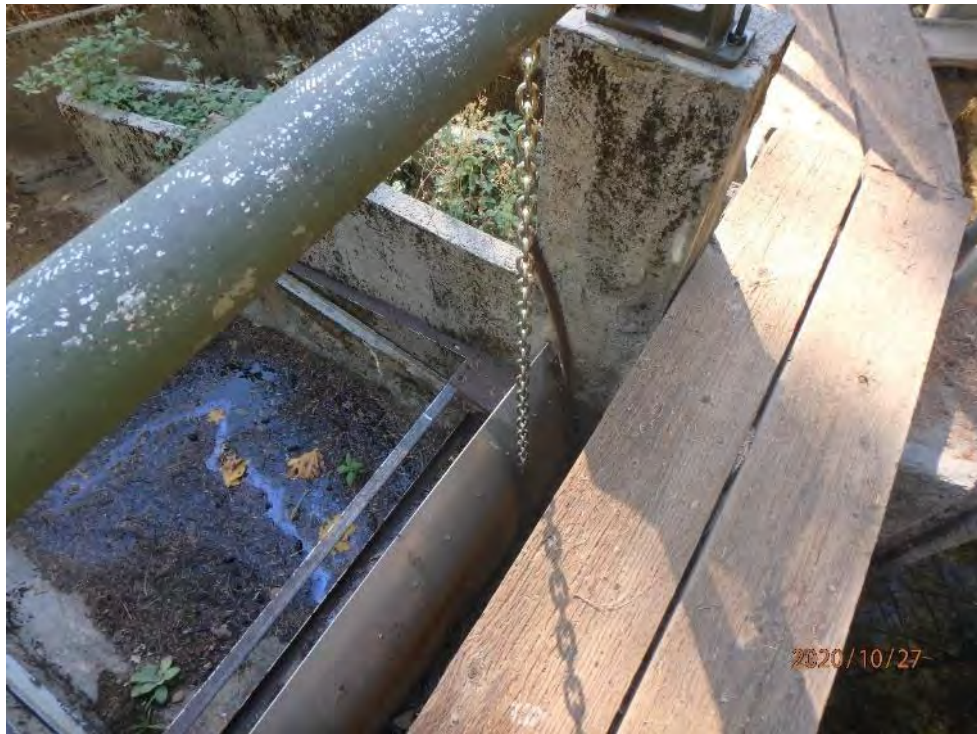
Photo 42 - View of Little Tunnel Spillway

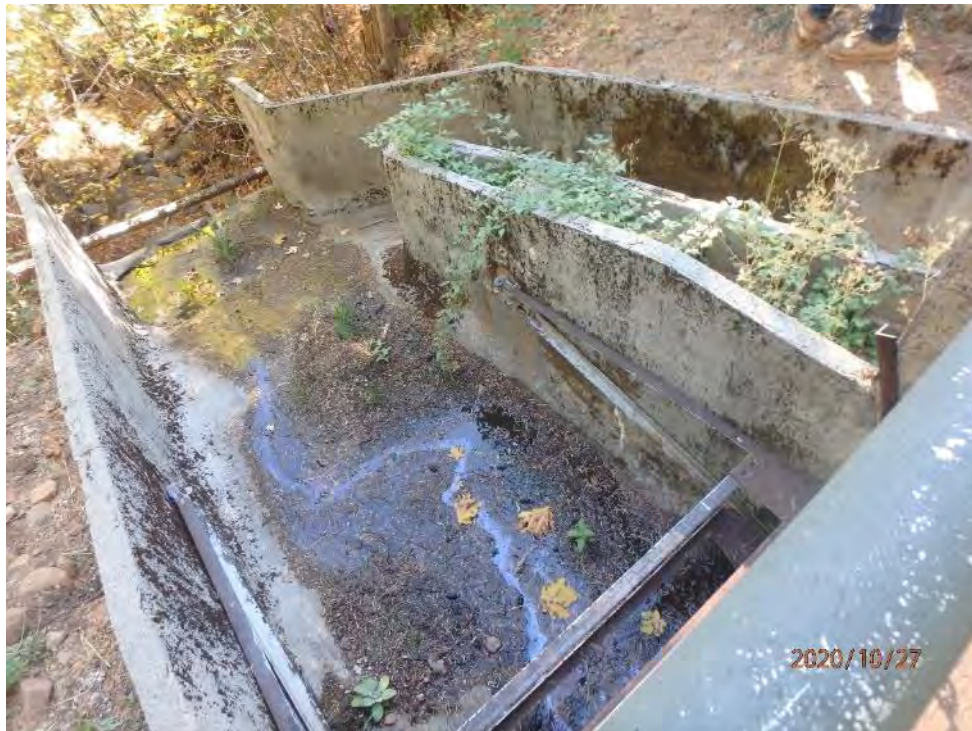
Photo 43 - View of Little Tunnel Spillway

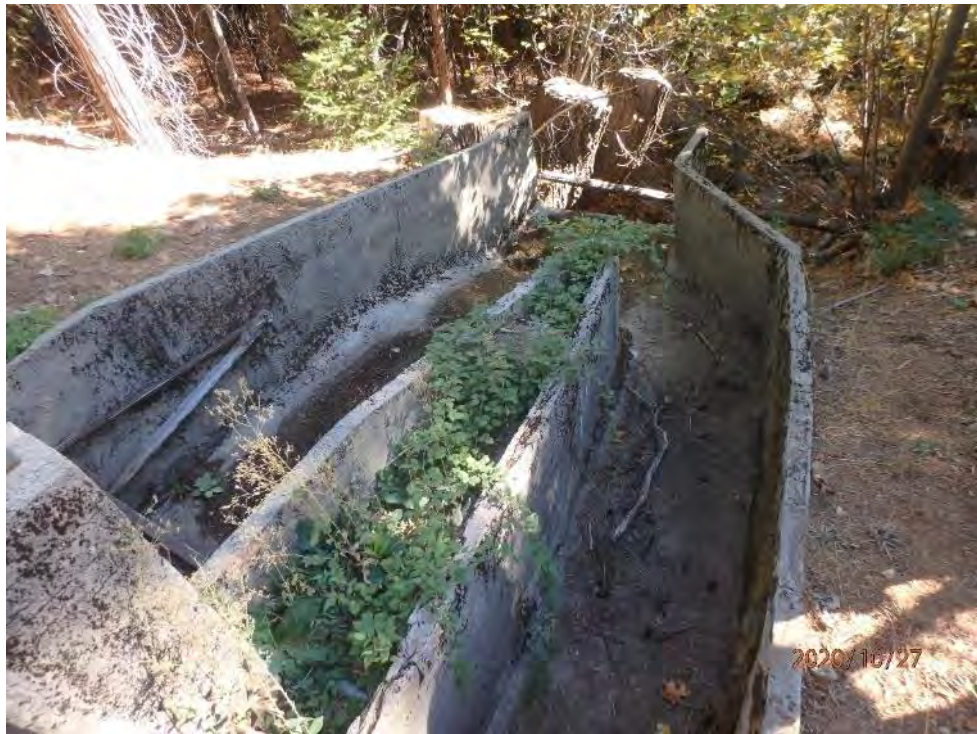
Photo 44 - View of Little Tunnel Spillway

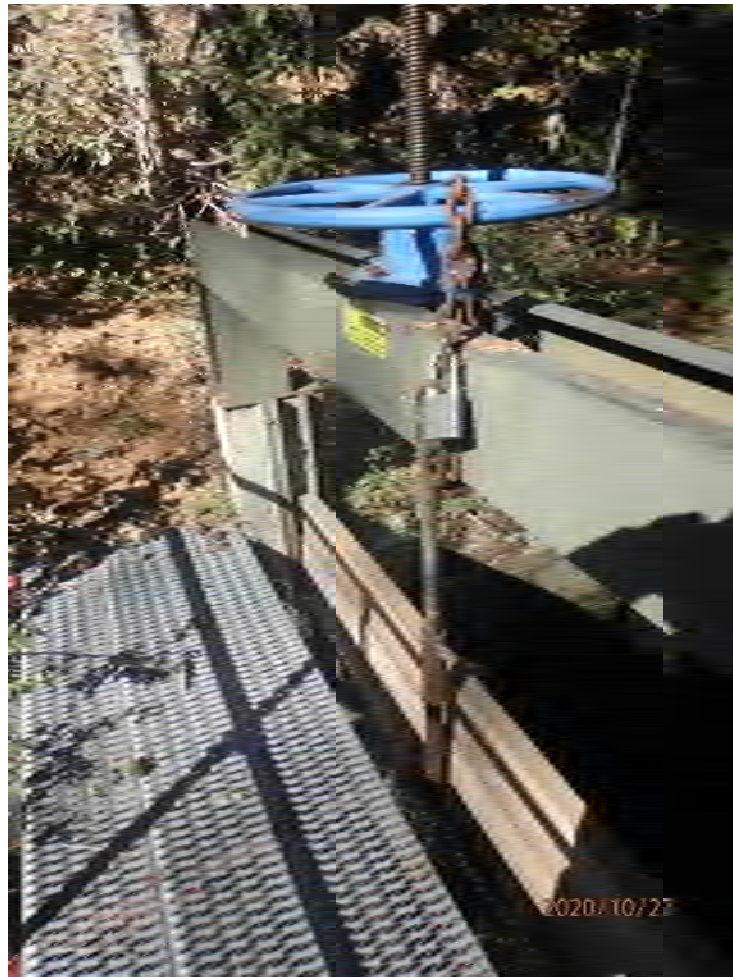
Photo 45 - View of Little Tunnel Spillway

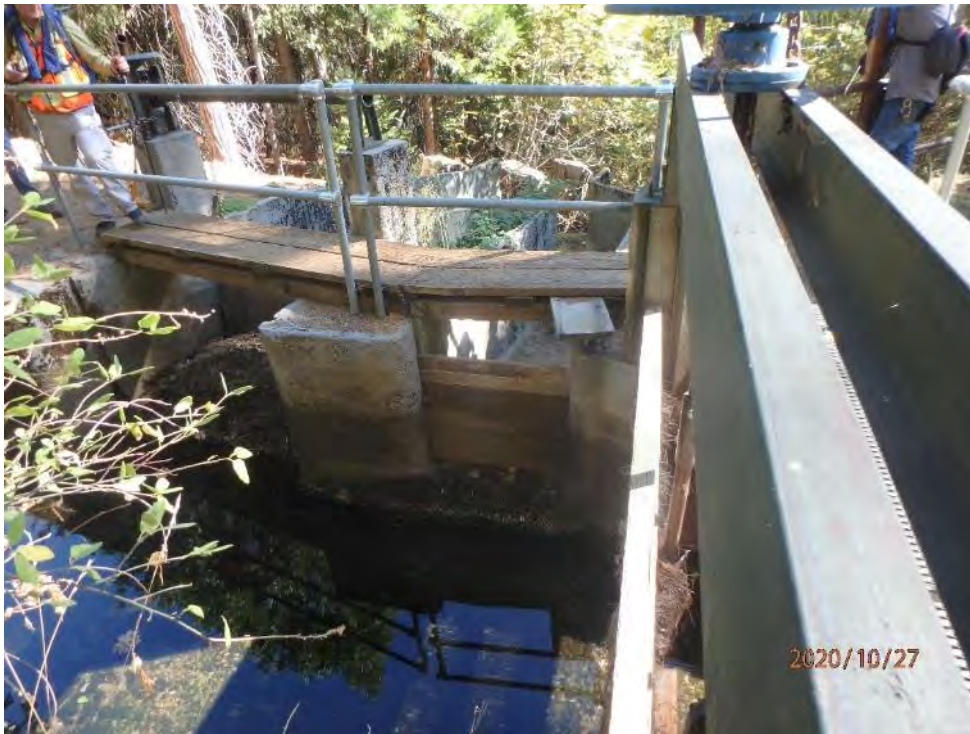
Photo 46 - View of Little Tunnel Spillway

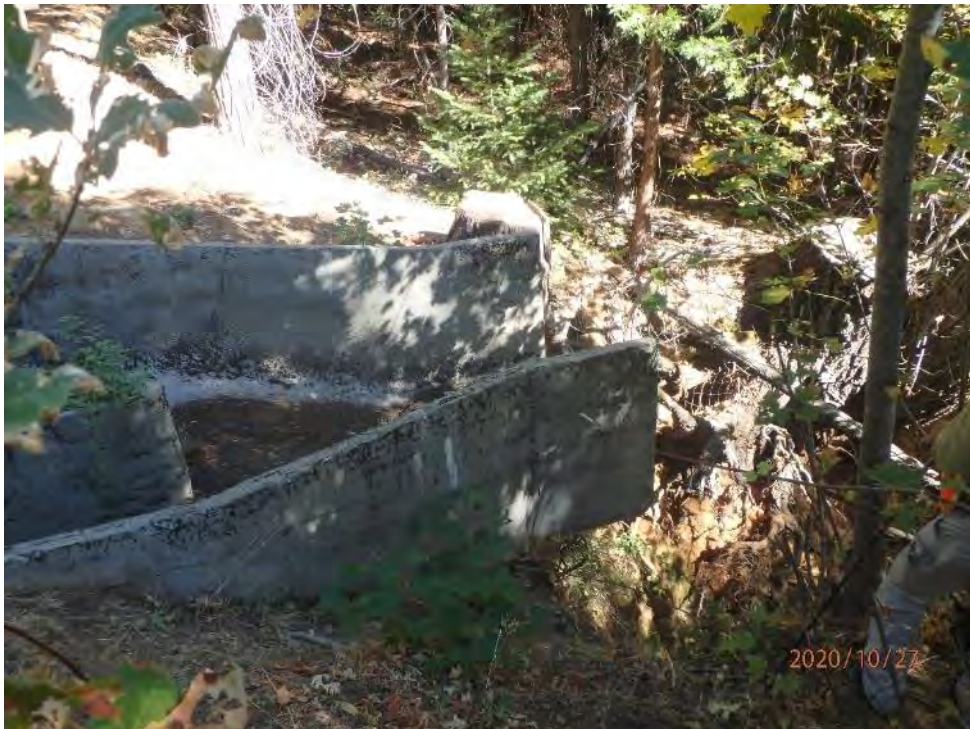
Photo 47 - View of Little Tunnel Spillway

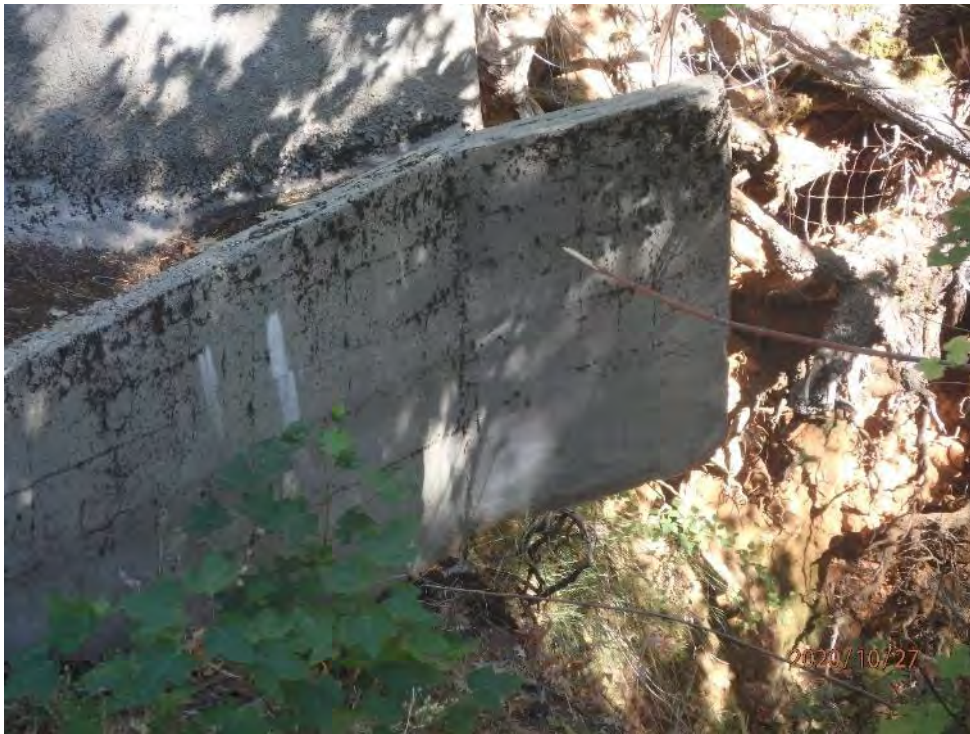
Photo 48 - View of Little Tunnel Spillway

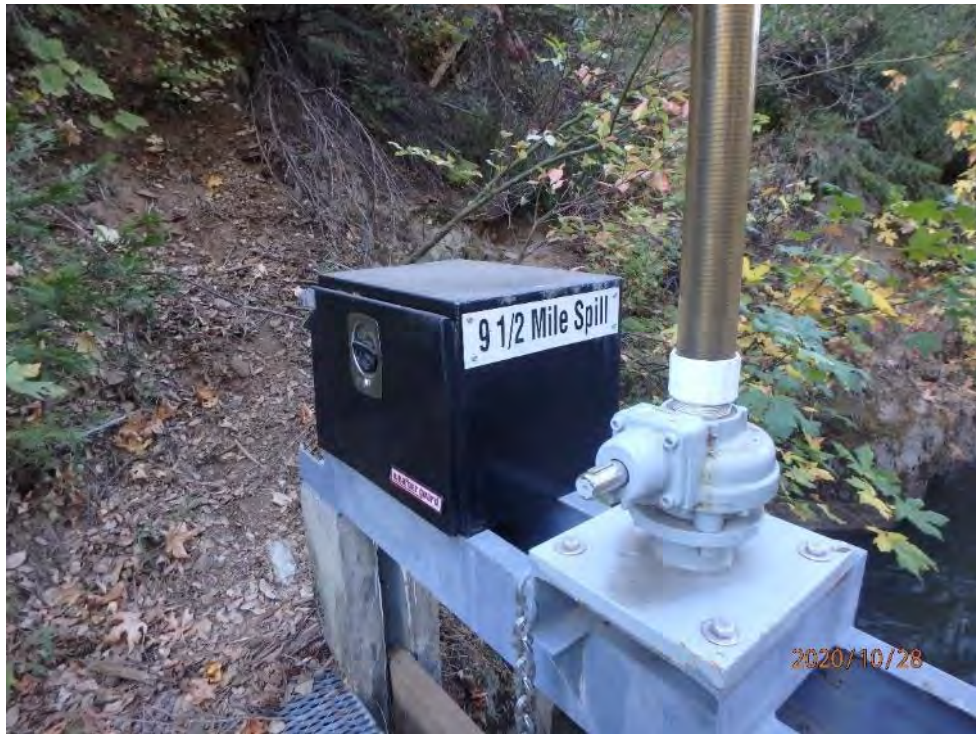
Photo 58 - View of 9 ½ Mile Spill

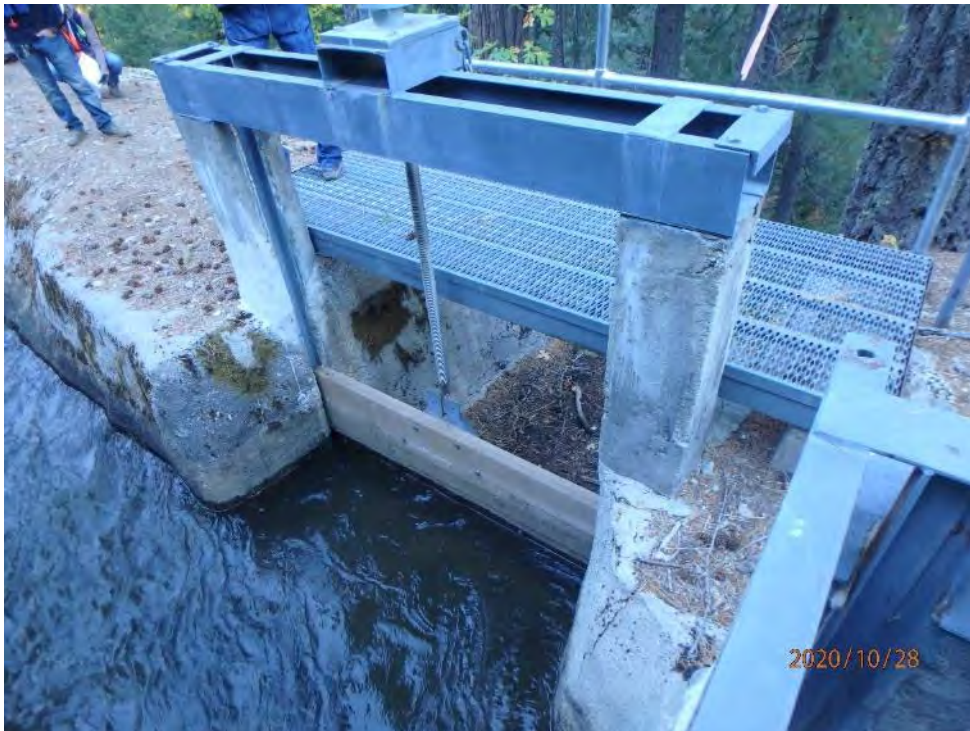
Photo 59 - View of 9 1/2 Mile Spill

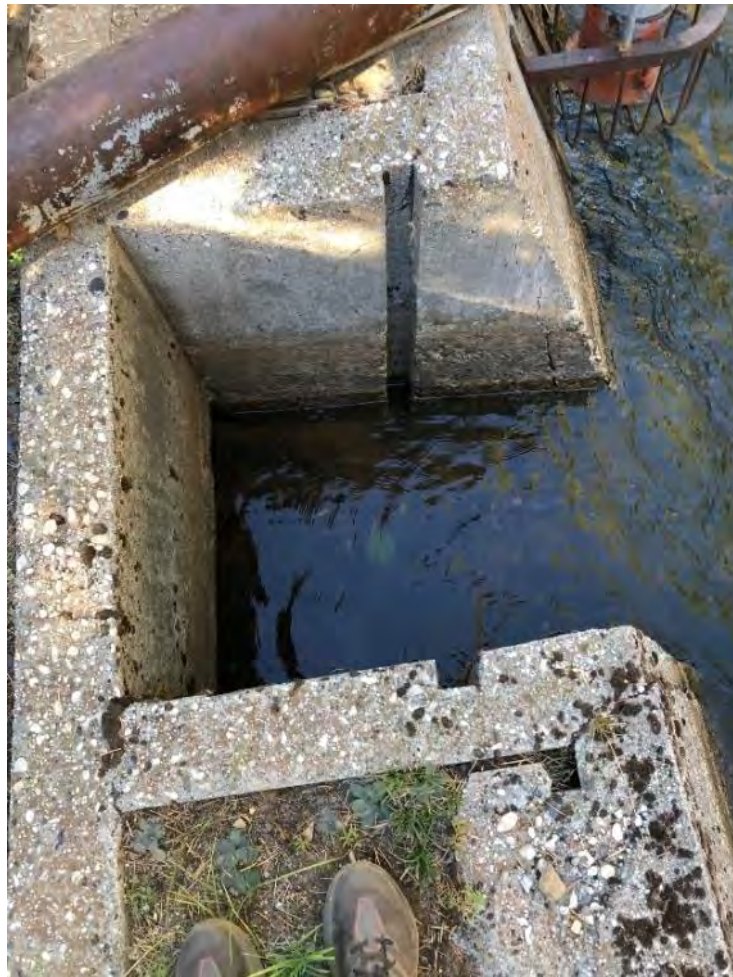
Photo 63 - View of 9 ½ Mile Spill

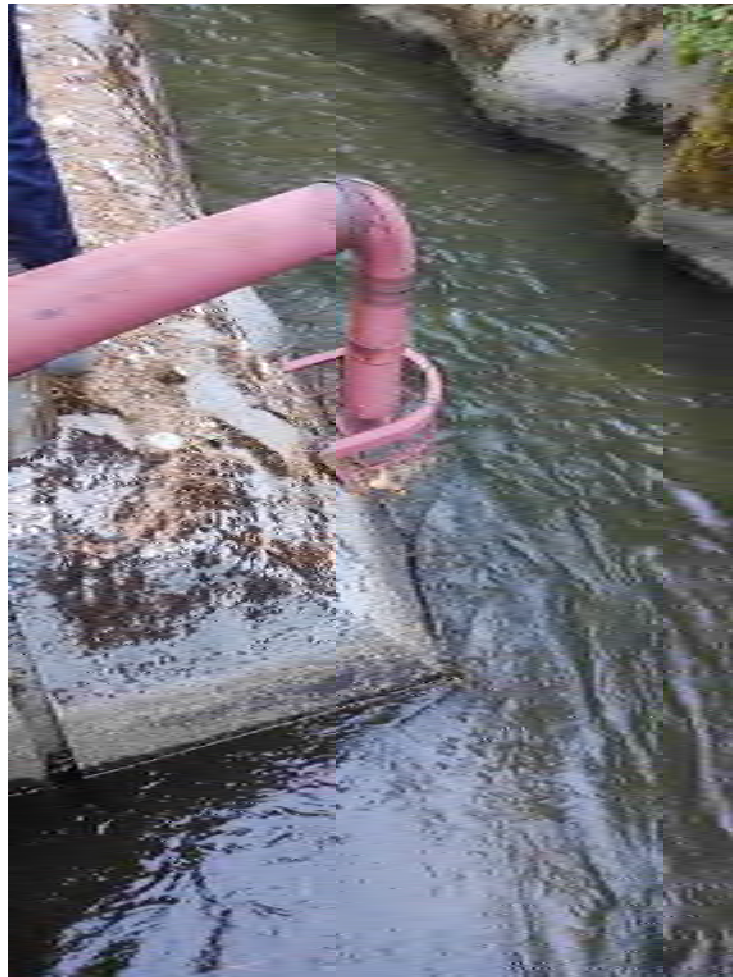
Photo 64 - View of 9 ½ Mile Spill Siphon
