**SUBJECT: South Yuba Canal Condition Assessment Report (Project #2419)**

# South Yuba Canal 2021 Condition Assessment

Final Report  
South Yuba Canal  
2021 Condition Assessment

Nevada Irrigation District

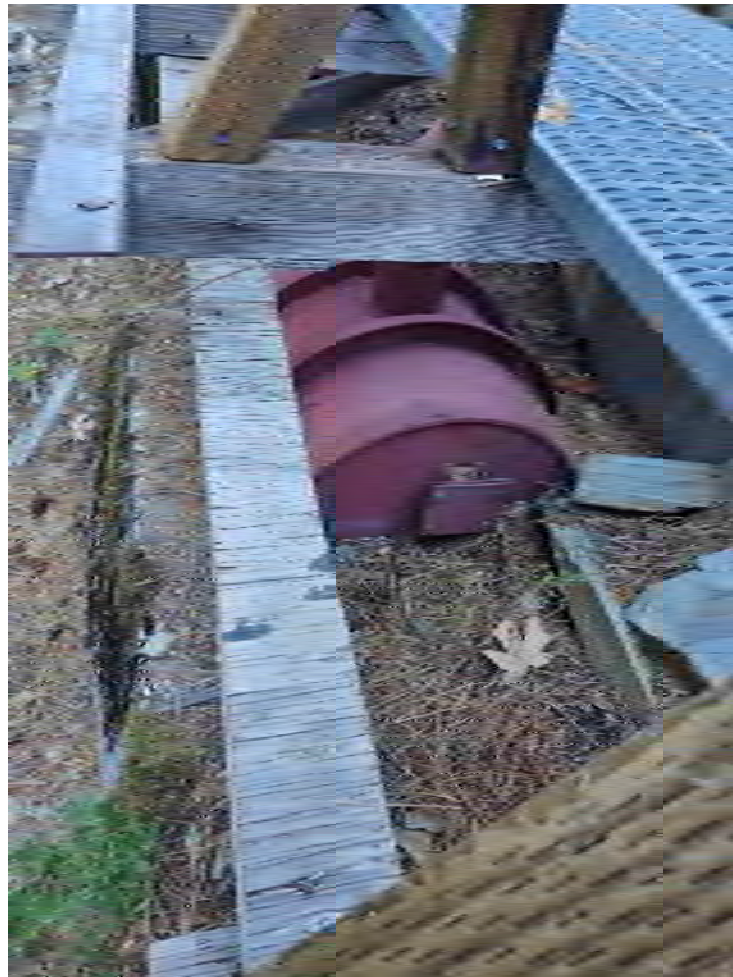
Photo 65 - View of 9 ½ Mile Spill Siphon

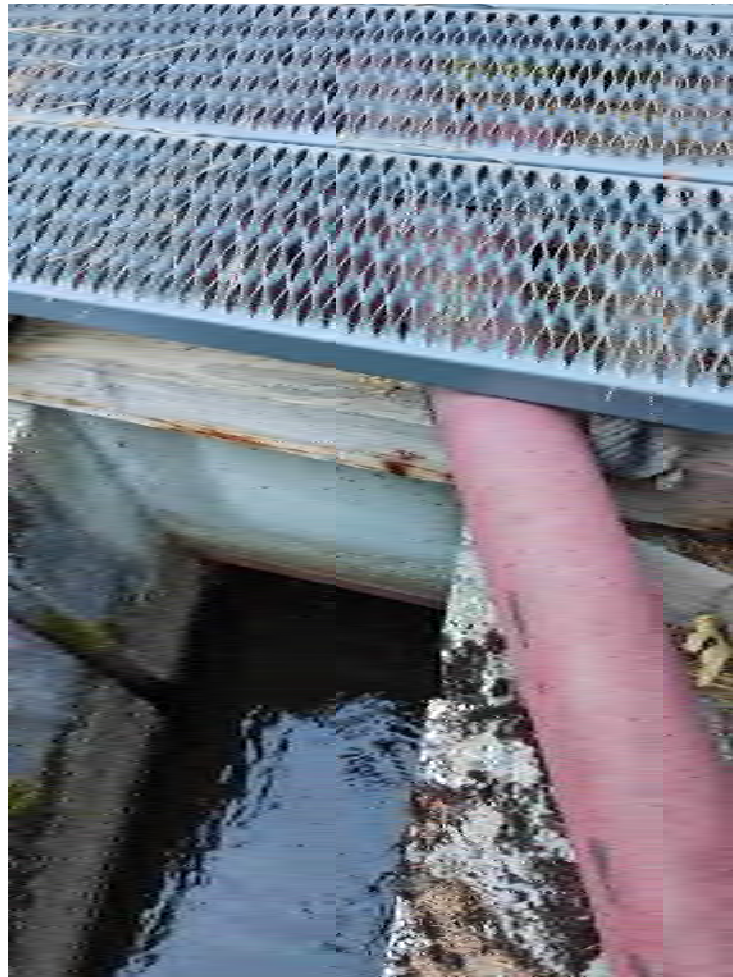
Photo 66 - View of 9 ½ Mile Spill Siphon

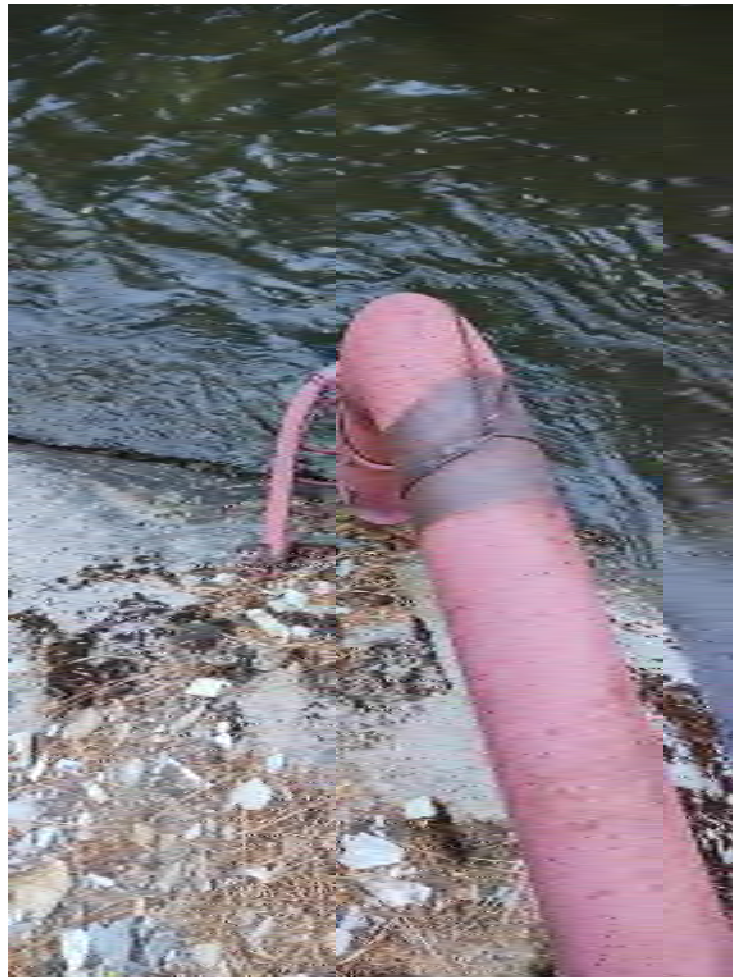
Photo 67 - View of 9 ½ Mile Spill Siphon

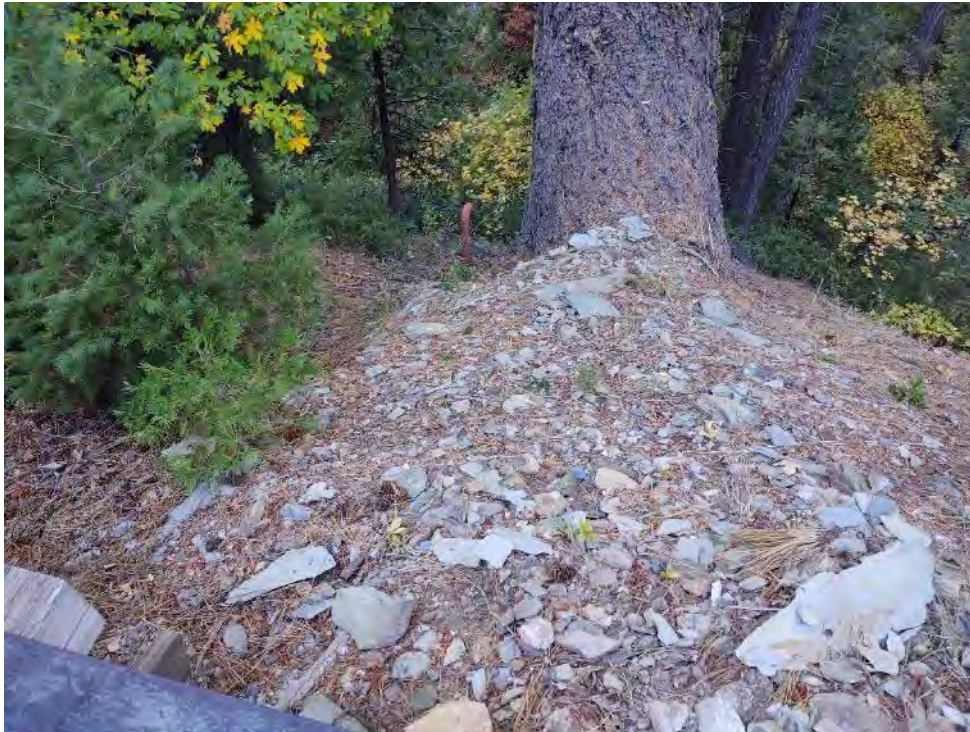
Photo 68 - View of 9 ½ Mile Spill Siphon

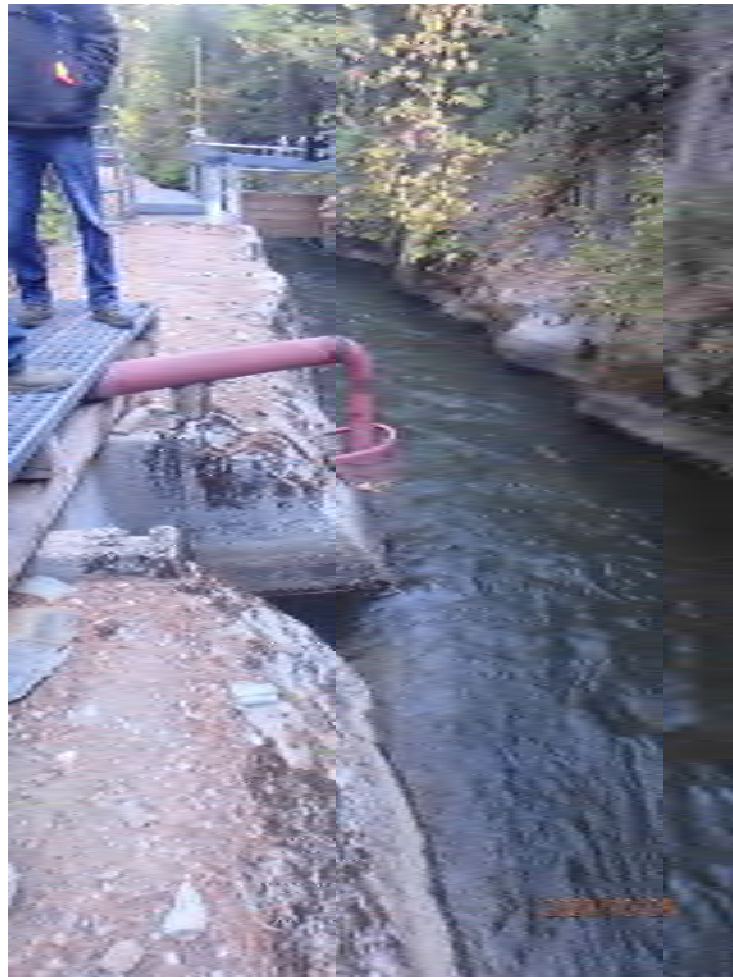
Photo 69 - View of 9 ½ Mile Spill Siphon

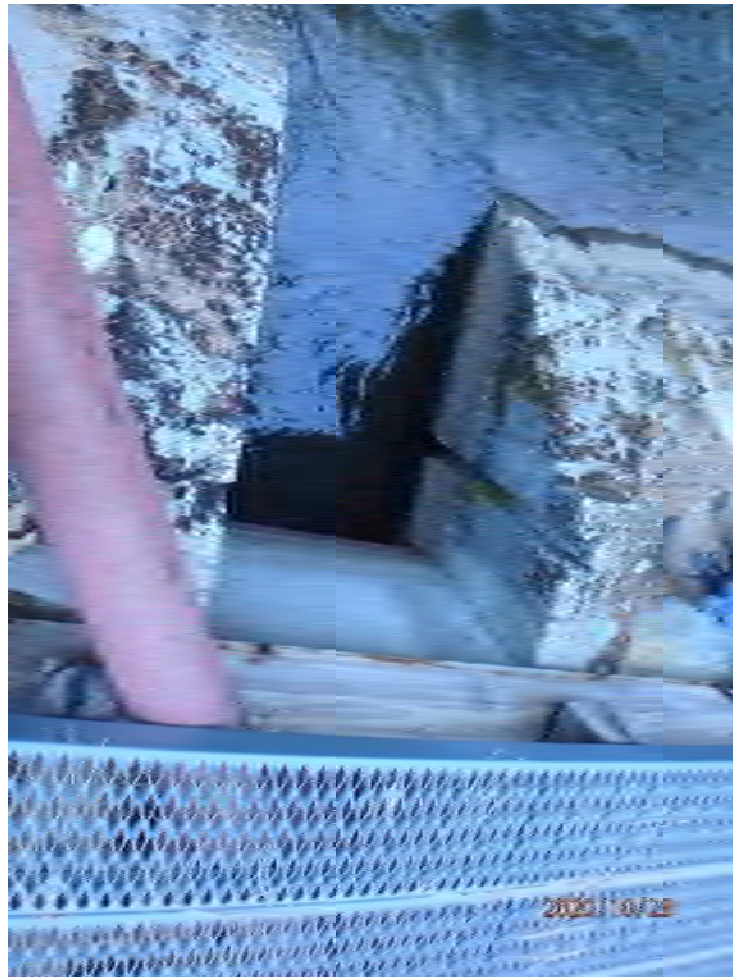
Photo 70 - View of 9 ½ Mile Spill Siphon

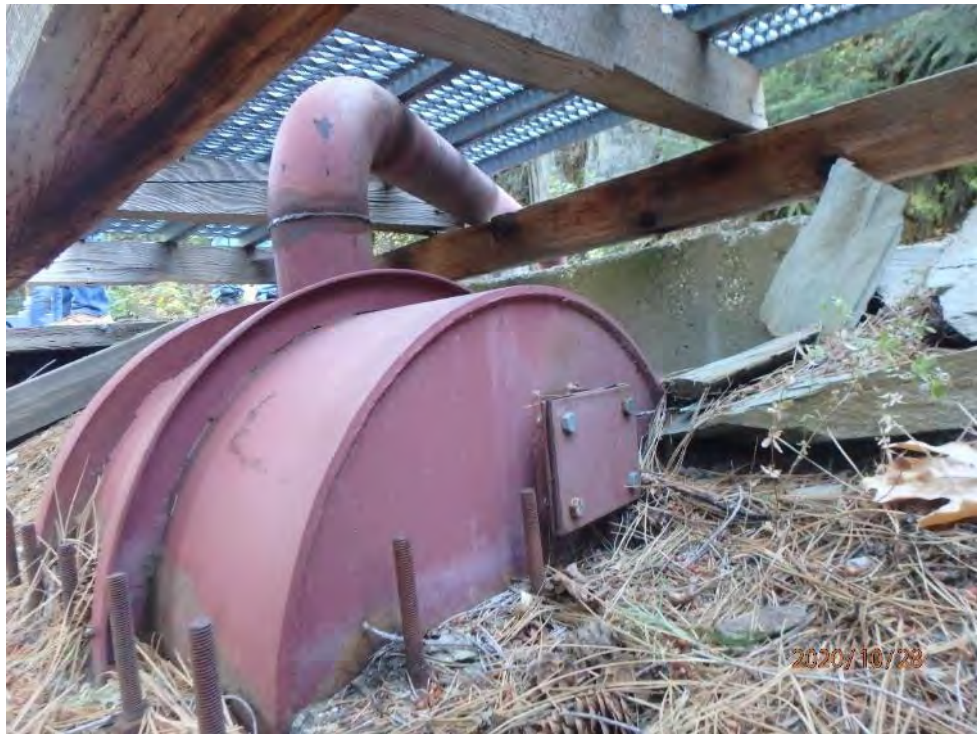
Photo 71 - View of 9 ½ Mile Spill Siphon

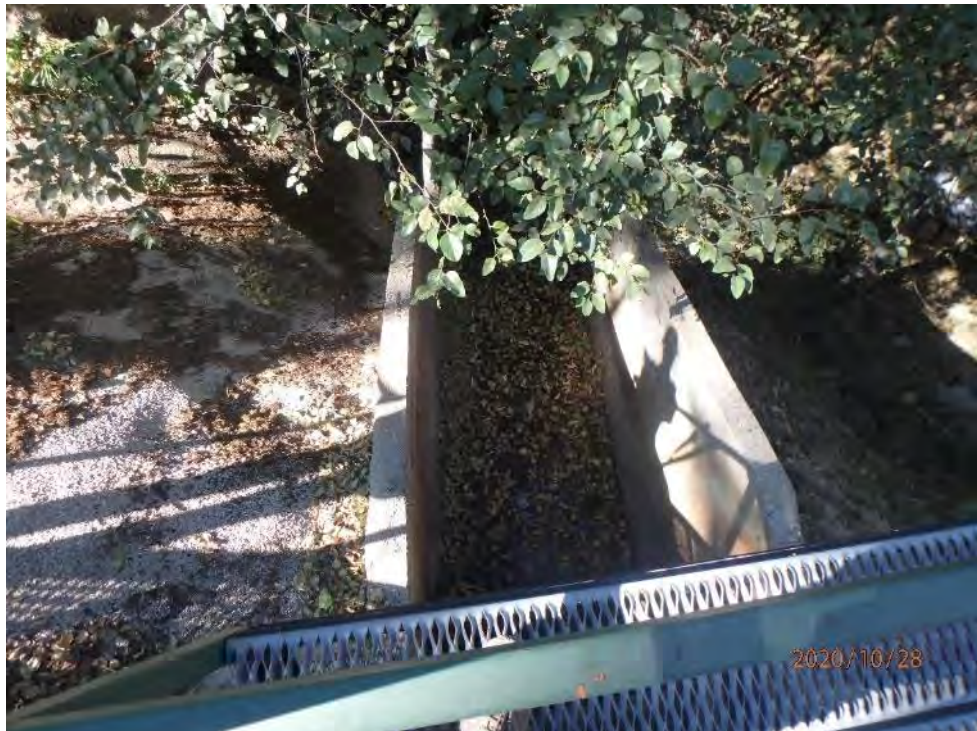
Photo 112 - View of 13 Mile Spillway

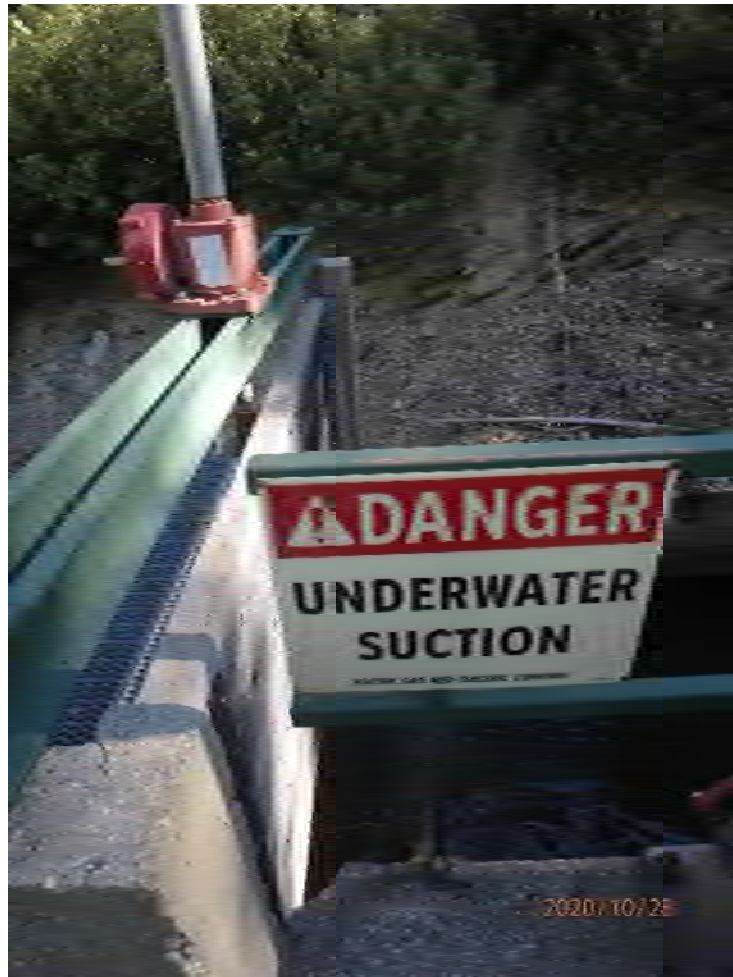
Photo 113 - View of 13 Mile Spillway

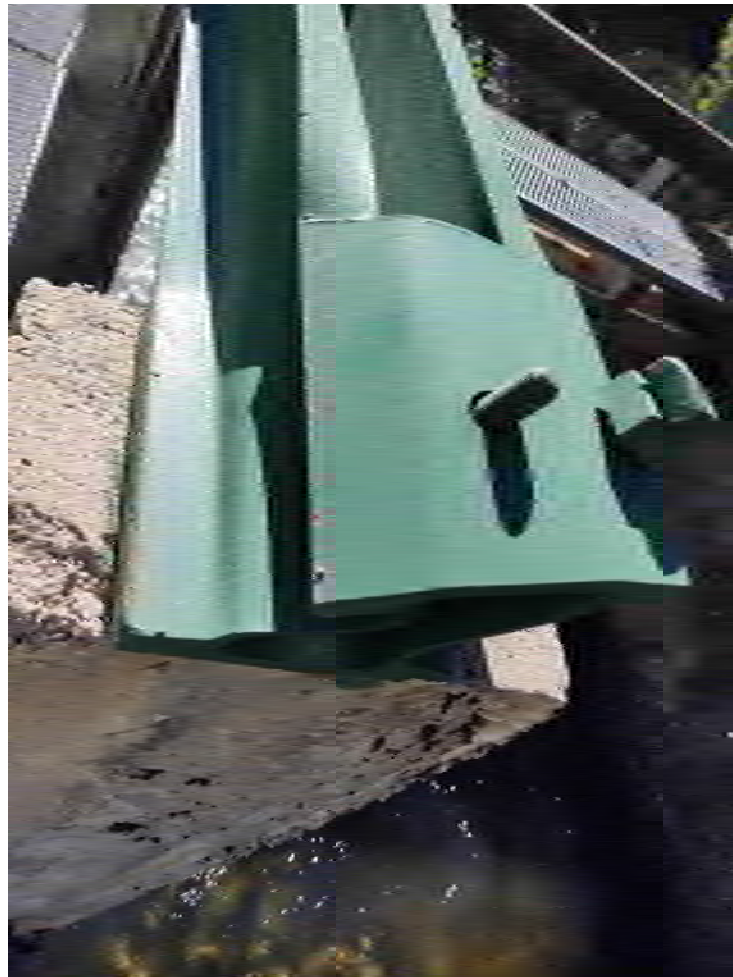
Photo 114 - View of 13 Mile Spillway

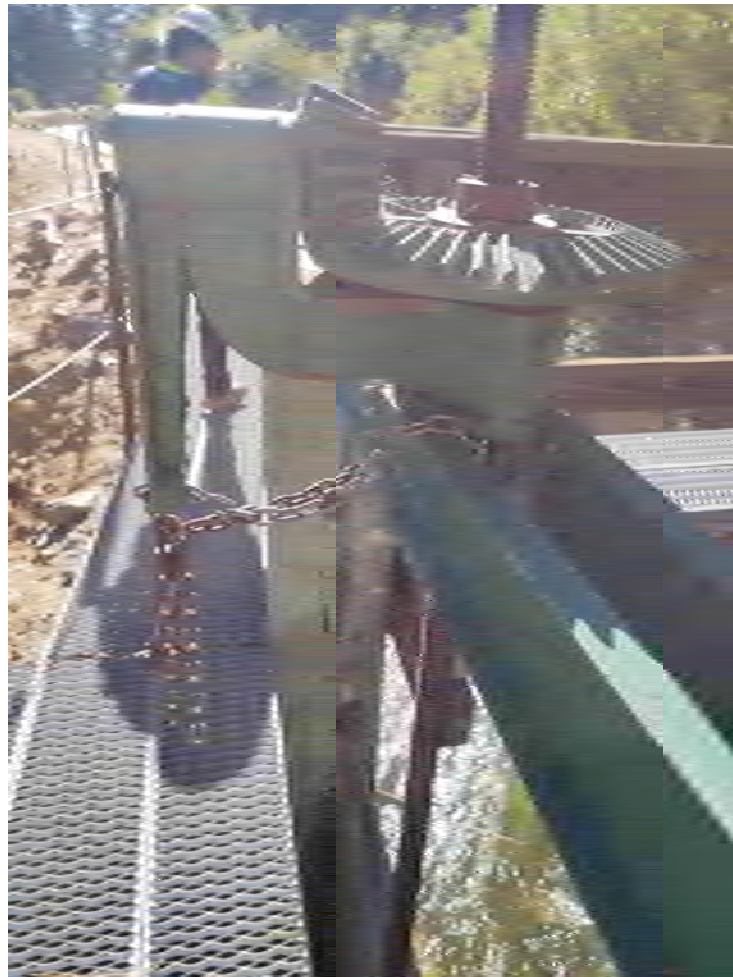
Photo 115 - View of 14 Mile Spill

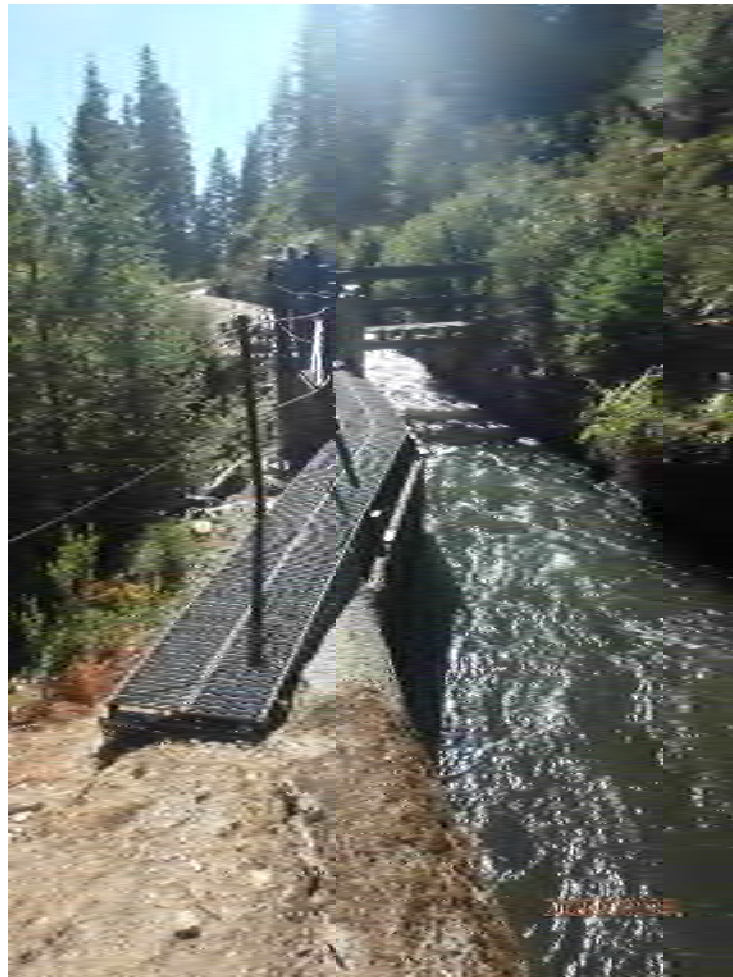
Photo 116 - View of 14 Mile Spill

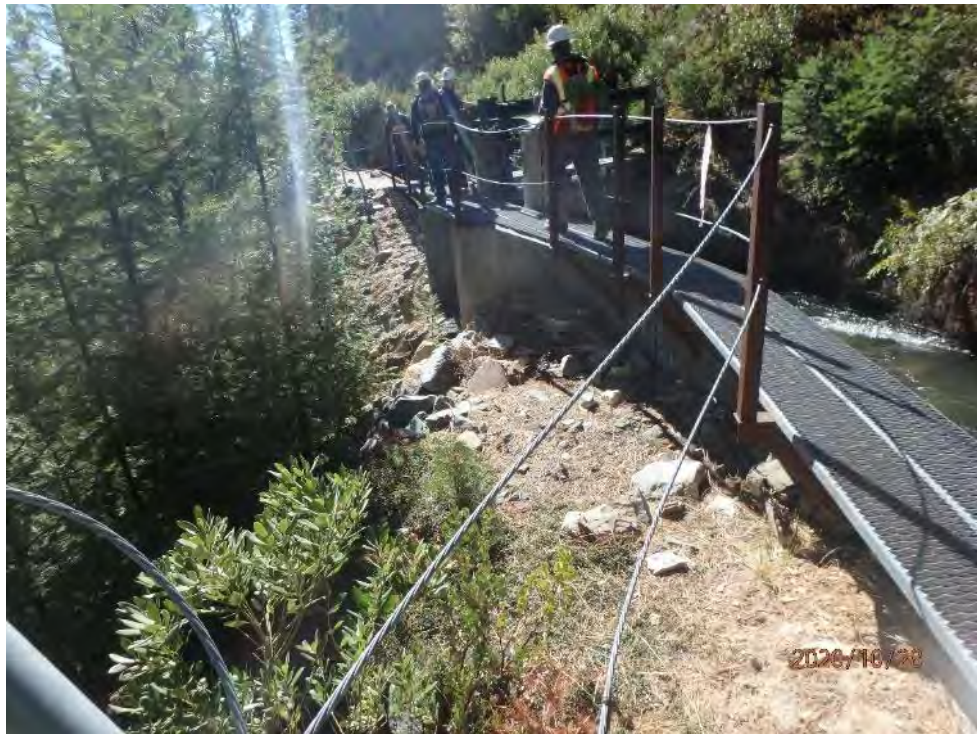
Photo 117 - View of 14 Mile Spill

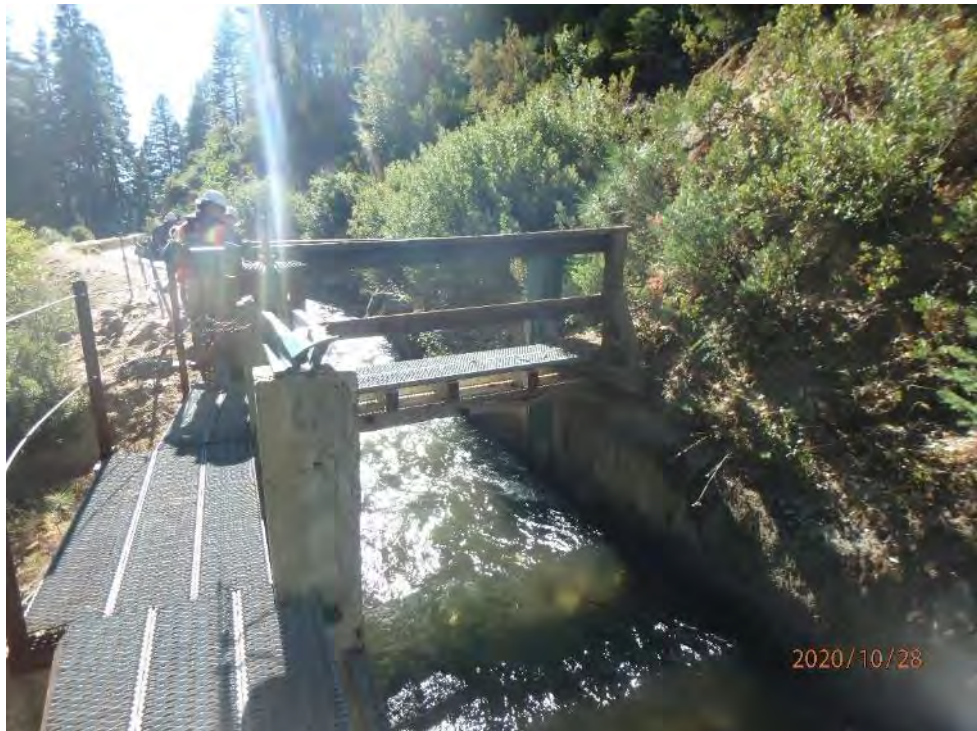
Photo 118 - View of 14 Mile Spill

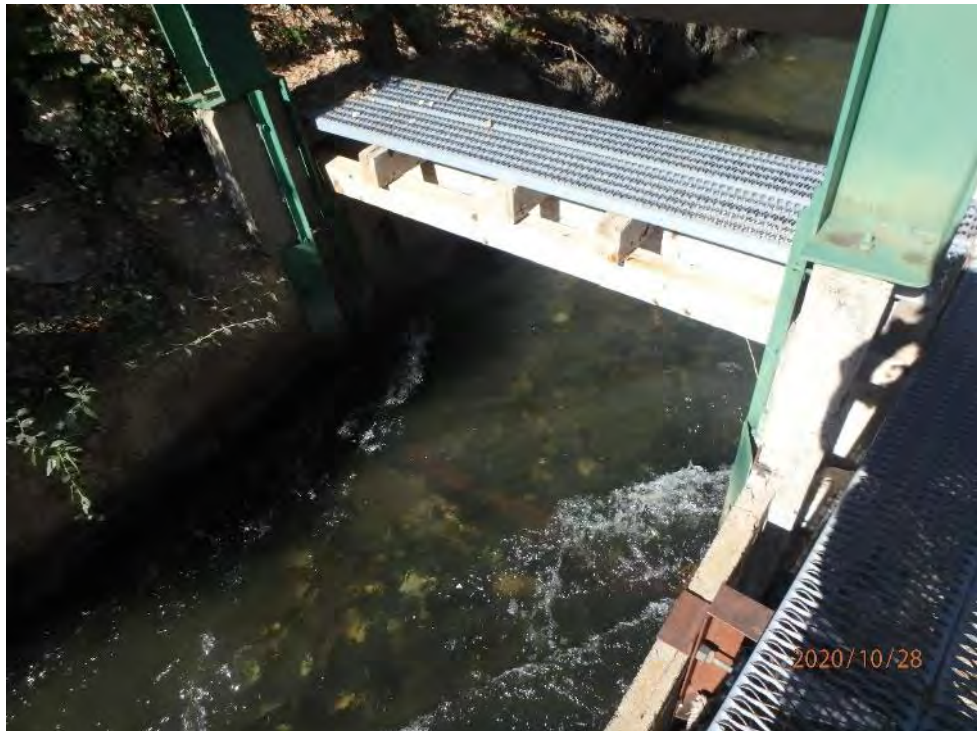
Photo 120 - View of 14 Mile Spill

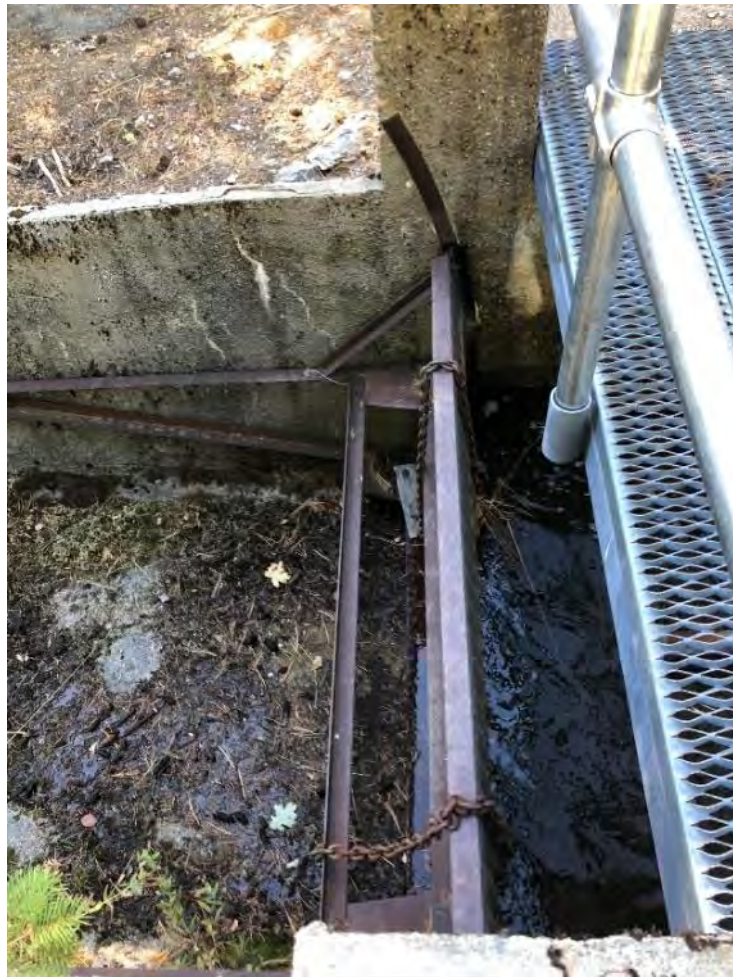
Photo 121 - View of 14 Mile Spill

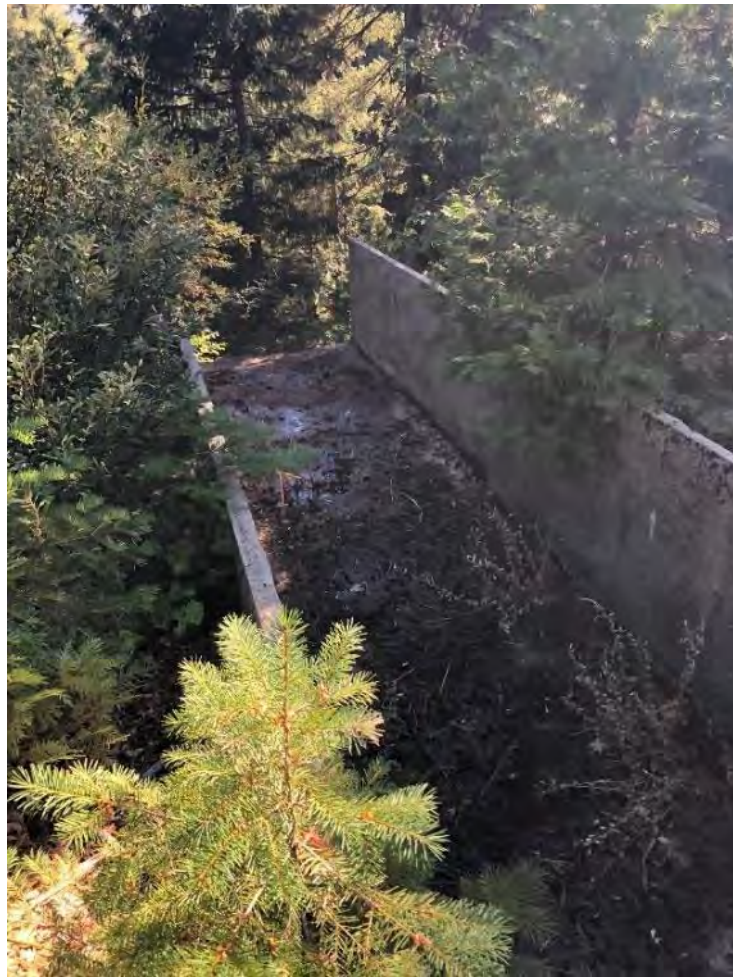
Photo 122 - View of Big Tunnel Side Spill

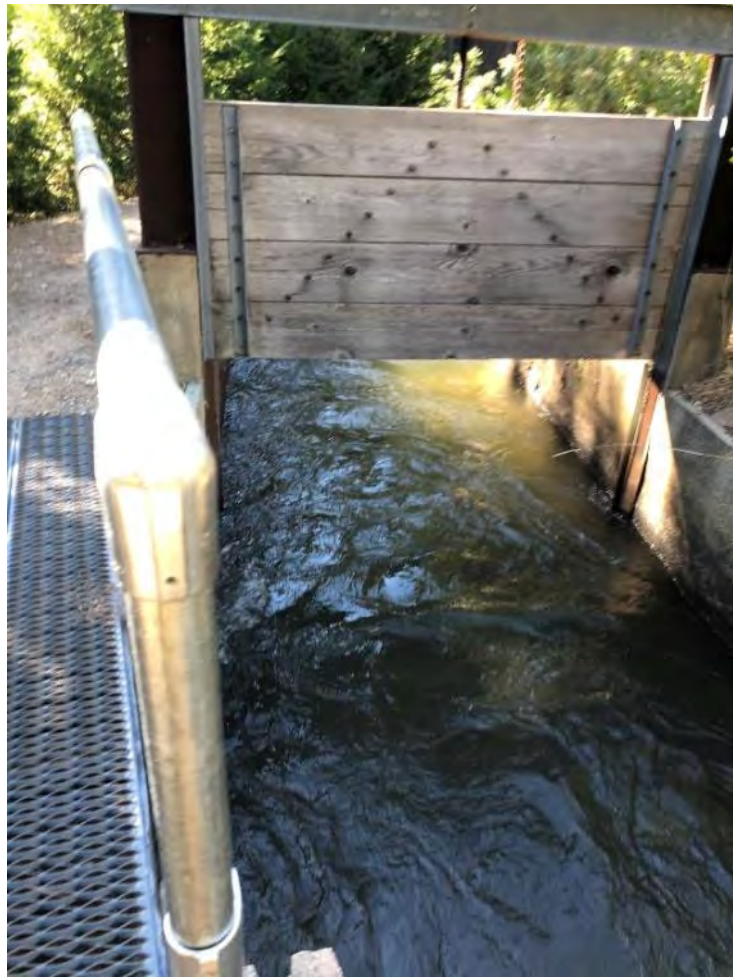
Photo 123 - View of Big Tunnel Side Spill

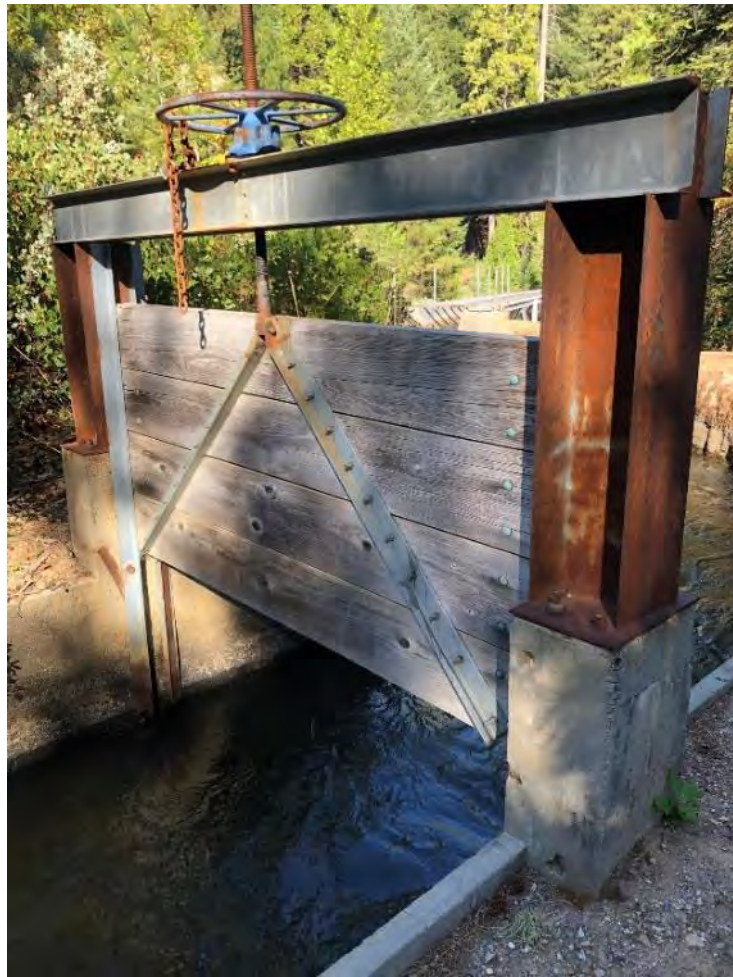
Photo 124 - View of Big Tunnel Side Spill

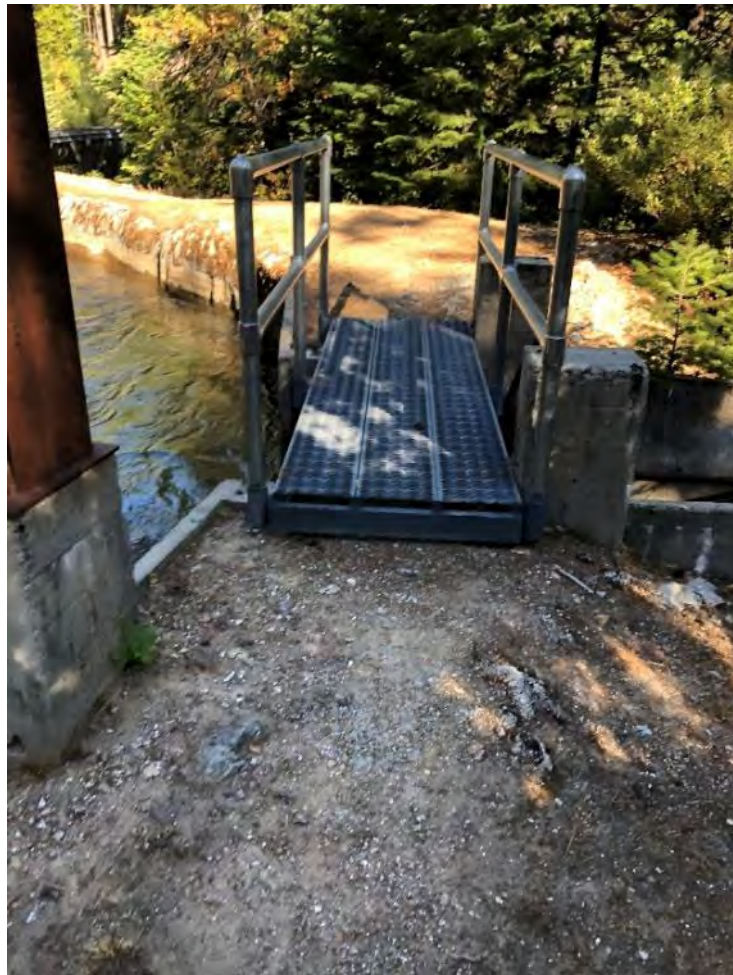
Photo 125 - View of Big Tunnel Side Spill

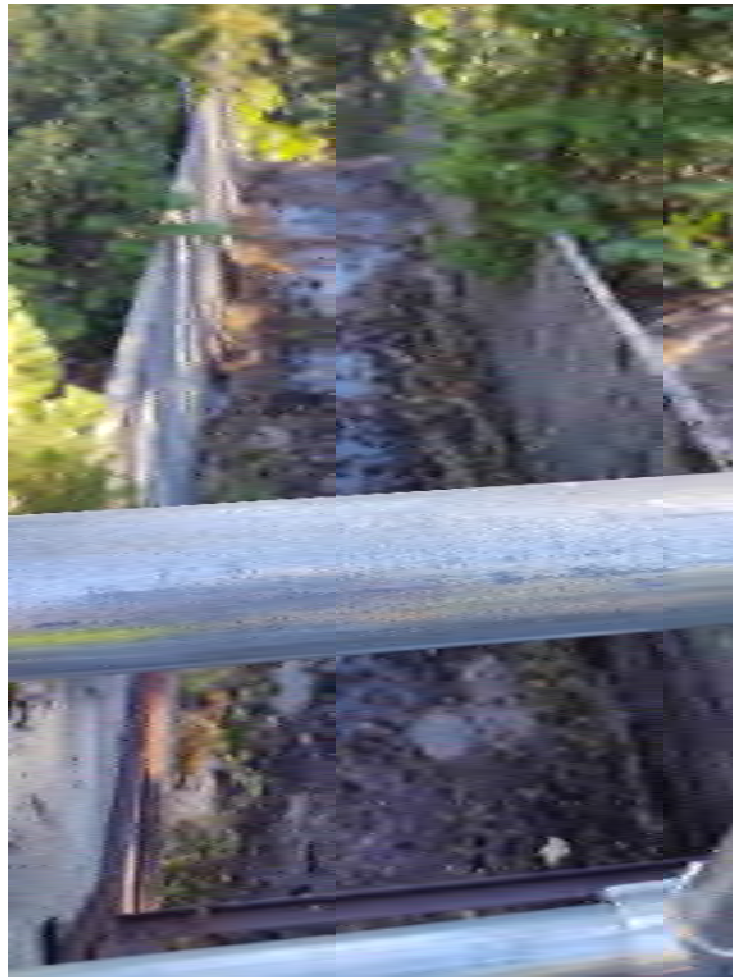
Photo 126 - View of Big Tunnel Side Spill

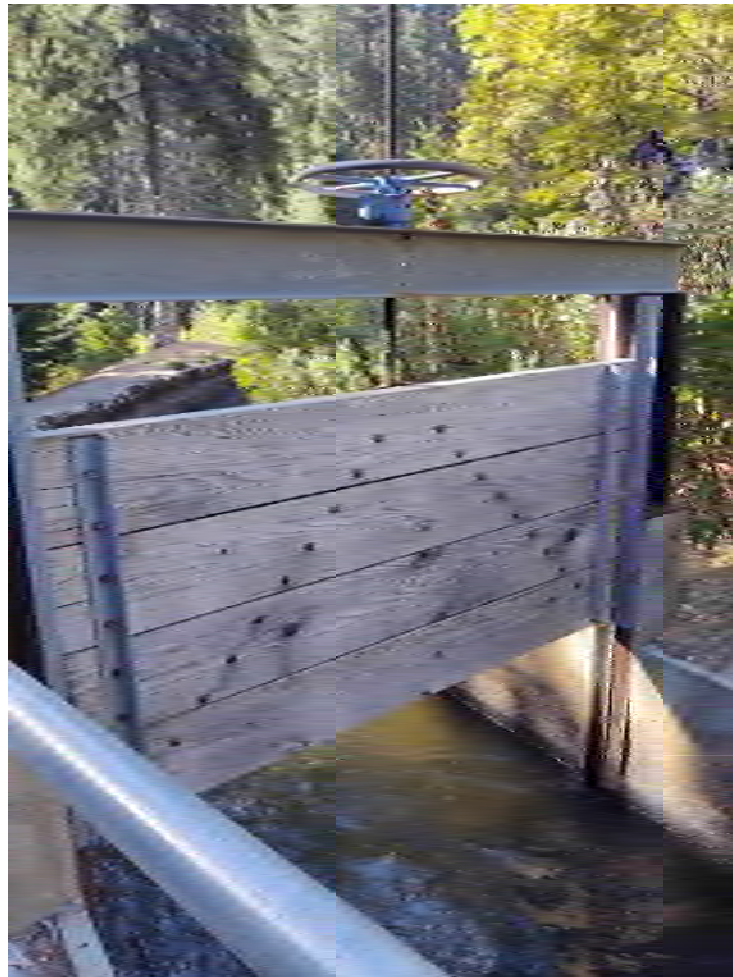
Photo 127 - View of Big Tunnel Side Spill

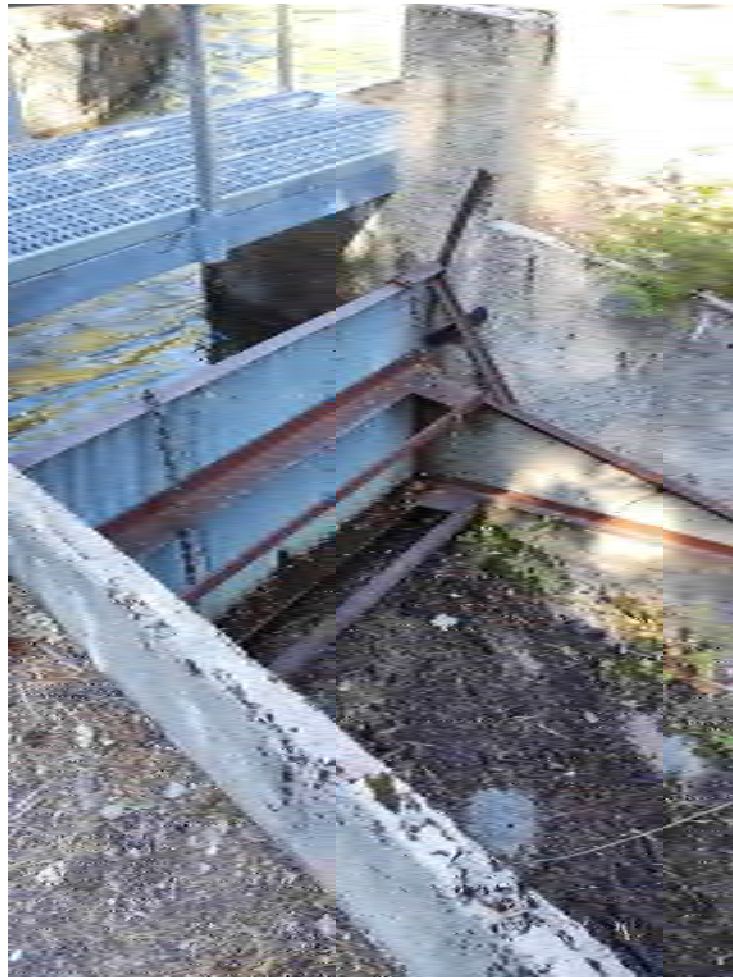
Photo 128 - View of Big Tunnel Side Spill

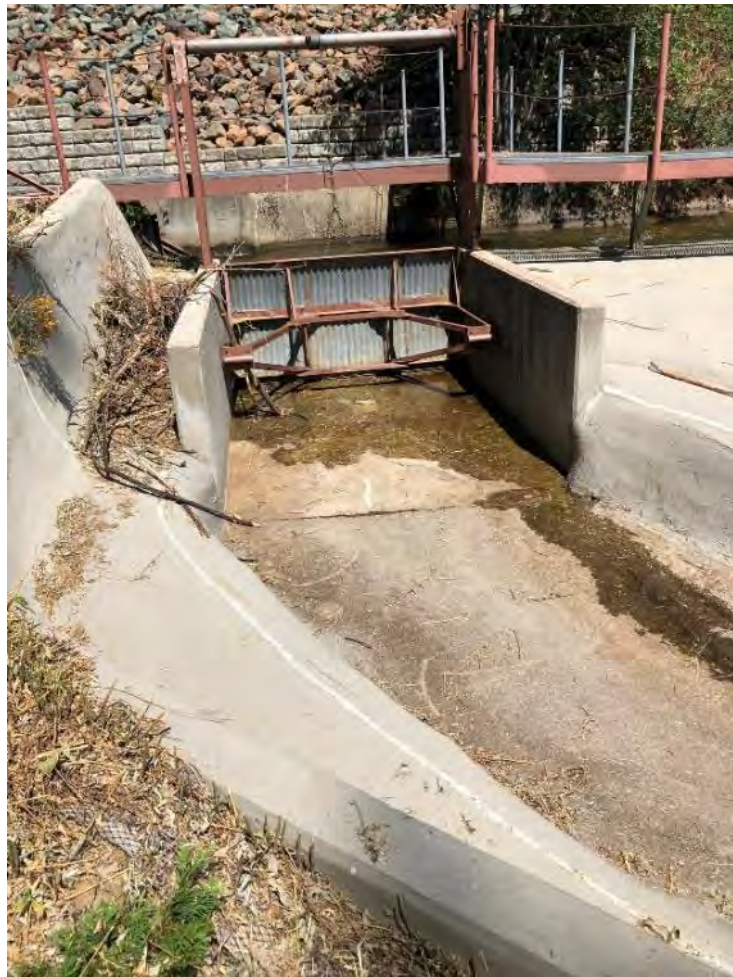
Photo 129 - View of Big Tunnel Side Spill

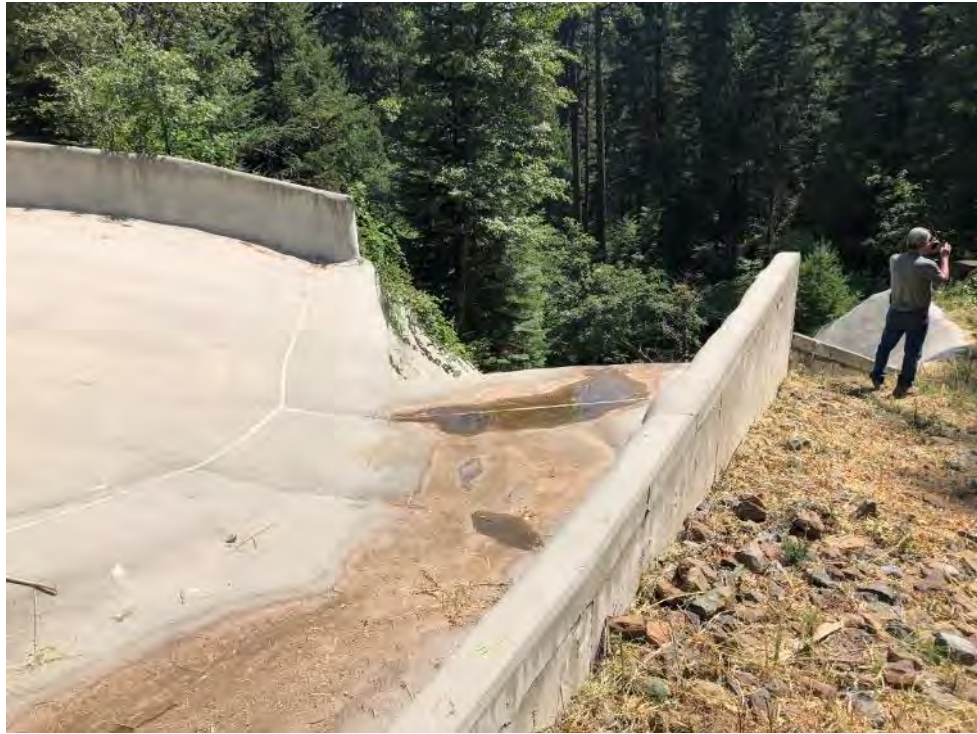
Photo 130 - View of Big Tunnel Spillway

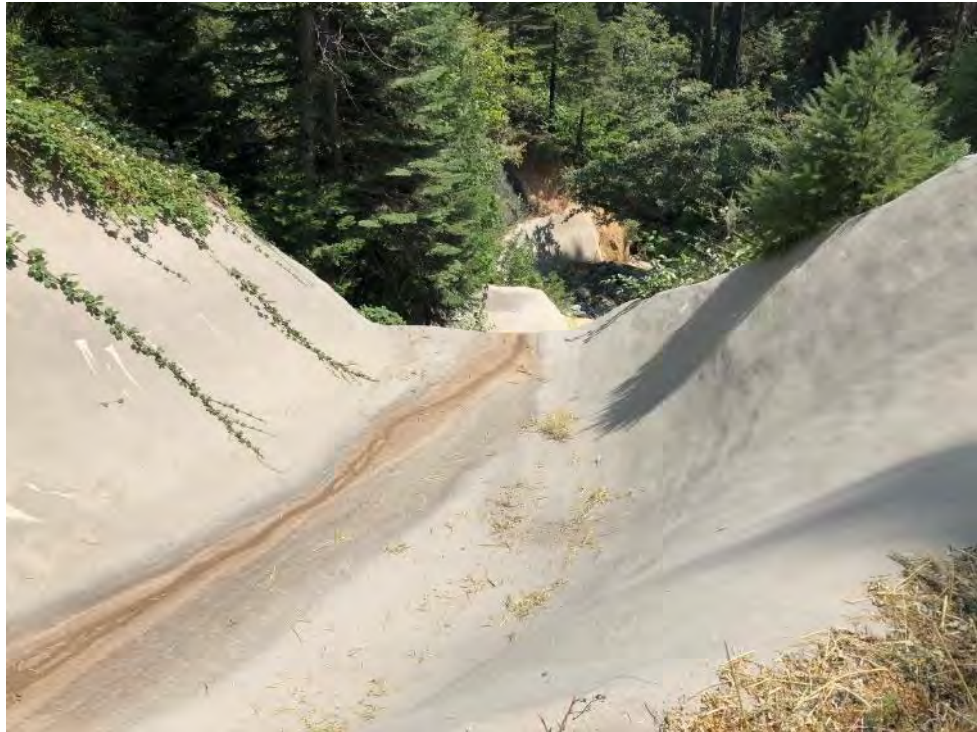
Photo 131 - View of Big Tunnel Spillway

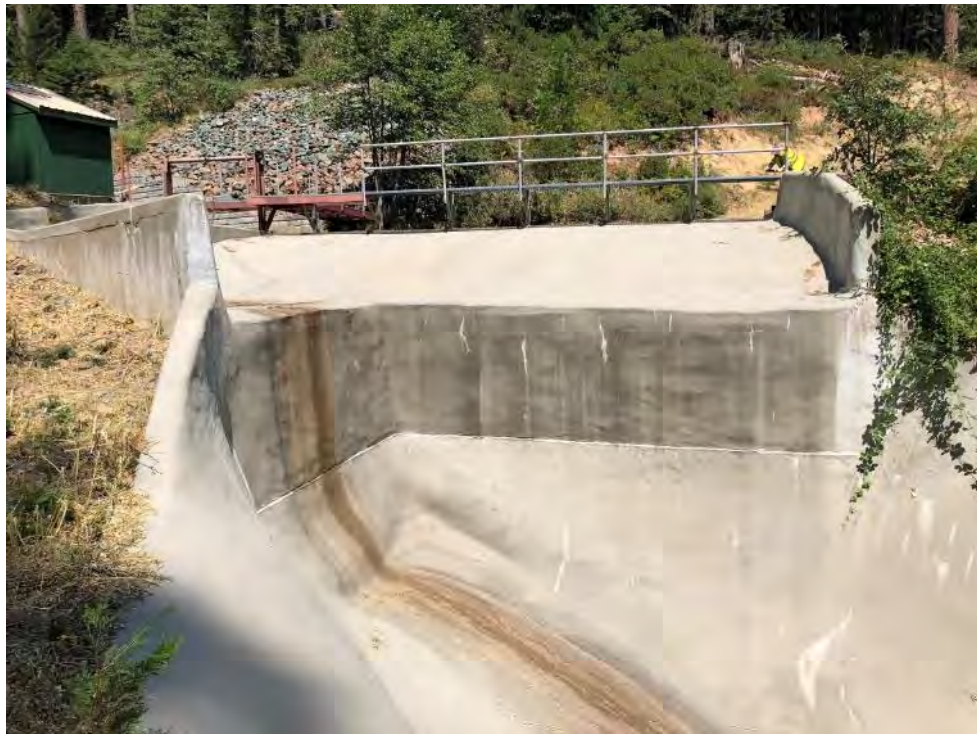
Photo 132 - View of Big Tunnel Spillway

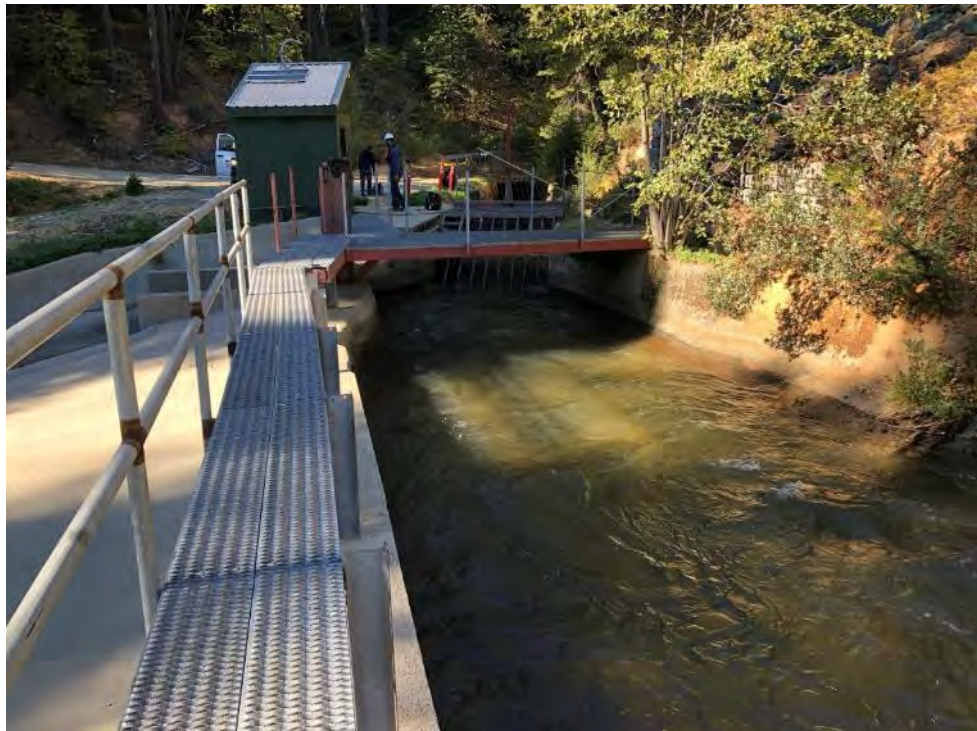
Photo 133 - View of Big Tunnel Spillway

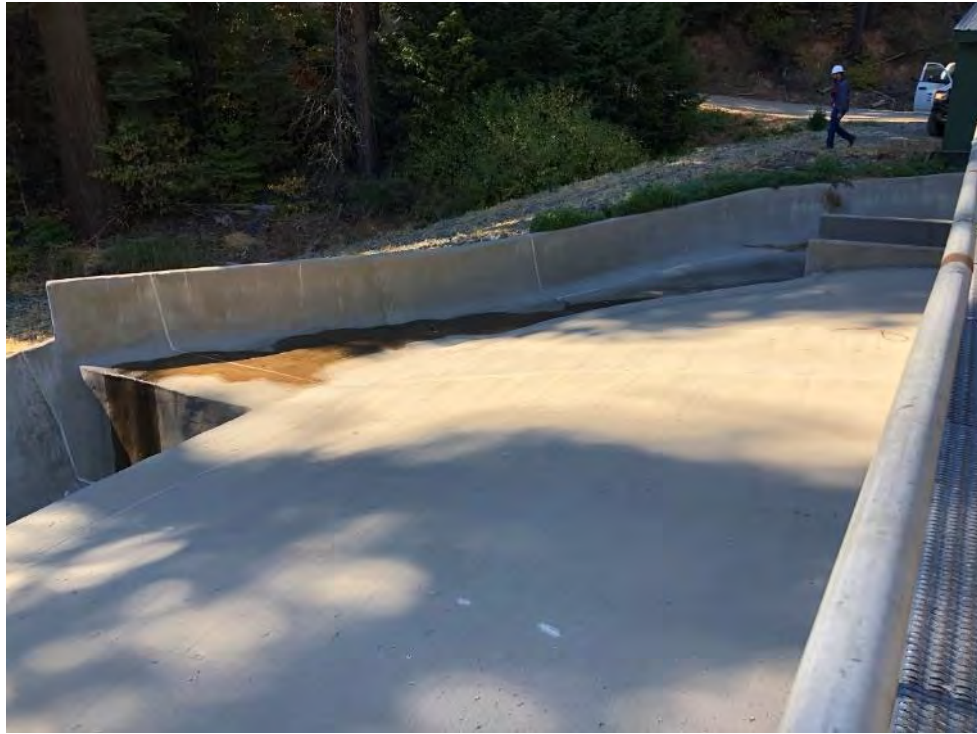
Photo 134 - View of Big Tunnel Spillway

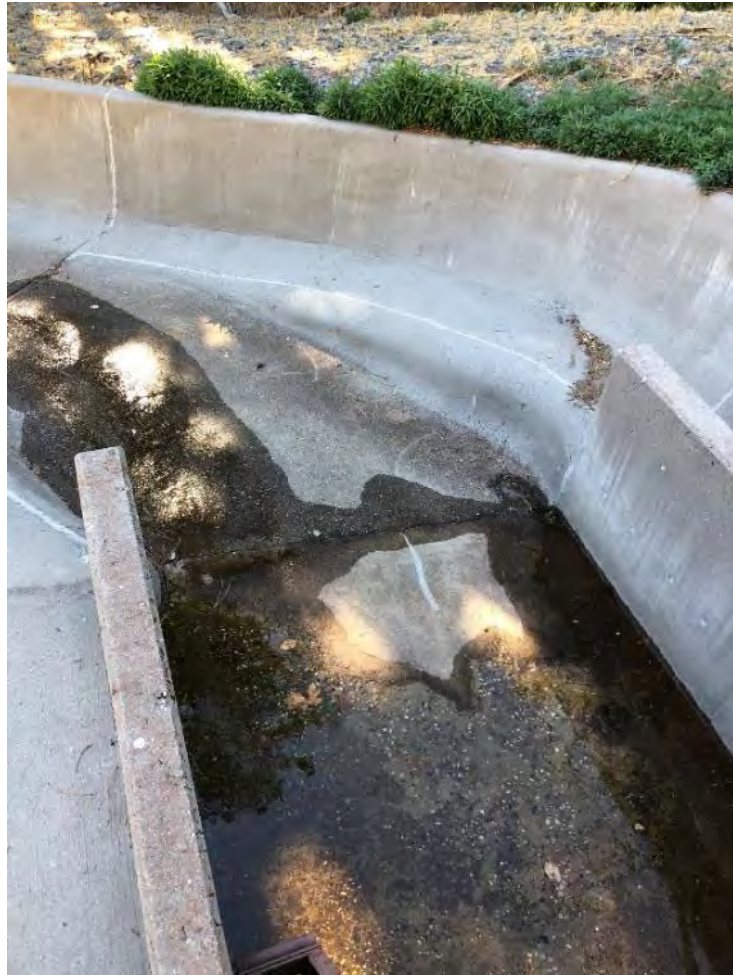
Photo 136 - View of Big Tunnel Spillway

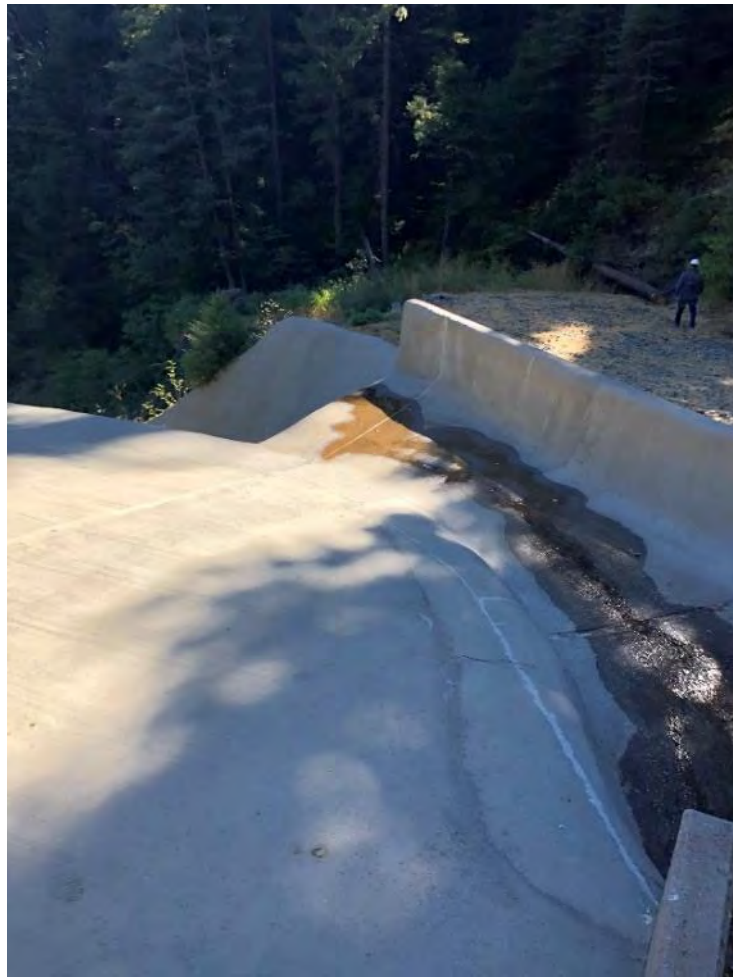
Photo 137 - View of Big Tunnel Spillway

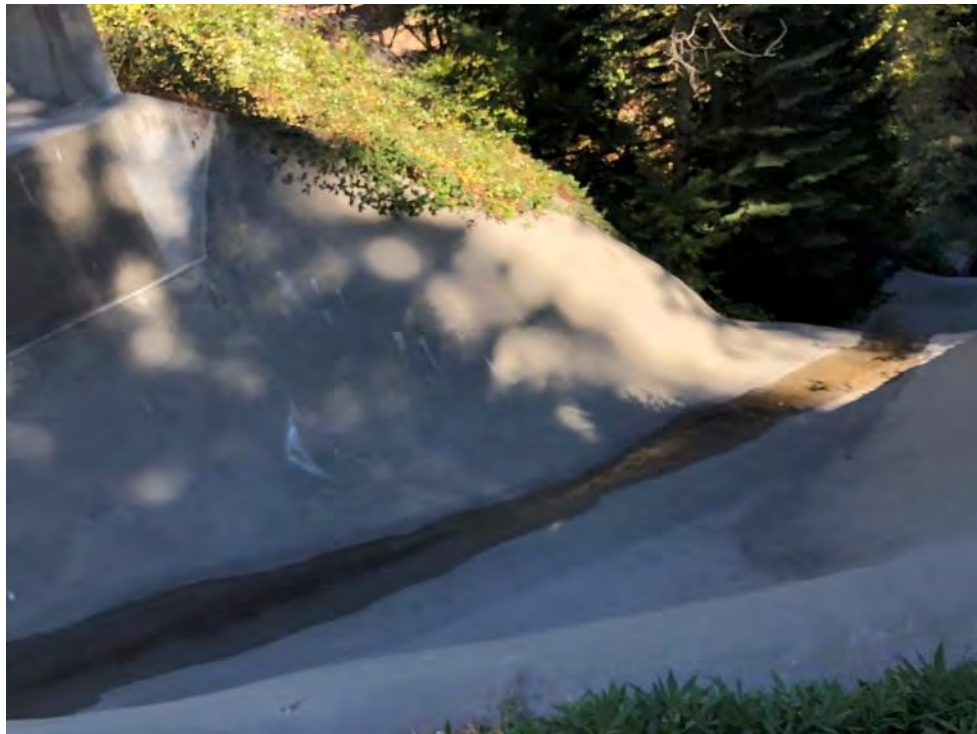
Photo 138 - View of Big Tunnel Spillway
