**SUBJECT: South Yuba Canal Condition Assessment Report (Project #2419)**

# South Yuba Canal 2021 Condition Assessment

Final Report  
South Yuba Canal  
2021 Condition Assessment

Nevada Irrigation District

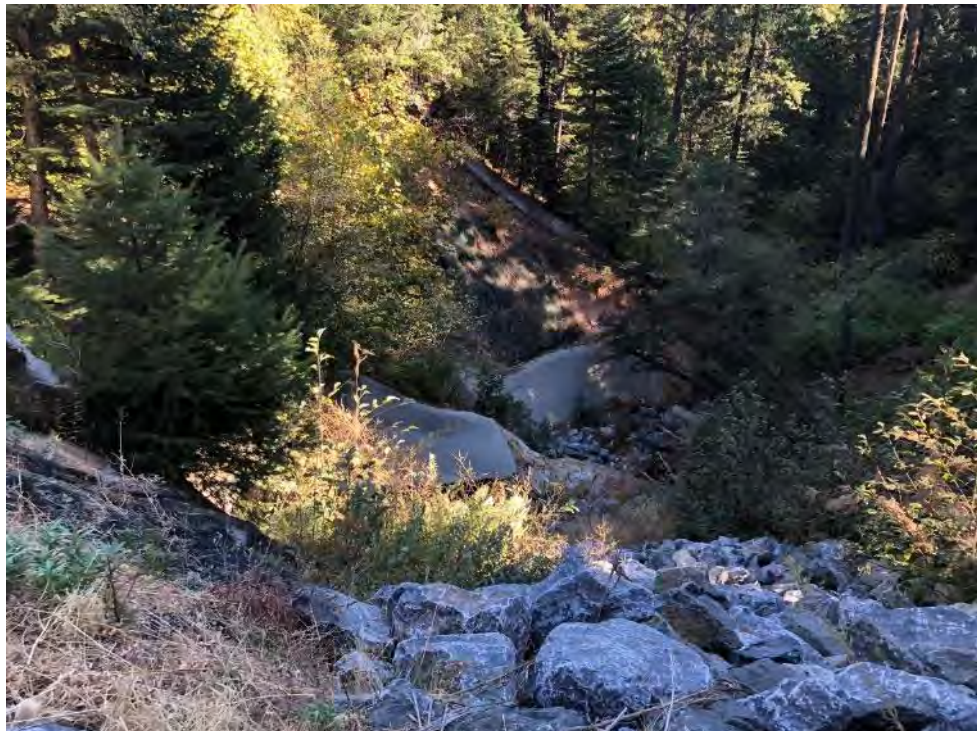
Photo 139 - View of Big Tunnel Spillway

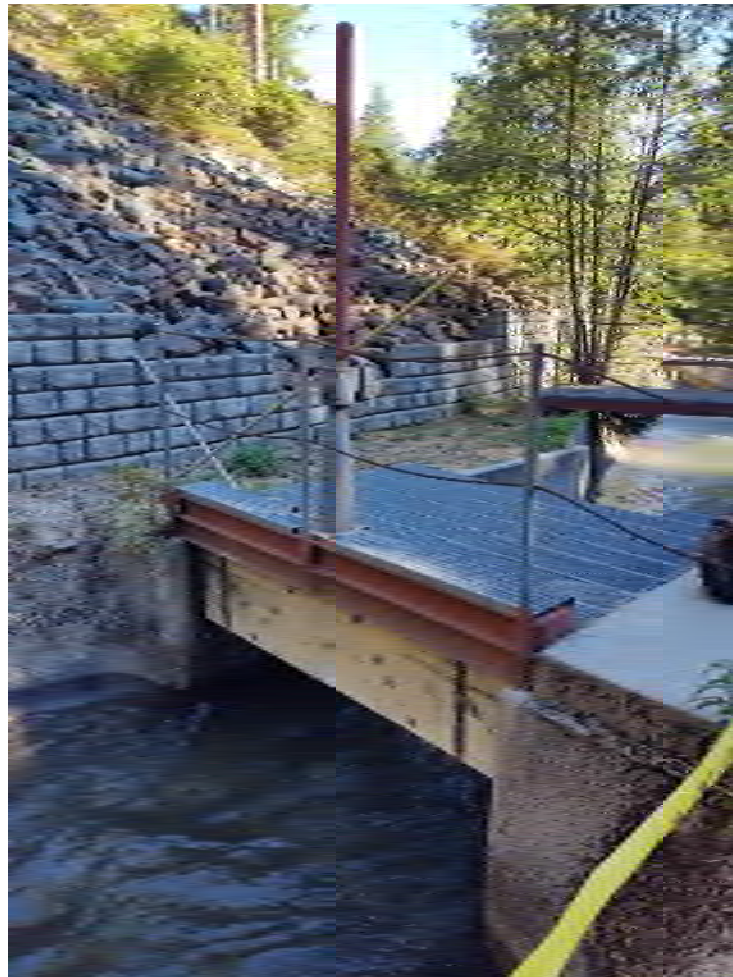
Photo 140 - View of Big Tunnel Spillway

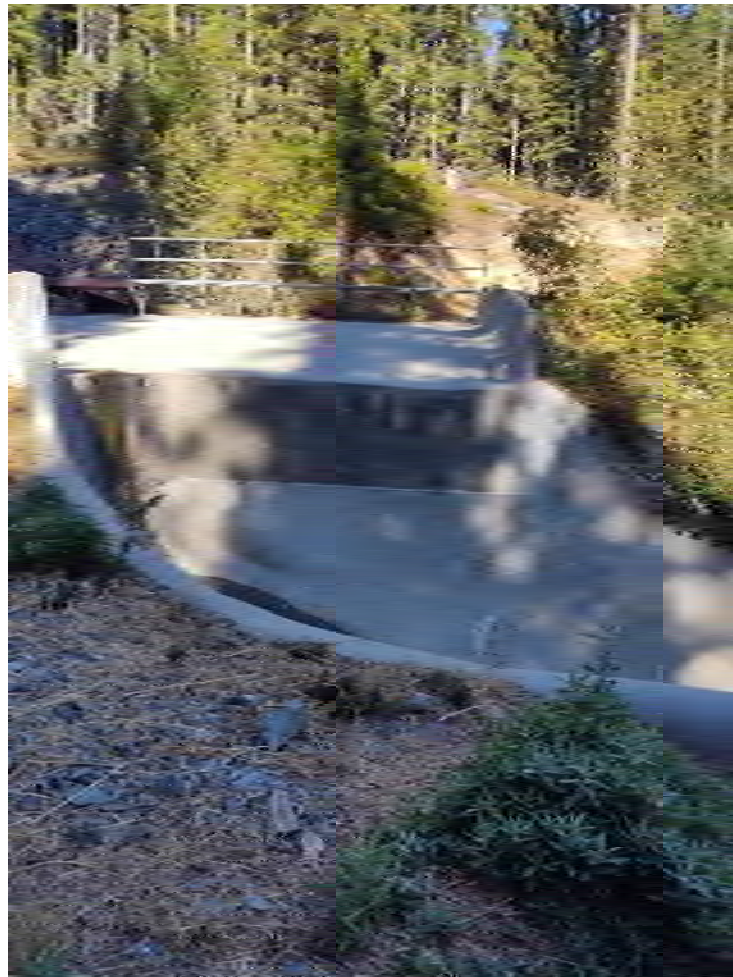
Photo 141 - View of Big Tunnel Spillway

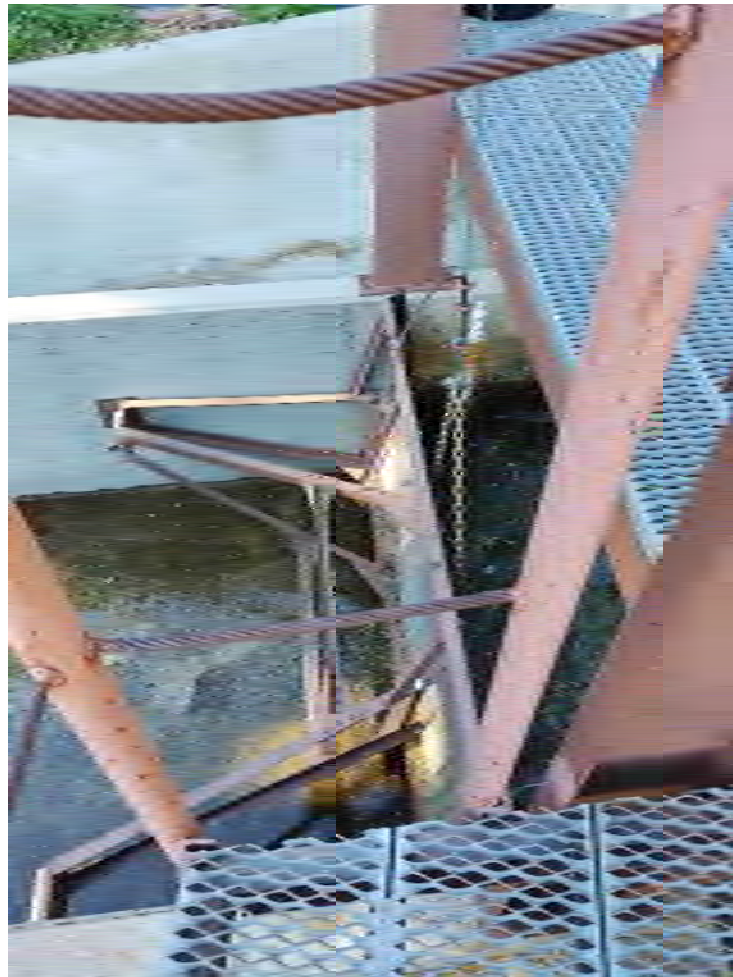
Photo 142 - View of Big Tunnel Spillway

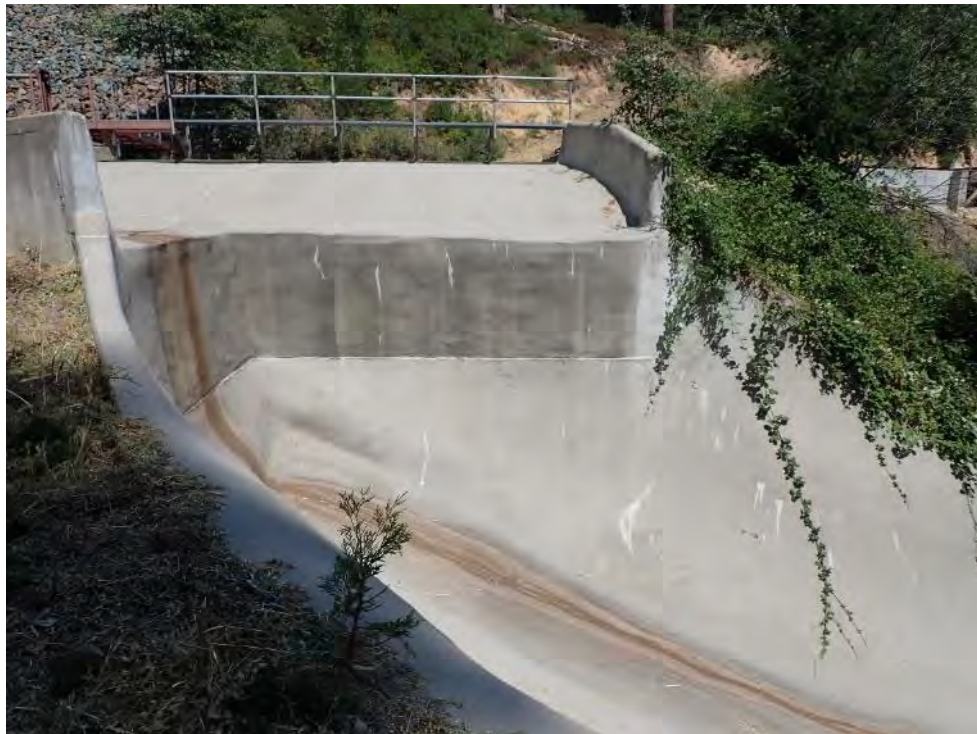
Photo 143 - View of Big Tunnel Spillway

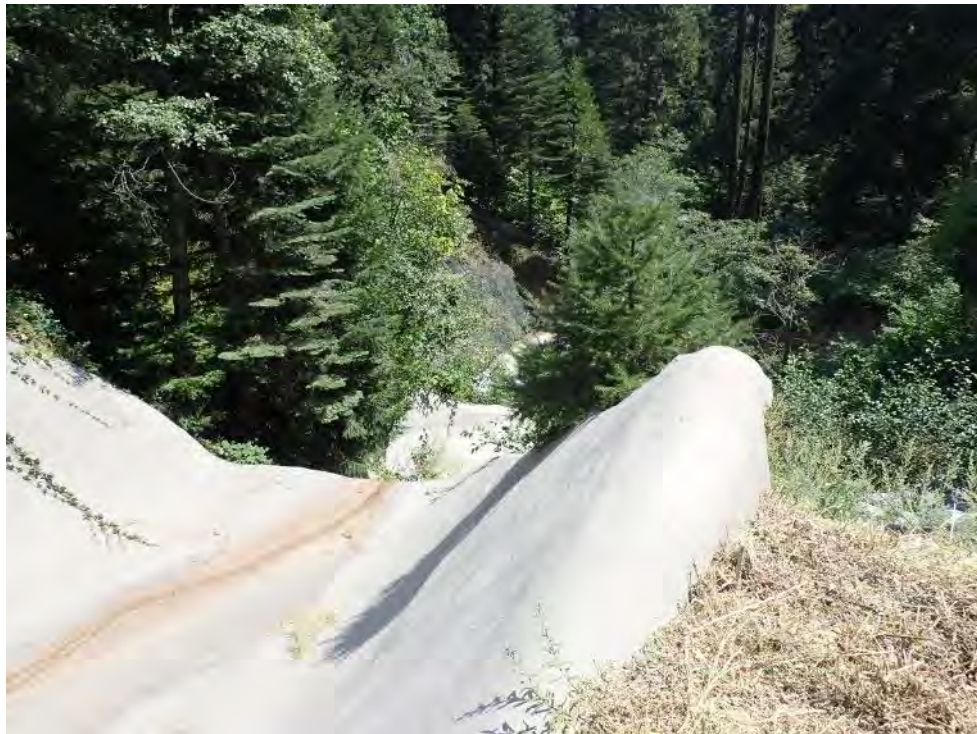
Photo 144 - View of Big Tunnel Spillway

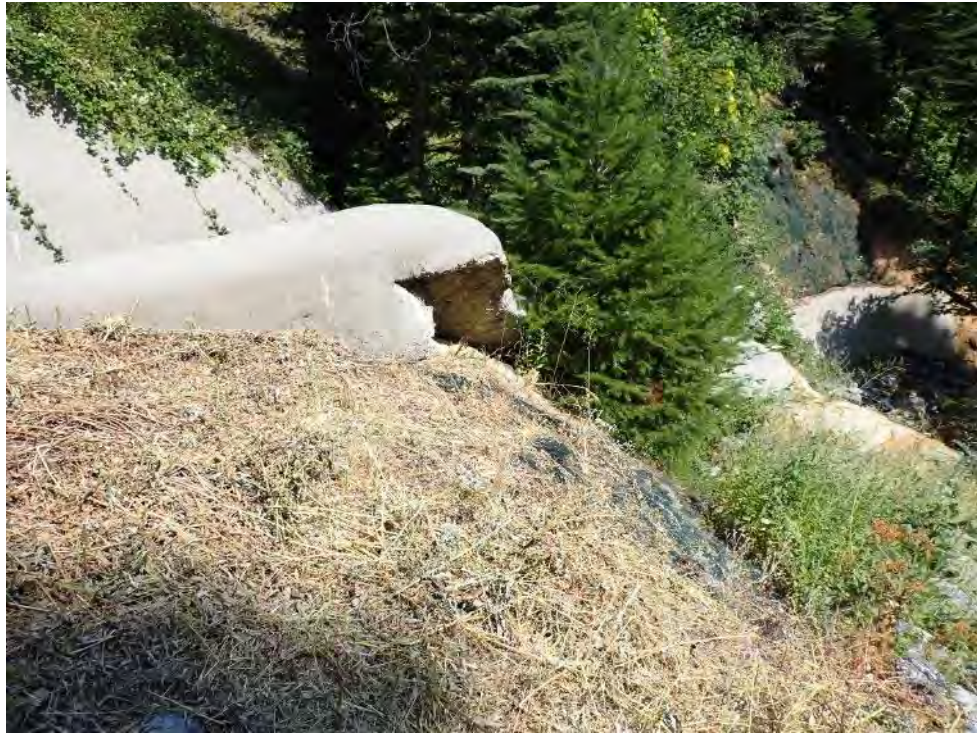
Photo 145 - View of Big Tunnel Spillway

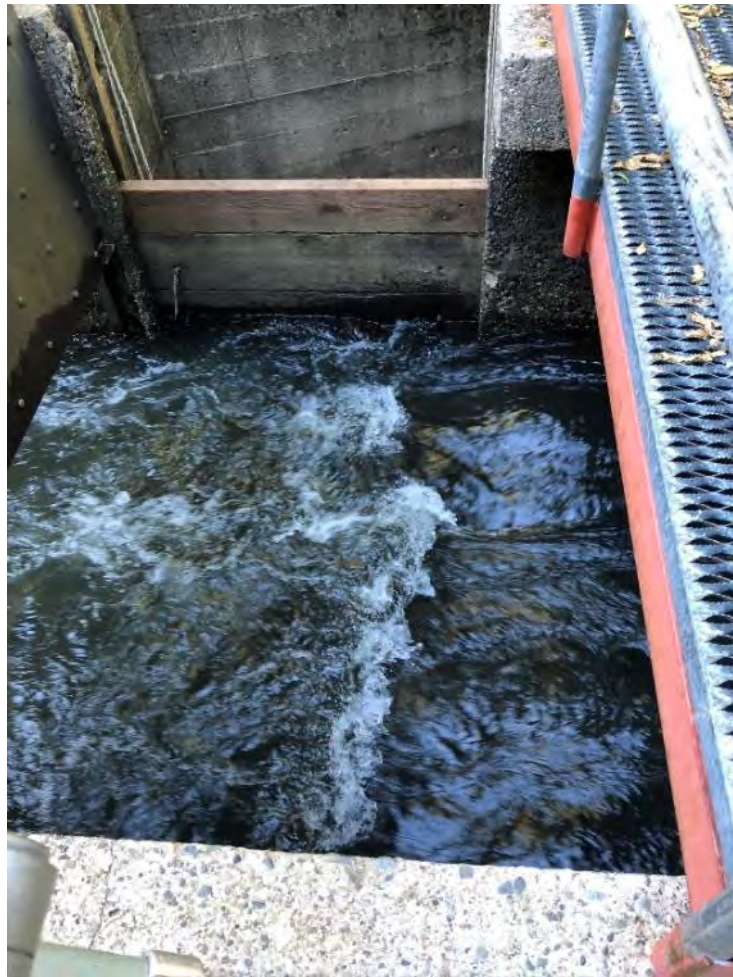
Photo 146 - View of Big Tunnel Spillway

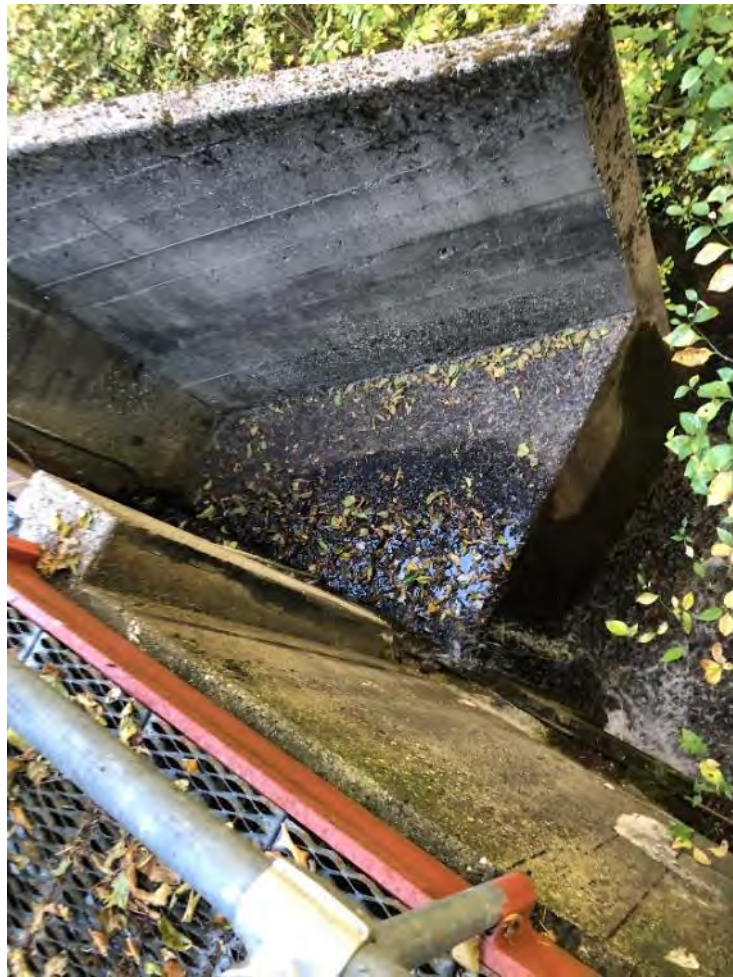
Photo 147 - View of Sand Bunker Spill

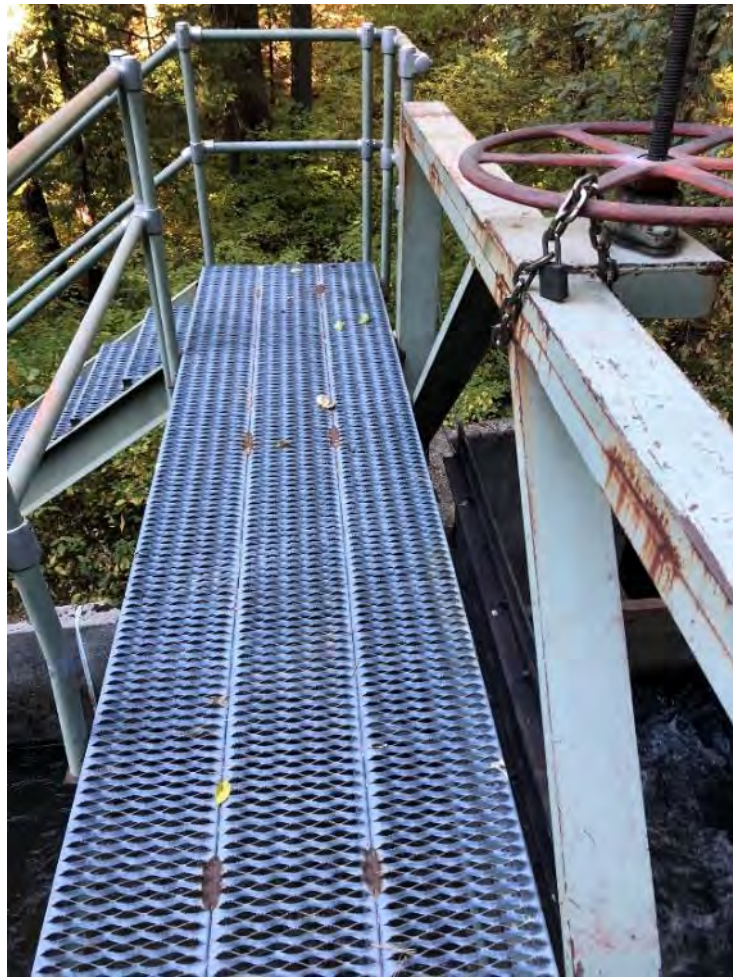
Photo 148 - View of Sand Bunker Spill

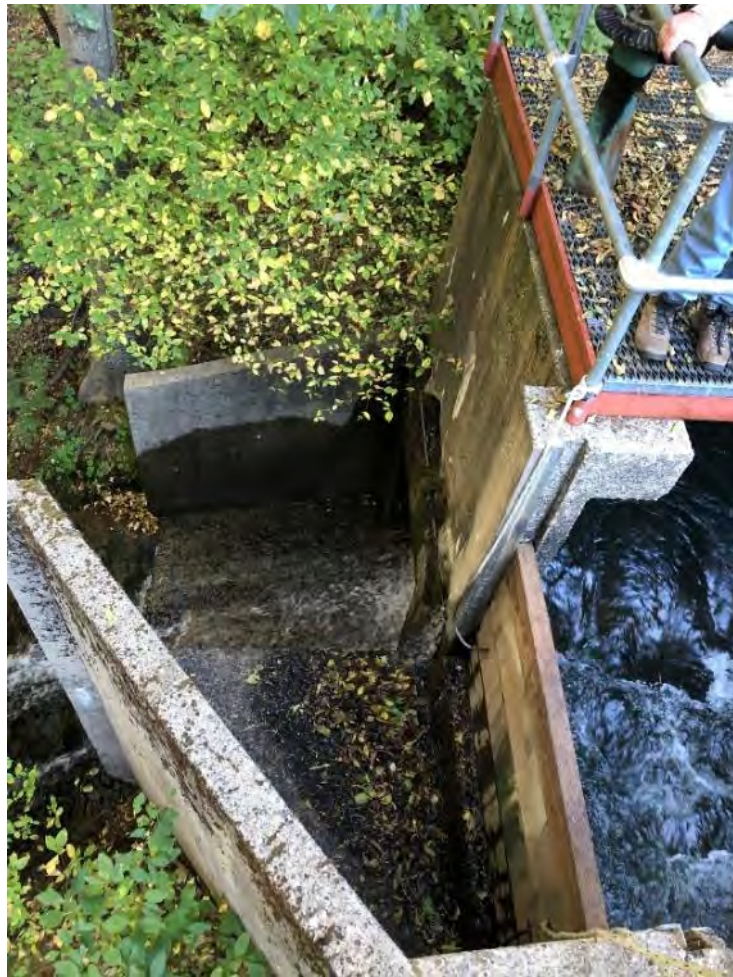
Photo 149 - View of Sand Bunker Spill

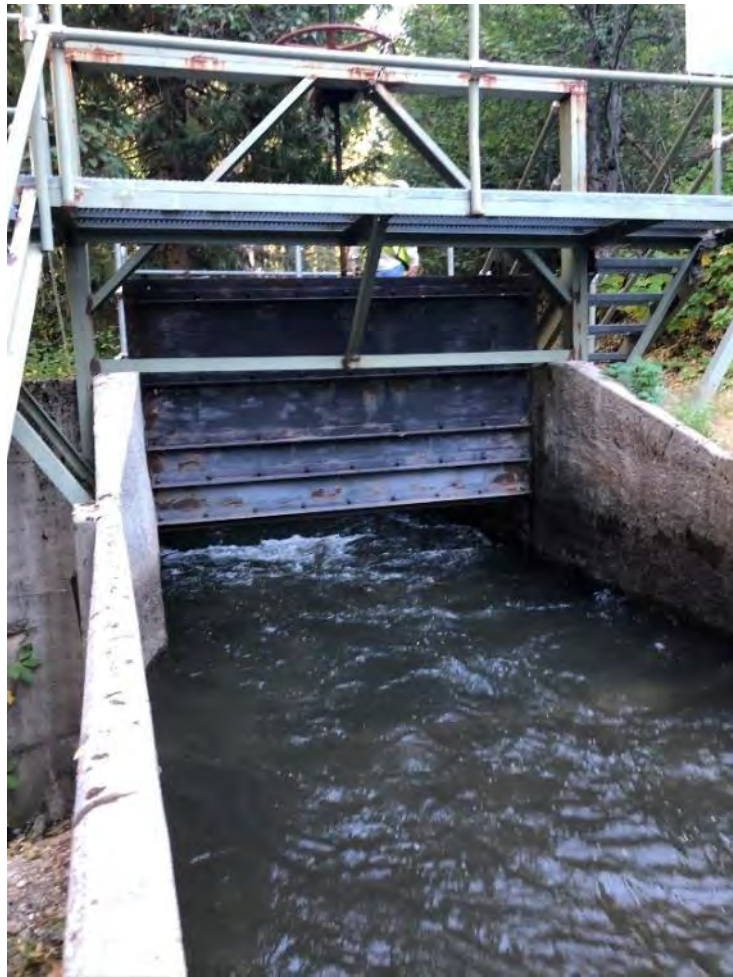
Photo 150 - View of Sand Bunker Spill

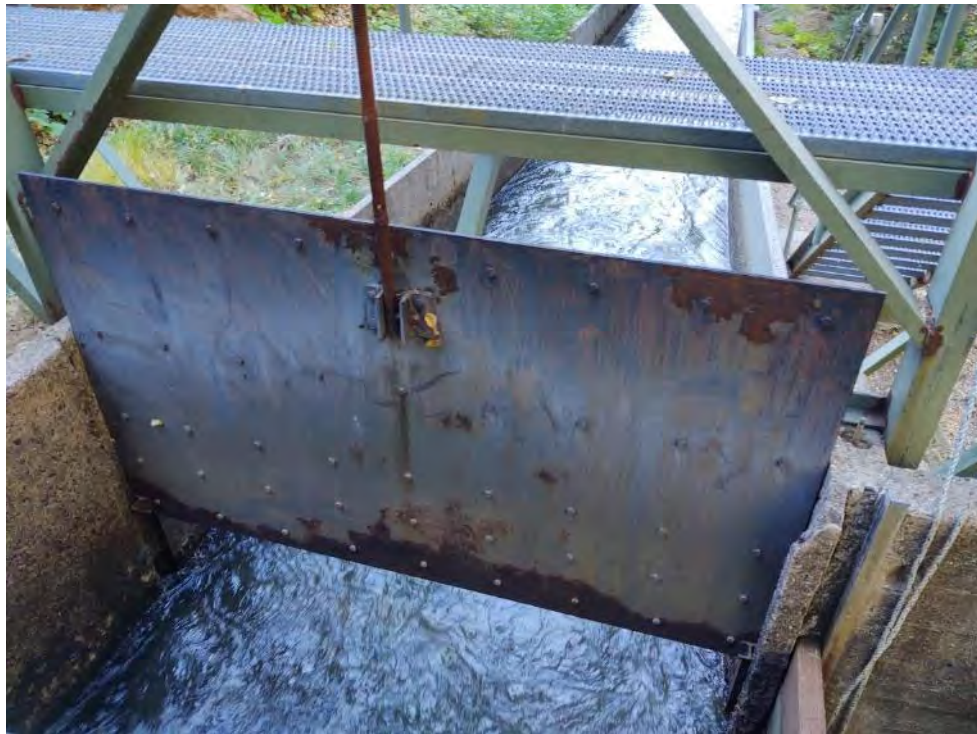
Photo 151 - View of Sand Bunker Spill

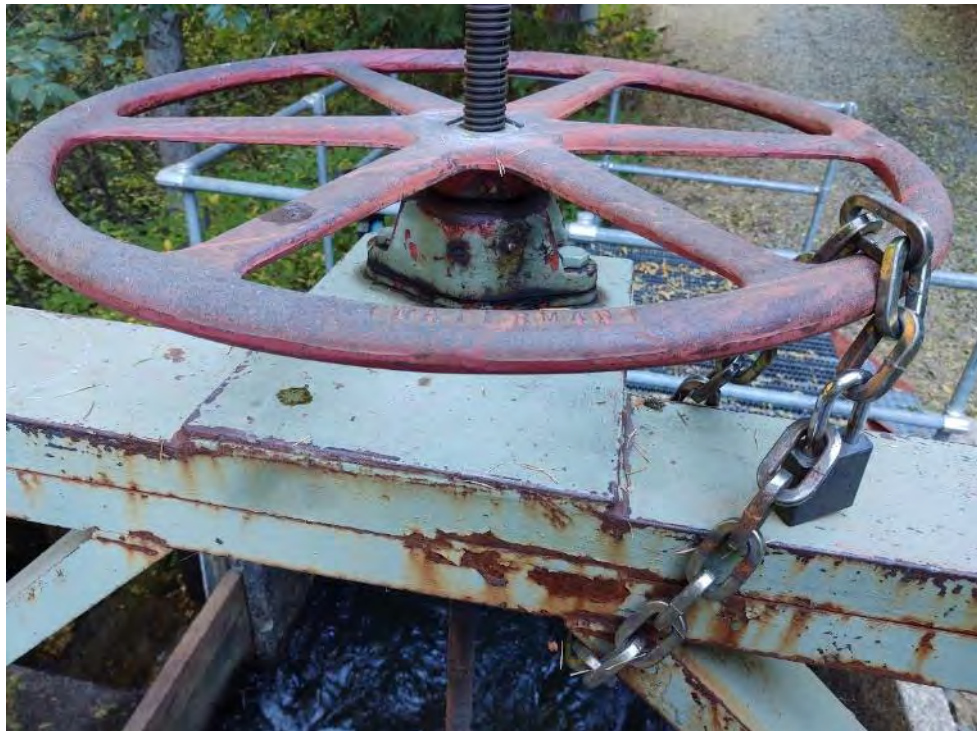
Photo 152 - View of Sand Bunker Spill

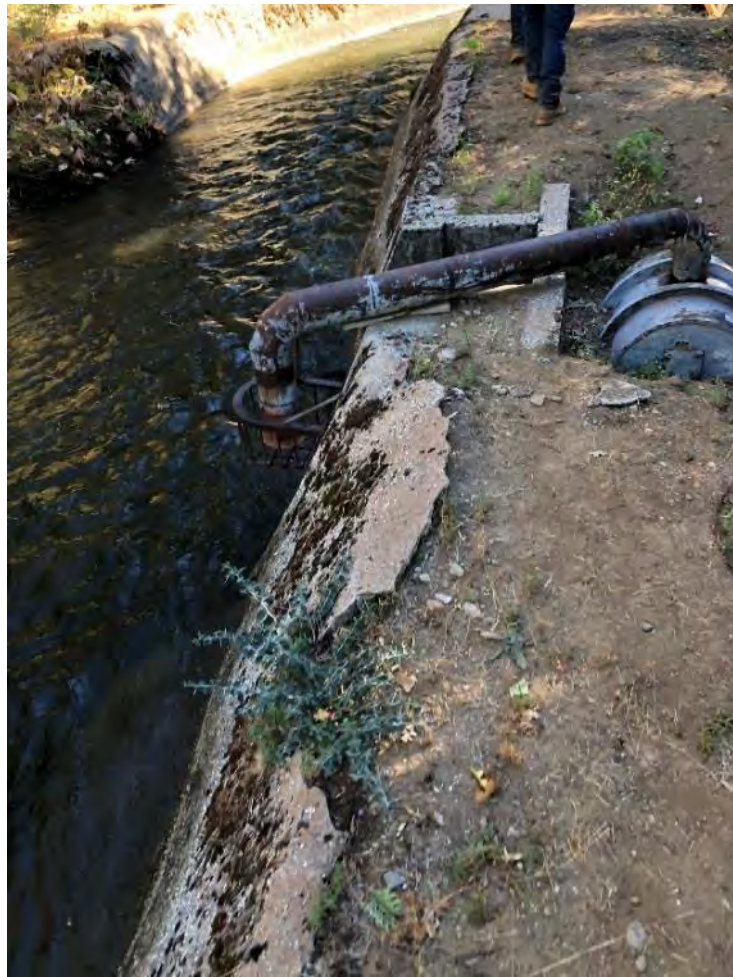
Photo 153 - View of Sand Bunker Spill

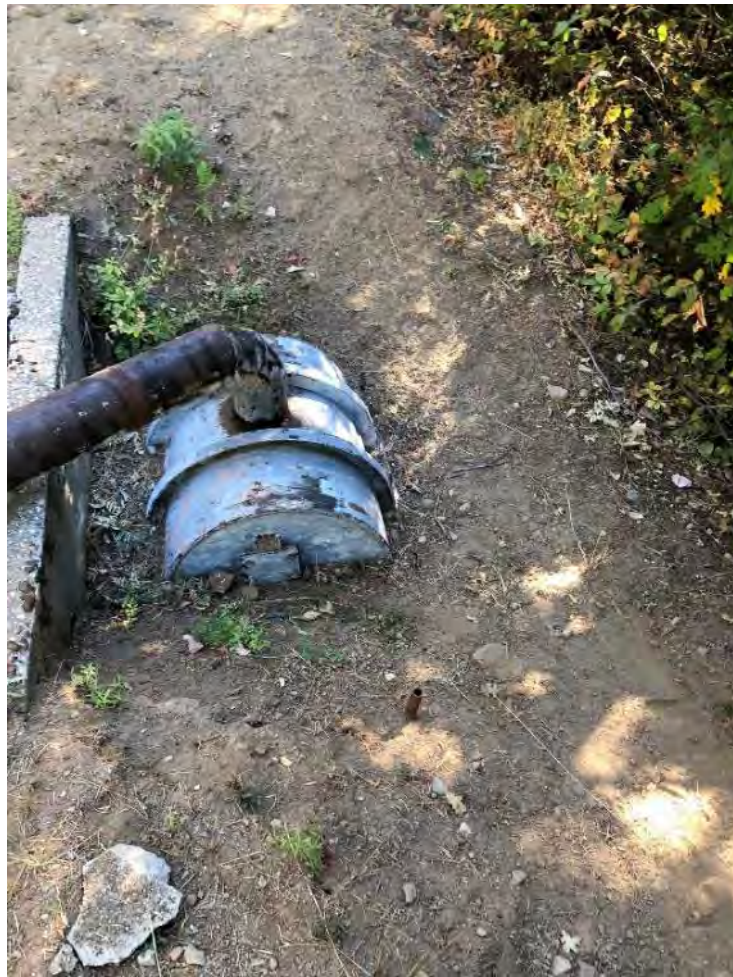
Photo 154 - View of Siphon Upstream of Sandsettler Spill Siphon

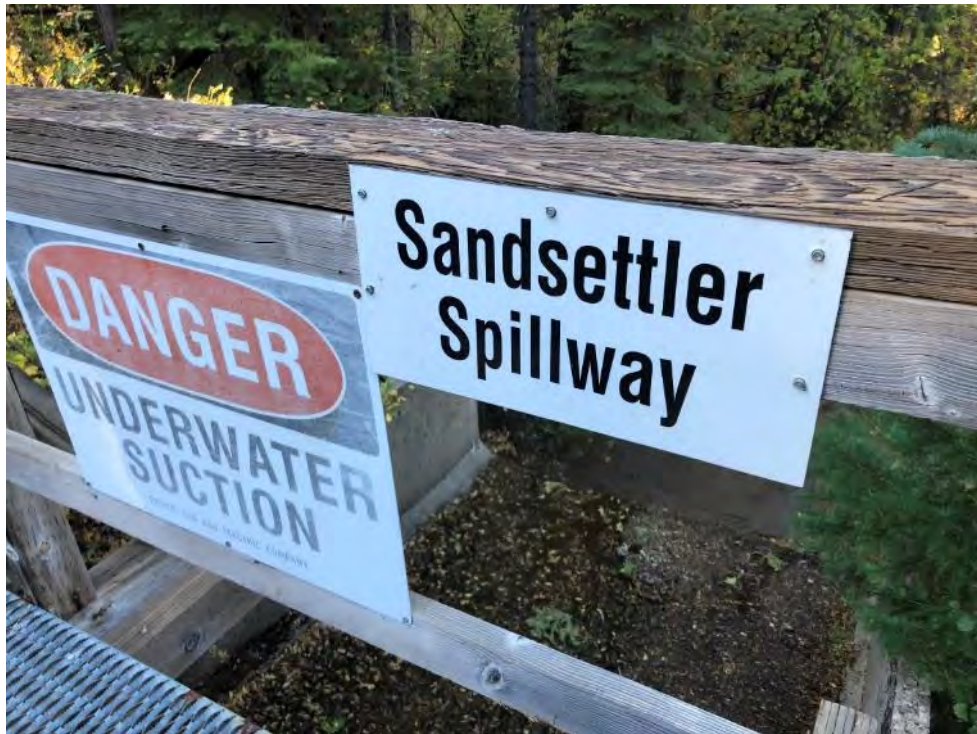
Photo 155 - View of Siphon Upstream of Sandsettler Spill Siphon

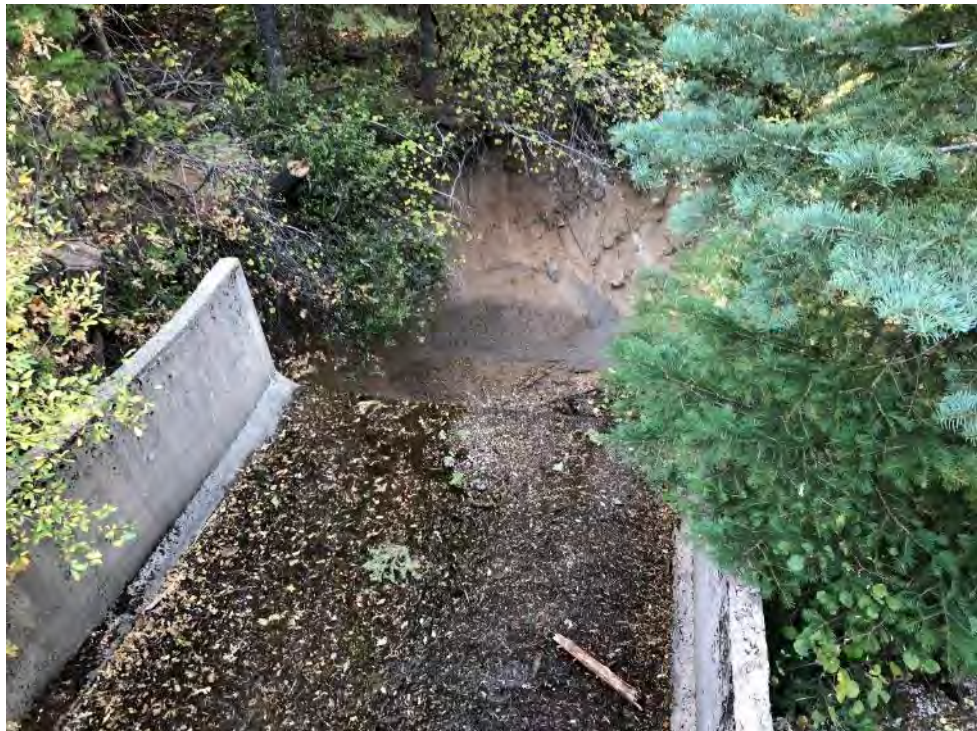
Photo 156 - View of Sandsettler Spillway

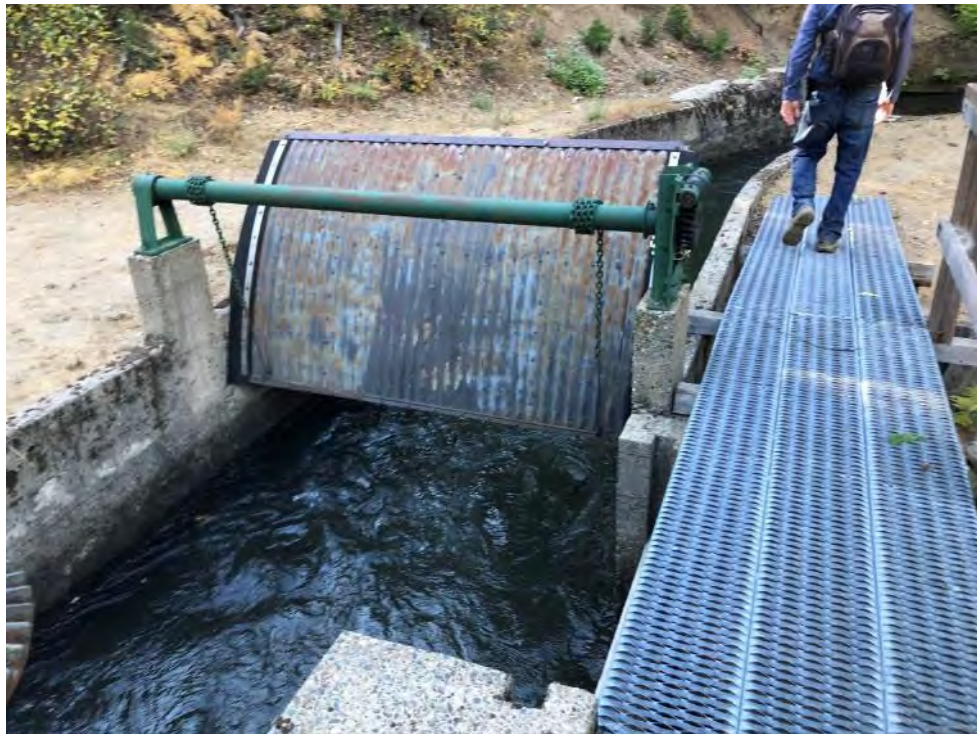
Photo 157 - View of Sandsettler Spillway

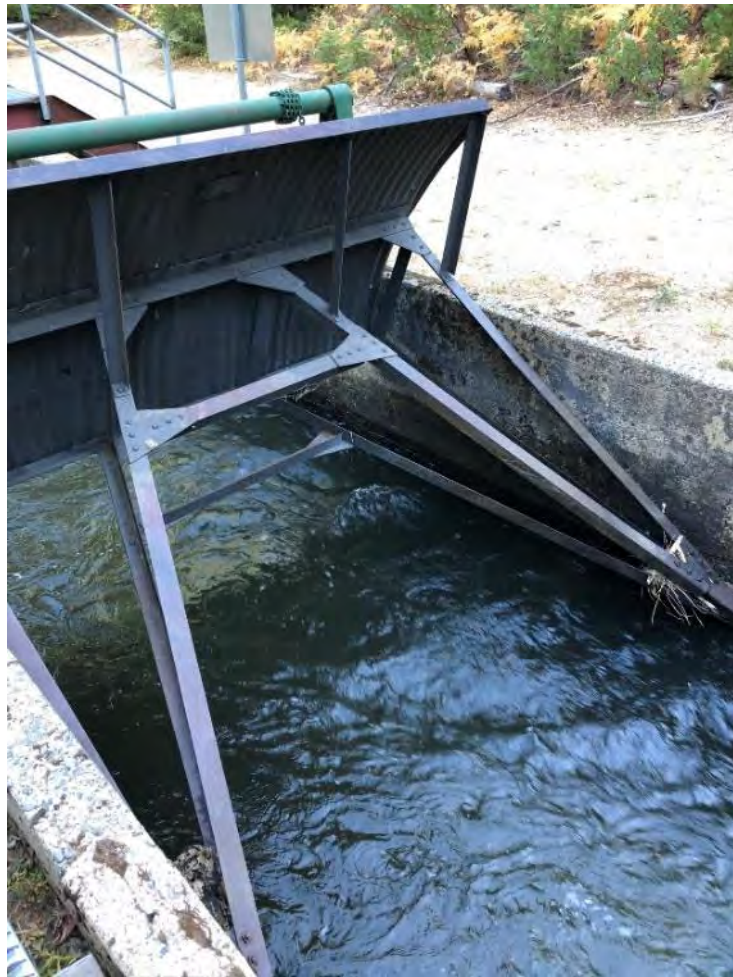
Photo 158 - View of Sandsettler Spillway

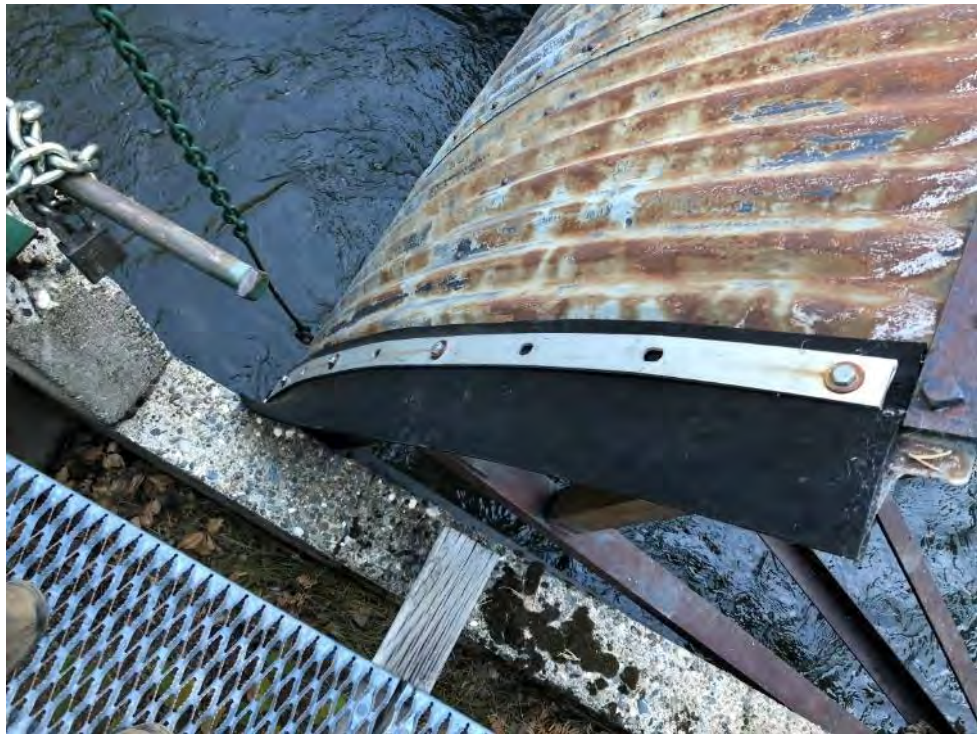
Photo 159 - View of Sandsettler Spillway

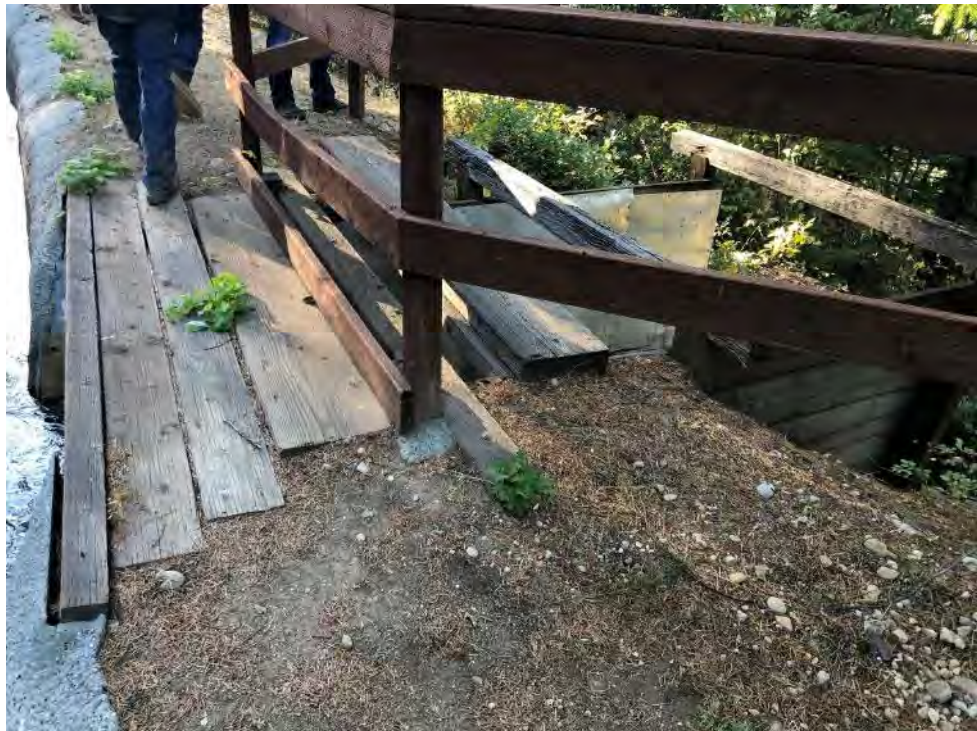
Photo 160 - View of Sandsettler Spillway

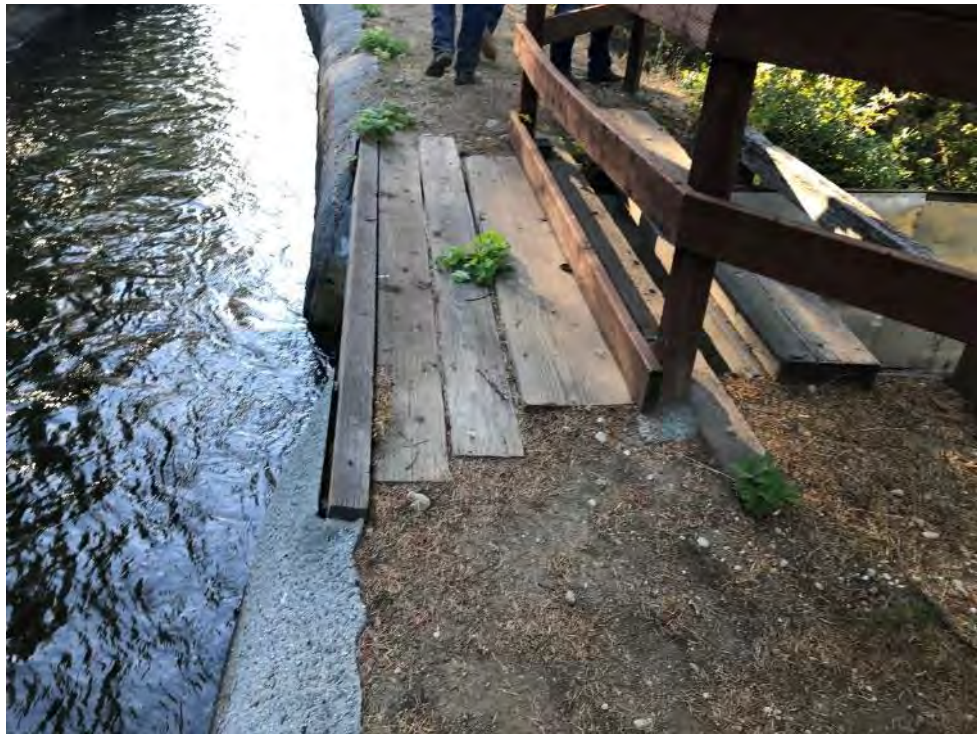
Photo 161 - View of Yunks Spill

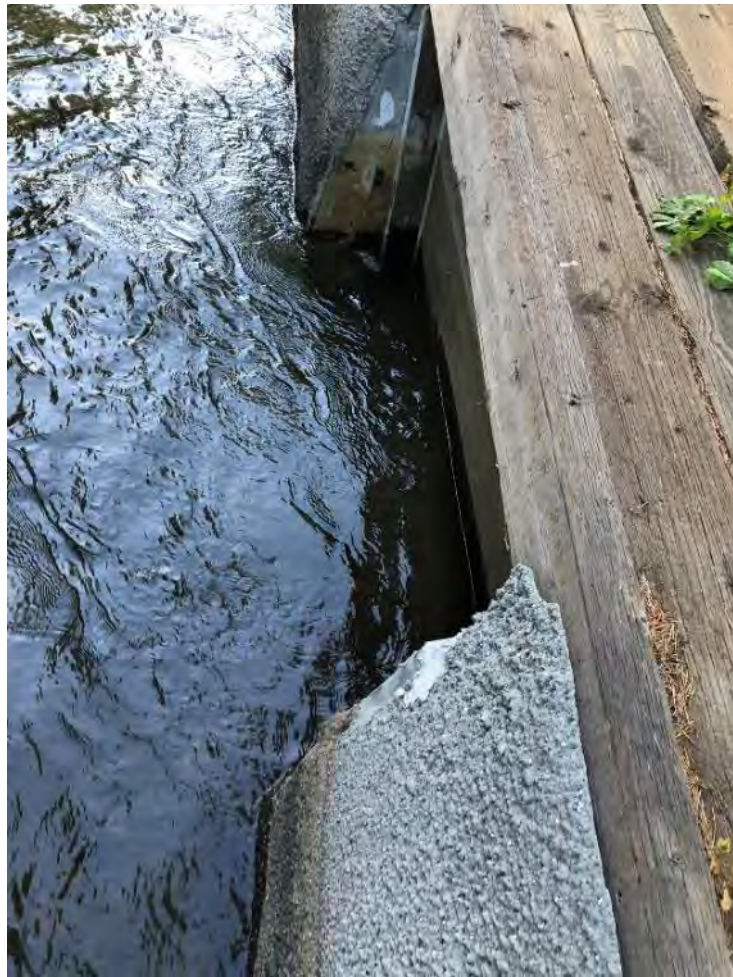
Photo 162 - View of Yunks Spill

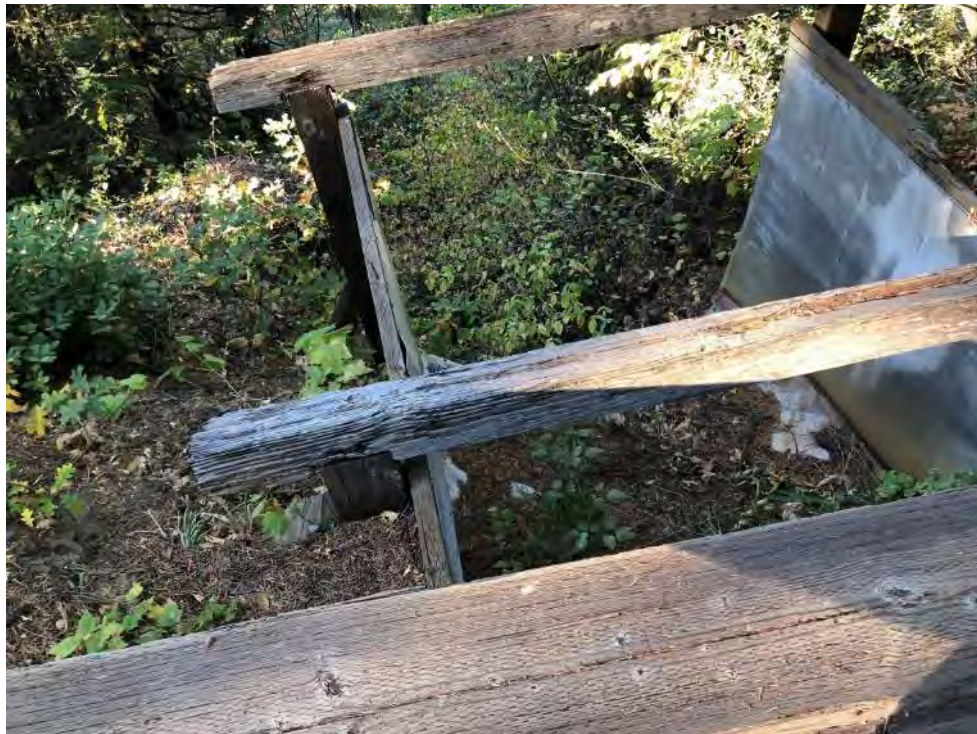
Photo 163 - View of Yunks Spill

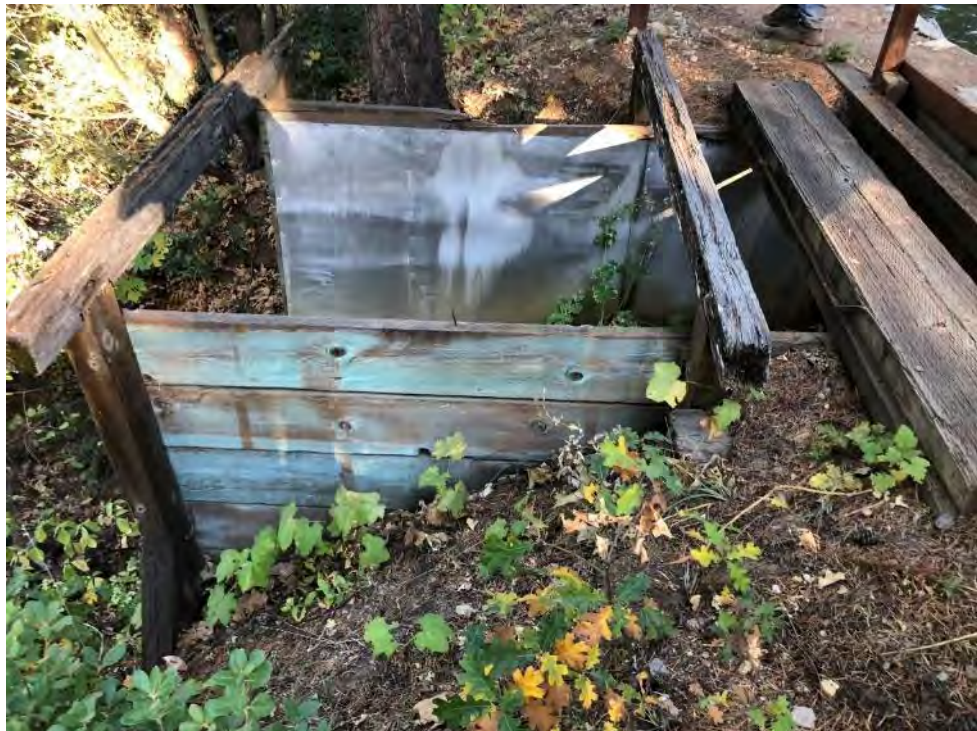
Photo 164 - View of Yunks Spill

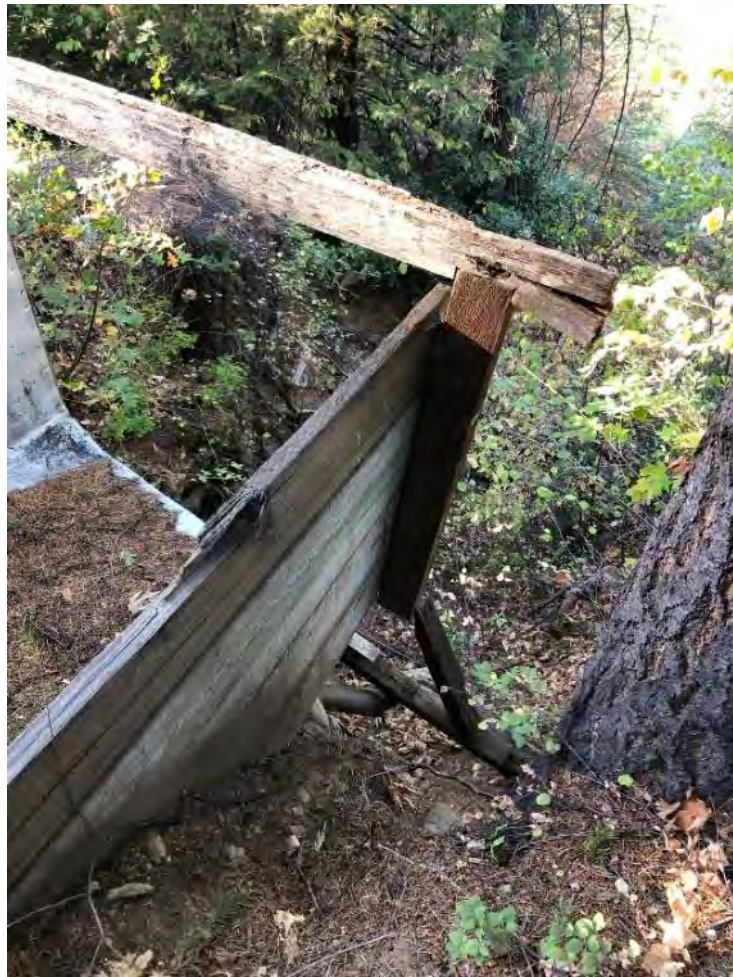
Photo 165 - View of Yunks Spill

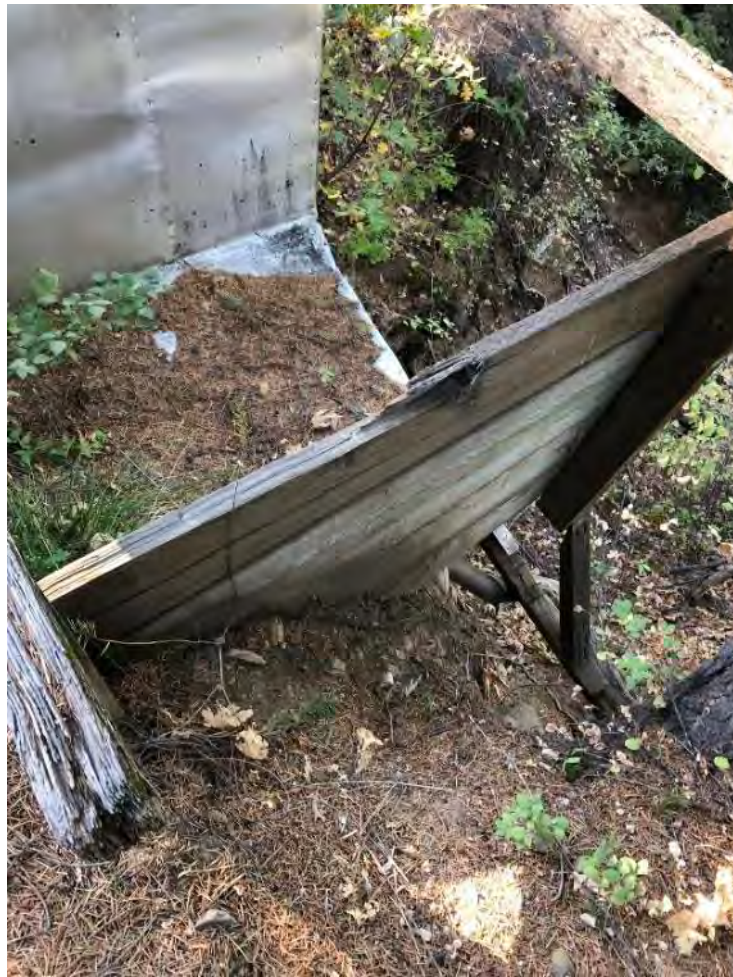
Photo 166 - View of Yunks Spill
