SUBJECT: Centennial Reservoir Project – Phase III Geotechnical Investigation

Discuss the results of Phase III of the Preliminary Geotechnical Investigation

CENTENNIAL RESERVOIR PROJECT Nevada Irrigation District

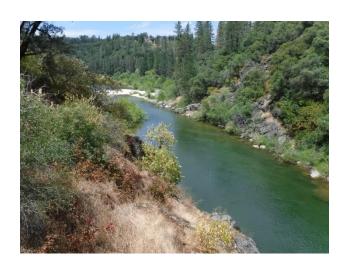
Geologic Mapping

- Mapping of rock outcrops, alluvium and landslides
- Evaluation of photo lineaments
- Developed plans for seismic line and boring locations
- Confirmed regional geologic mapping

Strike (Degrees Az.)	Dip (Degrees)	Discontinuity Type	No. of Data points
120-130	12 SW	Bedding	25
8-20	80 E	Joint Set 1	37
277-292	85 N	Joint Set 2	29

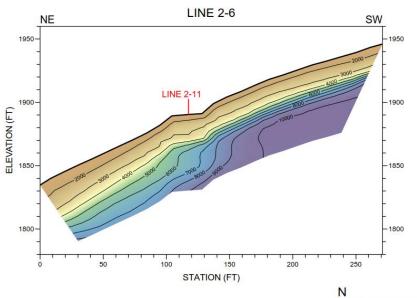
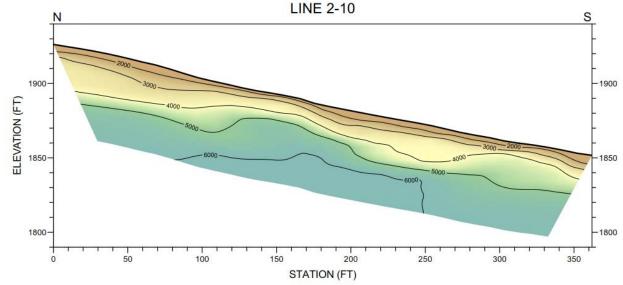
Surface Geophysical Surveys

- 15 seismic refraction survey lines at Axis 2 site
- Close confirmation with bore hole data

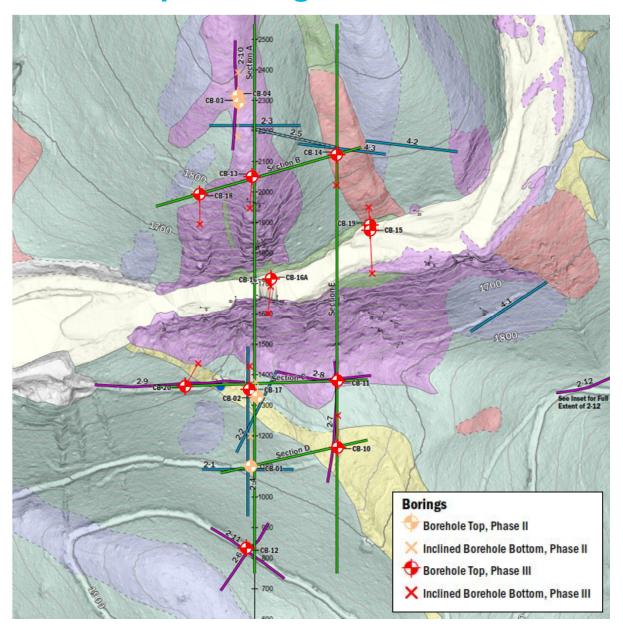
Site Exploration Map - Borings

- 16 core borings
 - o 2 vertical
 - o 14 inclined
 - o Up to 254 feet deep
 - o Total drilling 2715 feet
- Water pressure (packer) testing
- Televiewer and caliper logging
- Downhole seismic velocities
- Rock strength testing

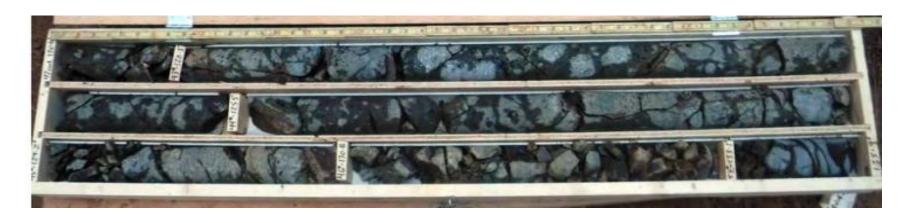
CB-1, 120.0 – 133.9 ft.

Core Boring Sample: south (left) abutment

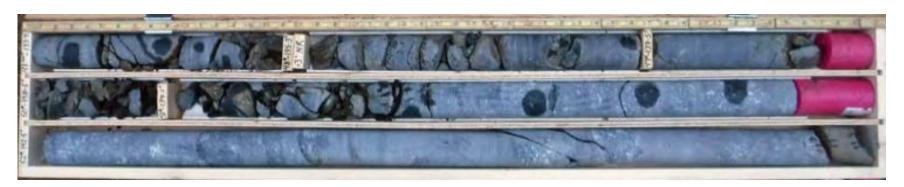
CB-1, 133.9 – 147.5 ft.

Ø Weathering and fracturing decrease with depth

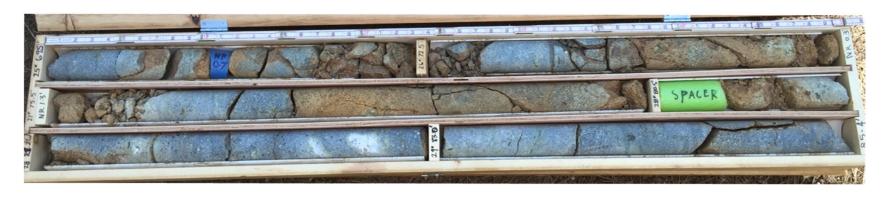
Rock Core: CB-13, 69.5 – 85.4 ft.

Rock Core and Televiewer Log: north (right) abutment

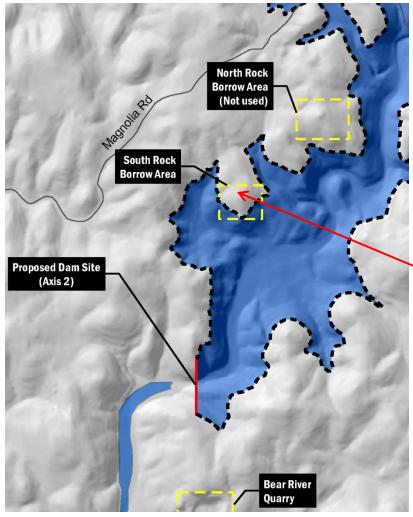
Potential Rock Borrow Area Investigation

- Geologic mapping
- Seismic refraction surveys
- 5 core borings totaling 585 feet
- Downhole seismic velocities
- 2 piezometers
- Rock strength testing
- Durability testing

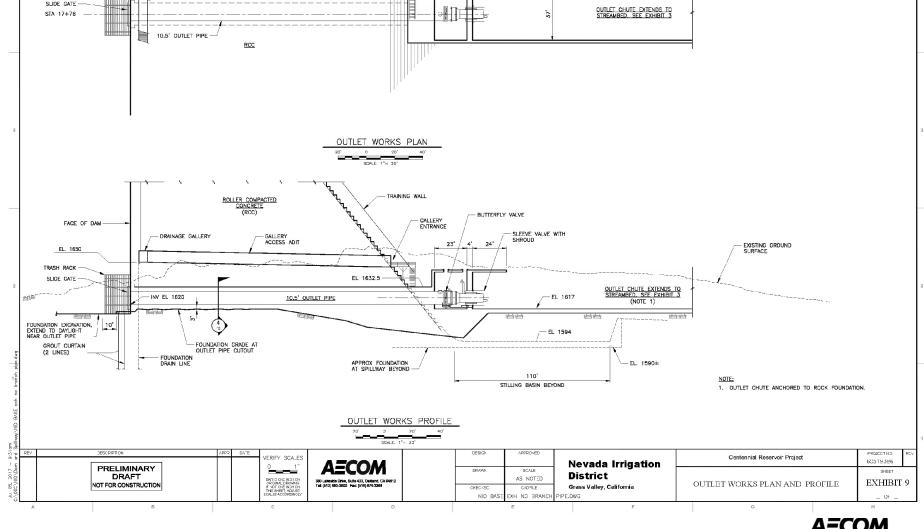
Outlet Works DOWNSTREAM STEPS DRAINAGE GALLERY RCC ADIT ACCESS PLATFORM - GALLERY ACCESS ADIT TRASH RACK SLIDE GATE OUTLET CHUTE EXTENDS TO STREAMBED, SEE EXHIBIT 3 10.5' OUTLET PIPE -RCC OUTLET WORKS PLAN TRAINING WALL BUTTERFLY VALVE FACE OF DAM SLEEVE VALVE WITH SHROUD - DRAINAGE GALLERY GALLERY ACCESS ADIT 23' EXISTING GROUND SURFACE EL. 1650 TRASH RACK SLIDE GATE

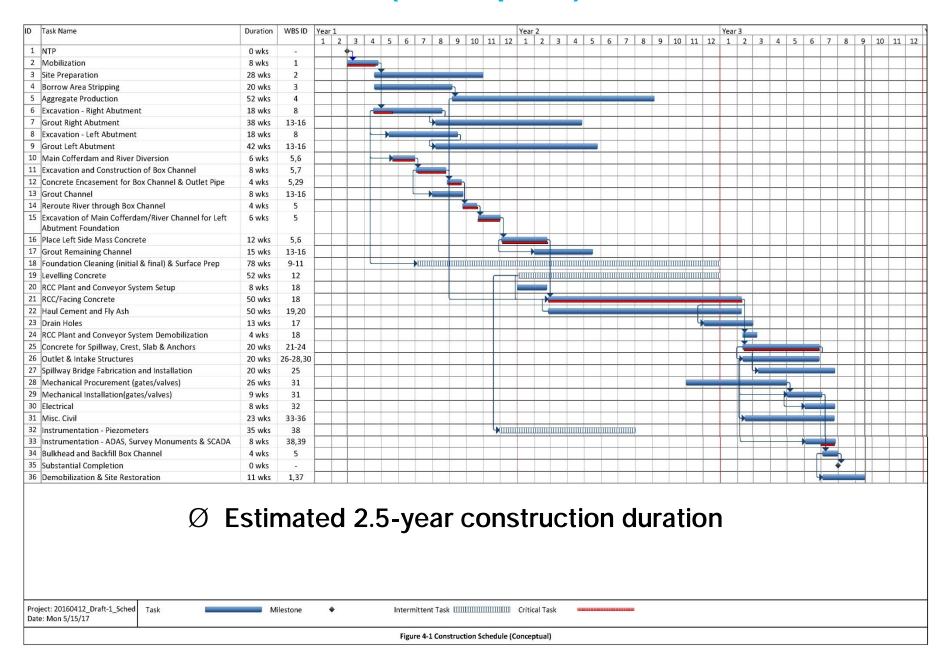
Construction Schedule (Conceptual)

- Work performed up to 6 days per week, 2 shifts per day
- No overly restrictive constraints on trucking materials to the site
- Dam foundation excavation: 15,000 cubic yards per week
- Foundation grouting (drilling and grouting): 600 linear feet per week for each drill rig and grout plant.
- RCC construction: 16,000 cubic yards per week
