**SUBJECT: South Yuba Canal Condition Assessment Report (Project #2419)**

# South Yuba Canal 2021 Condition Assessment

Final Report  
South Yuba Canal  
2021 Condition Assessment

Nevada Irrigation District

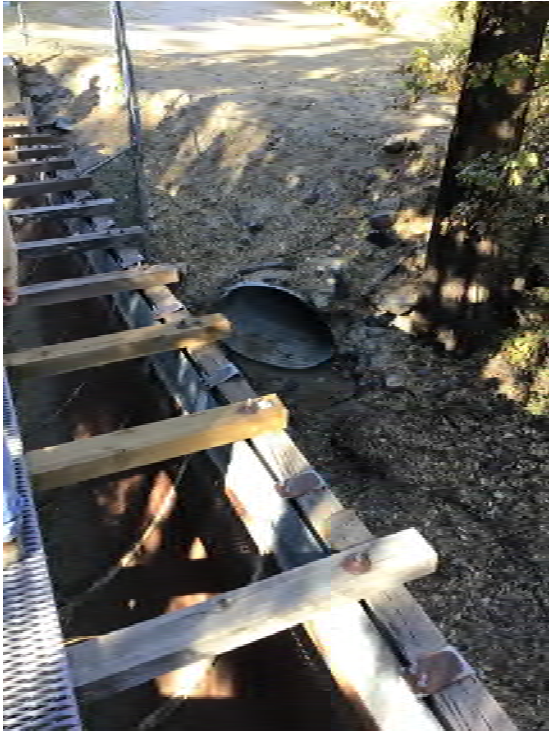
Photo 5 Highway 20 Culvert

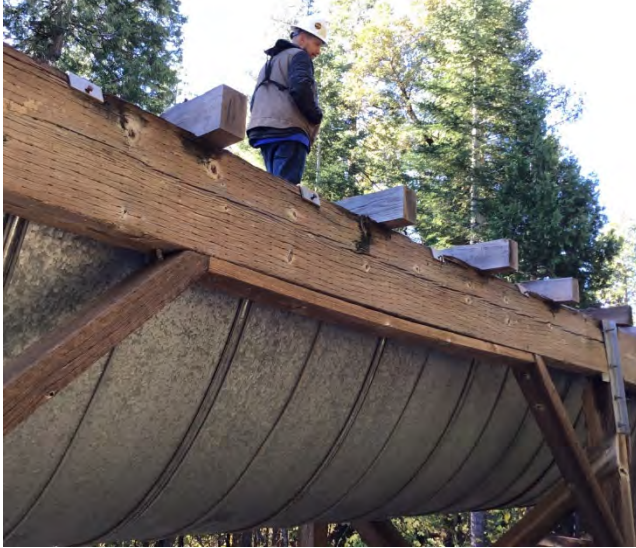
Photo 7 Sagging Girder

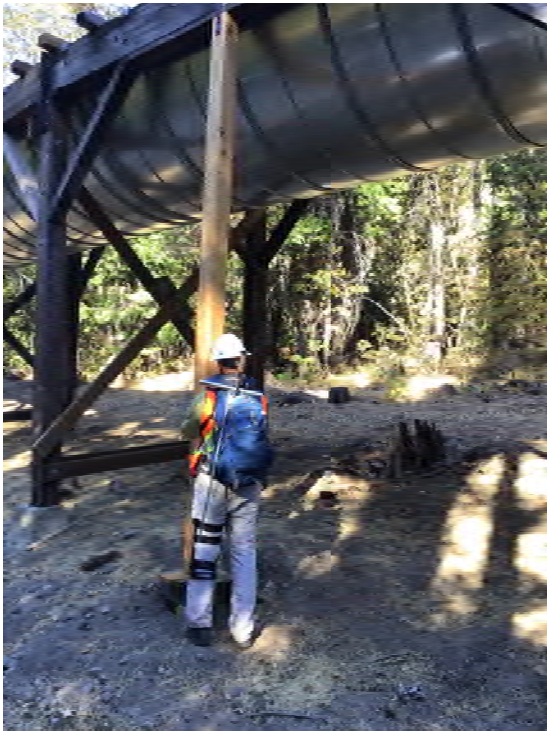
Photo 8 Temporary Support

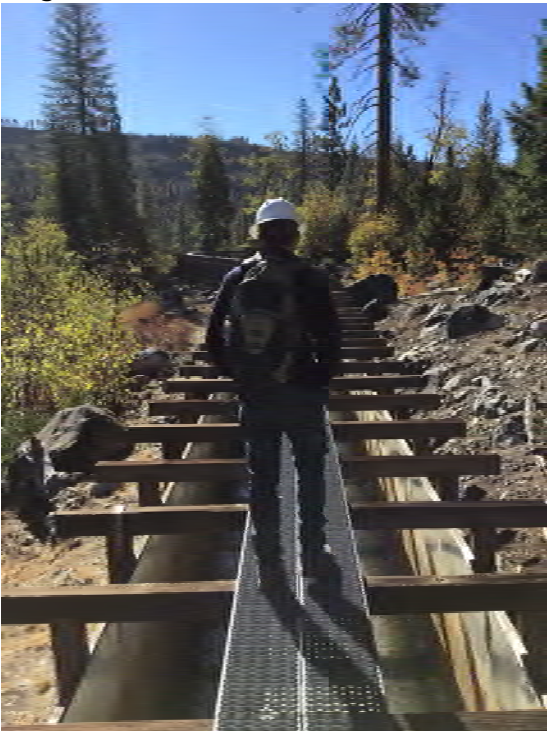
Photo 11 Flume out of Plumb

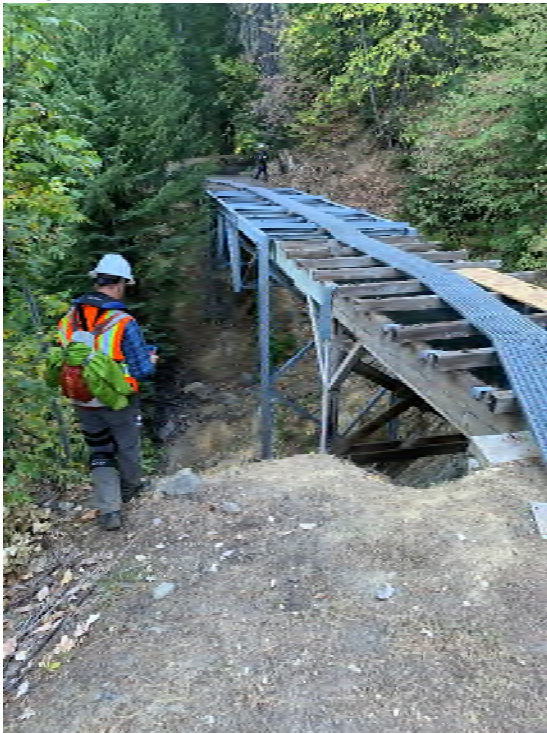
Photo 24 Historic Landslide at Flume 11/1

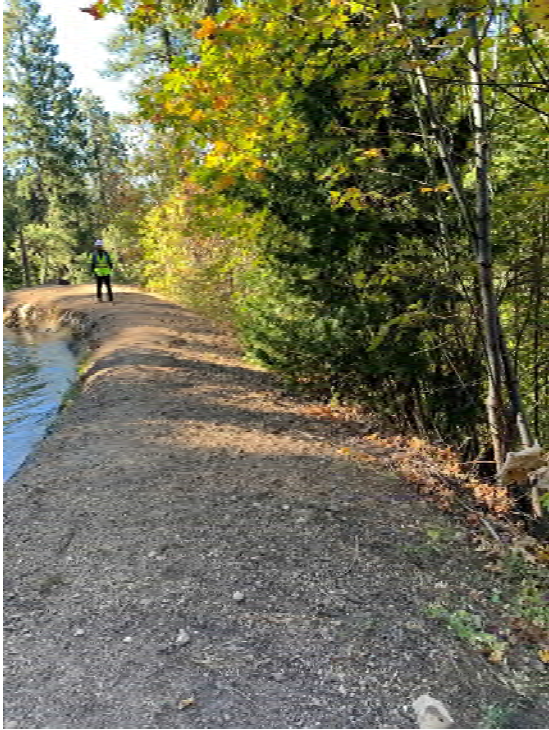
Photo 26 Potential Landslide

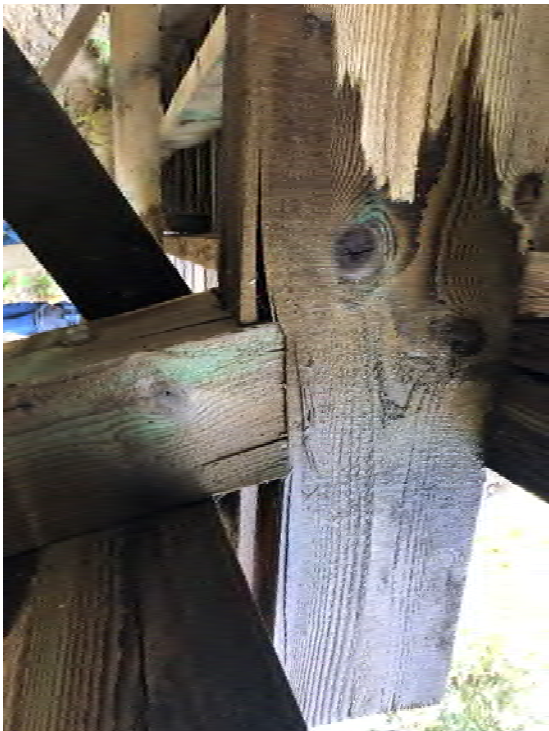
Photo 28 Crushed Girder in Timber Flume

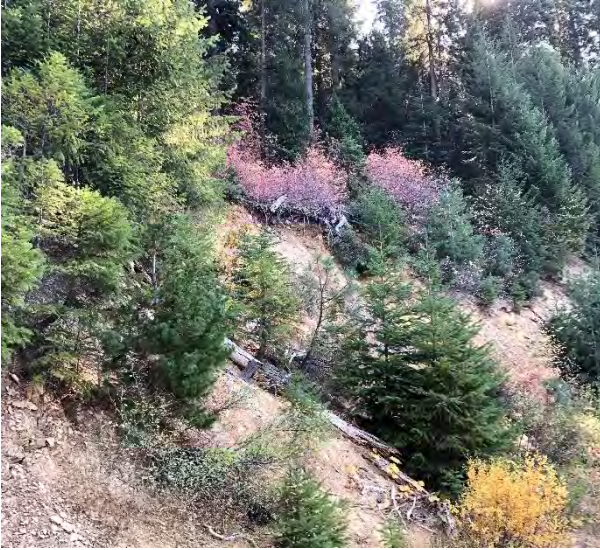
Photo 30 Upslope Landslide

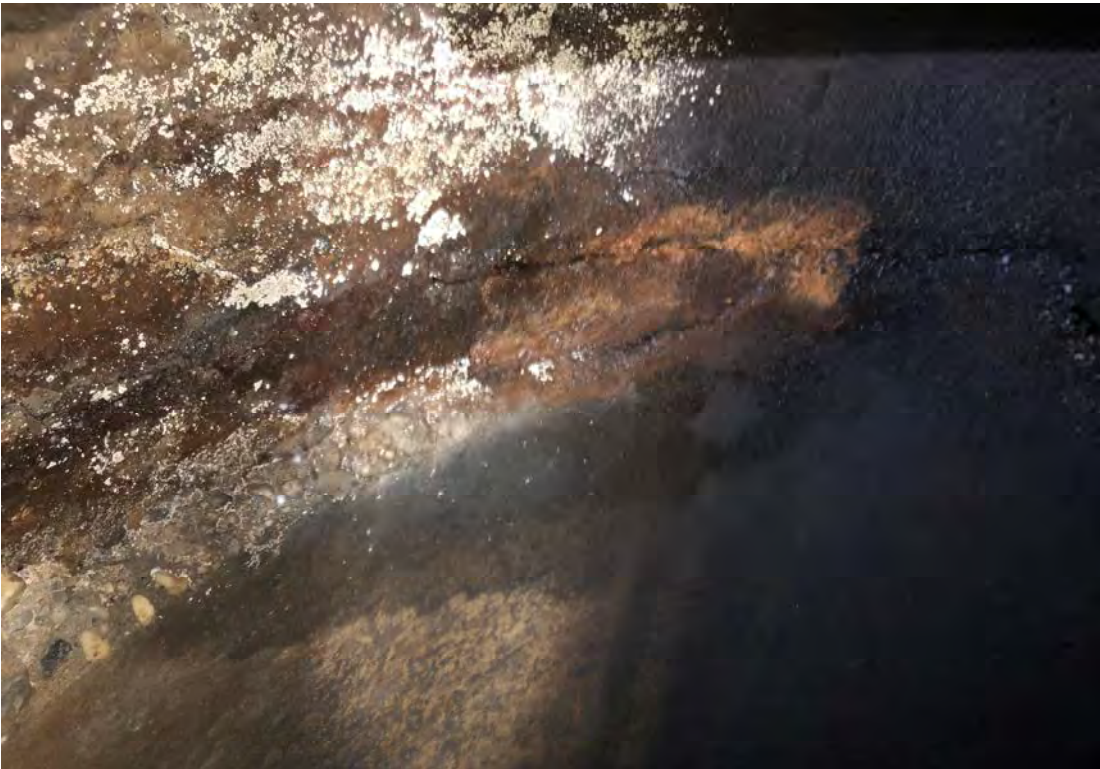
Big Tunnel 0+80

Lined section to station 0+79. metamorphic bed rock from 0+79. Bedrock is highly weathered, closely fractured, moderately weathered, moderately strong. Split sets at 3 foot centers and chain-link fence on the back. A void from a detached block in the back but nothing on the belly looks clean.

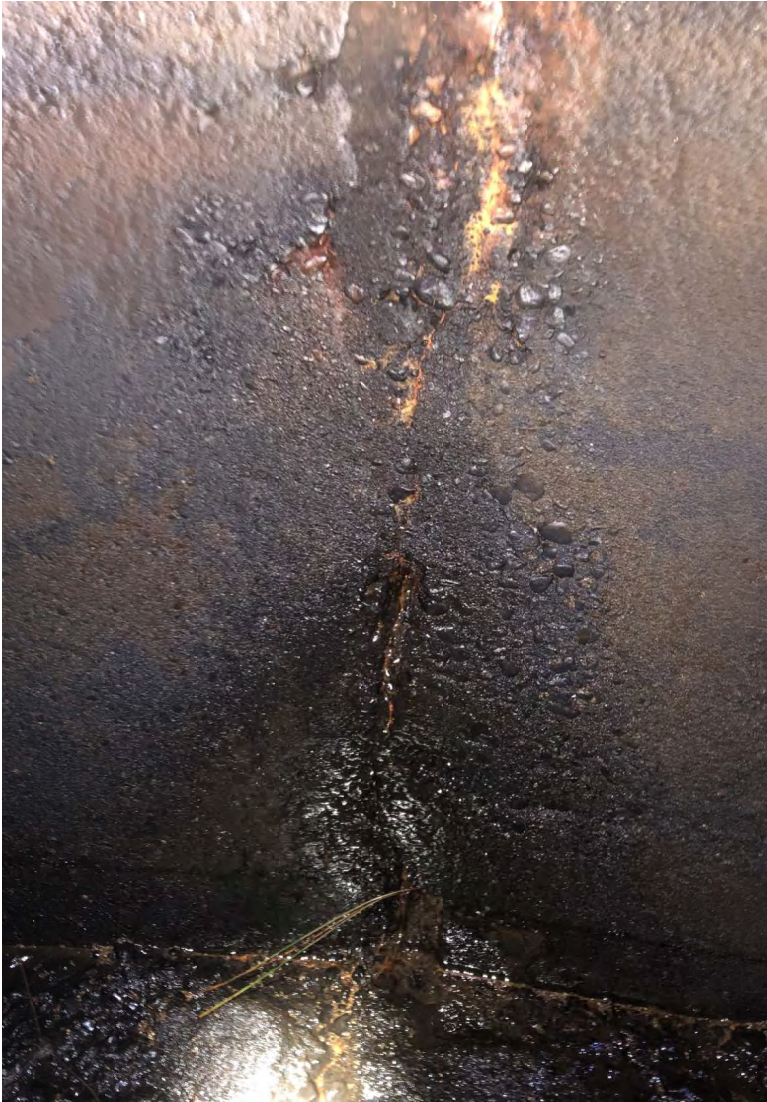
Big Tunnel Thin Cover On Wood 4+01

GHD recommends continued monitoring of the eroded thin liner sections discussed above. The original design called for thin shotcrete cover over old timber sets.

Within approximately five years, we anticipate that "dental" localized repair work may be needed in the eroded liner sections. Other than eroded liner sections, no evidence of structural distress was observed.

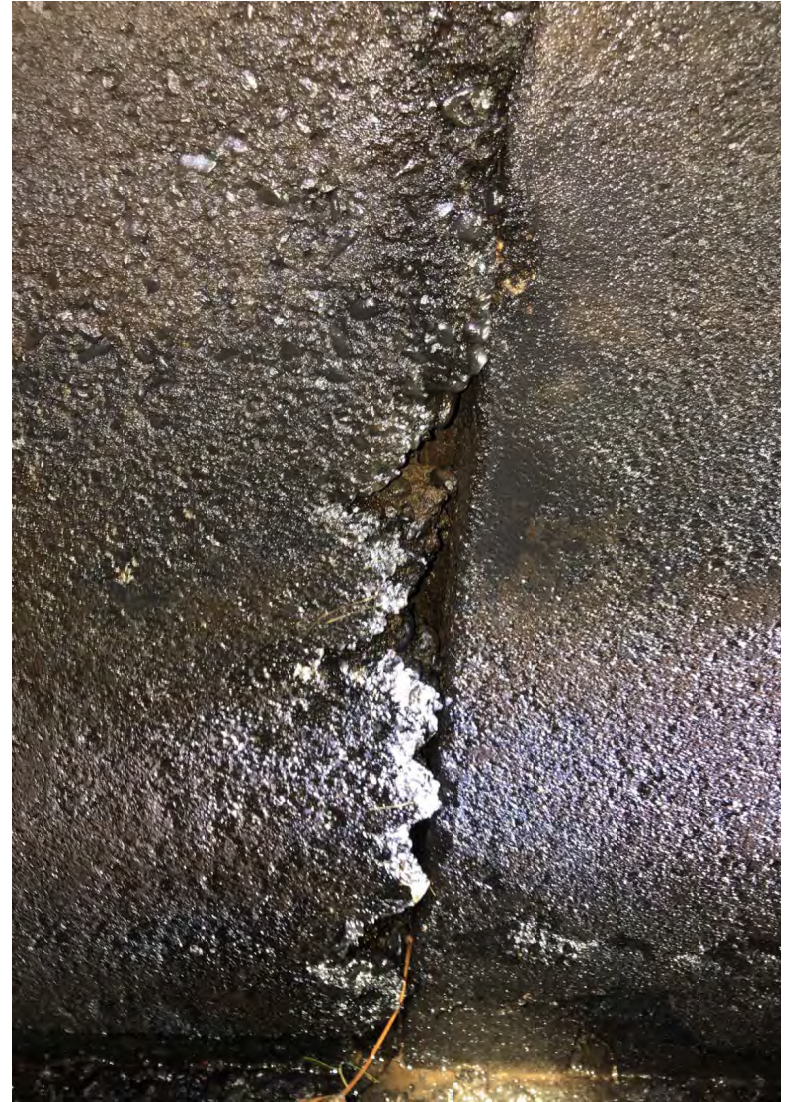
Big Tunnel Thin Cover On Wood1

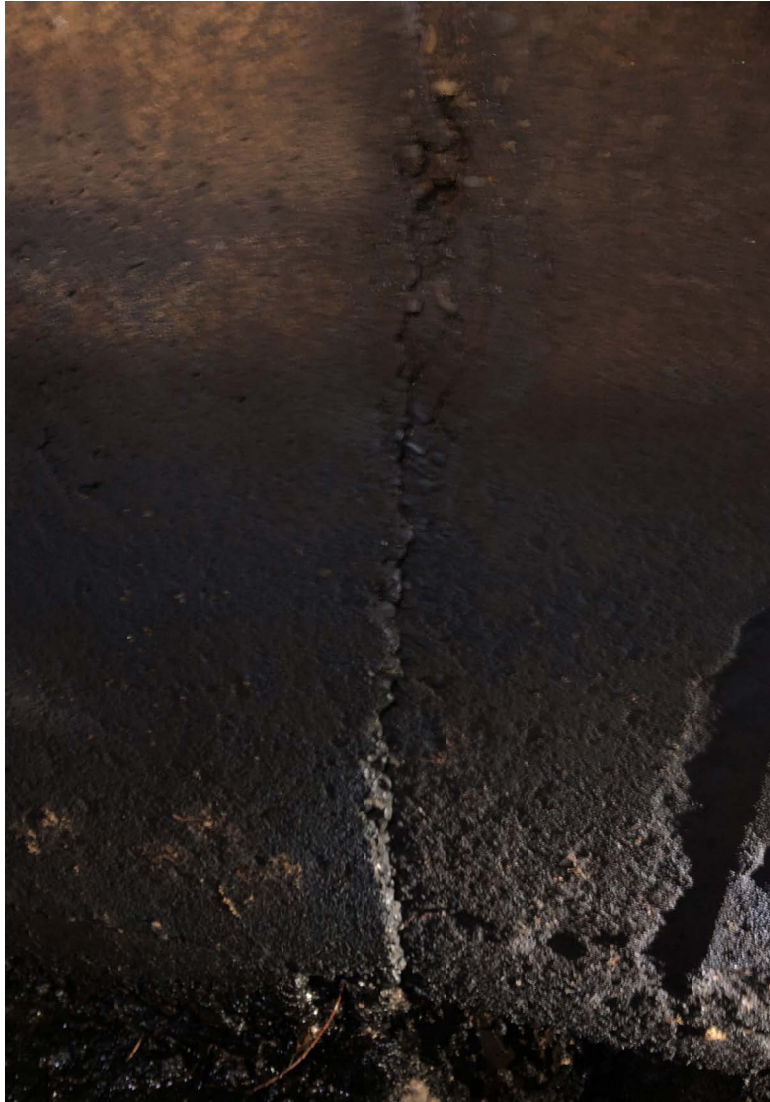
Big Tunnel Thin Cover On Wood 4+55

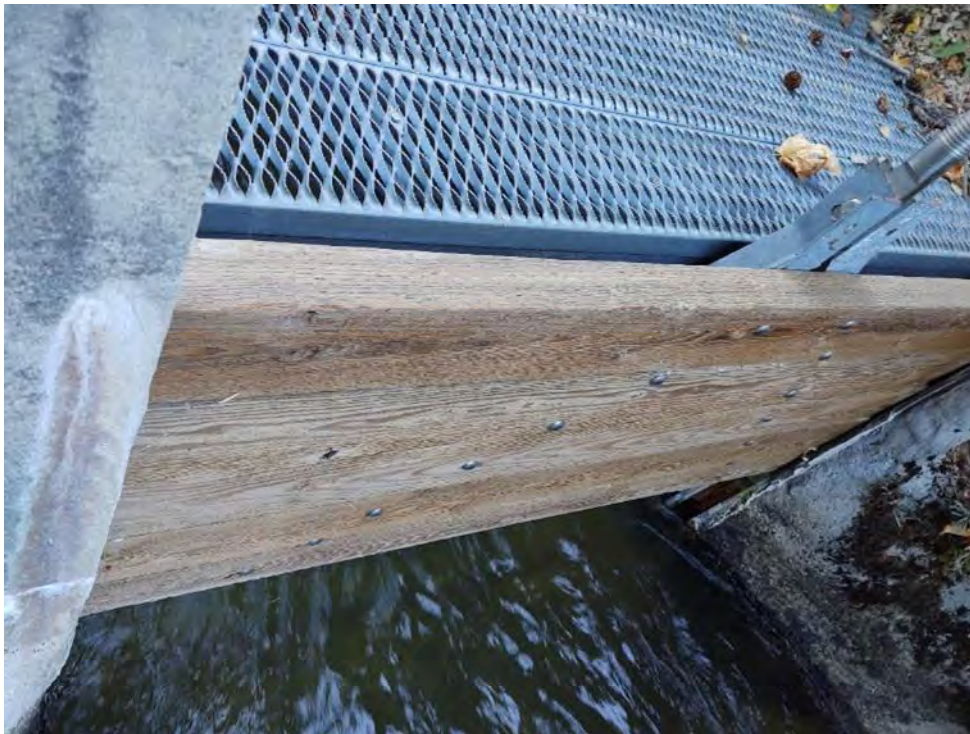
Photo 50 - View of 9 1/2 Mile Spill

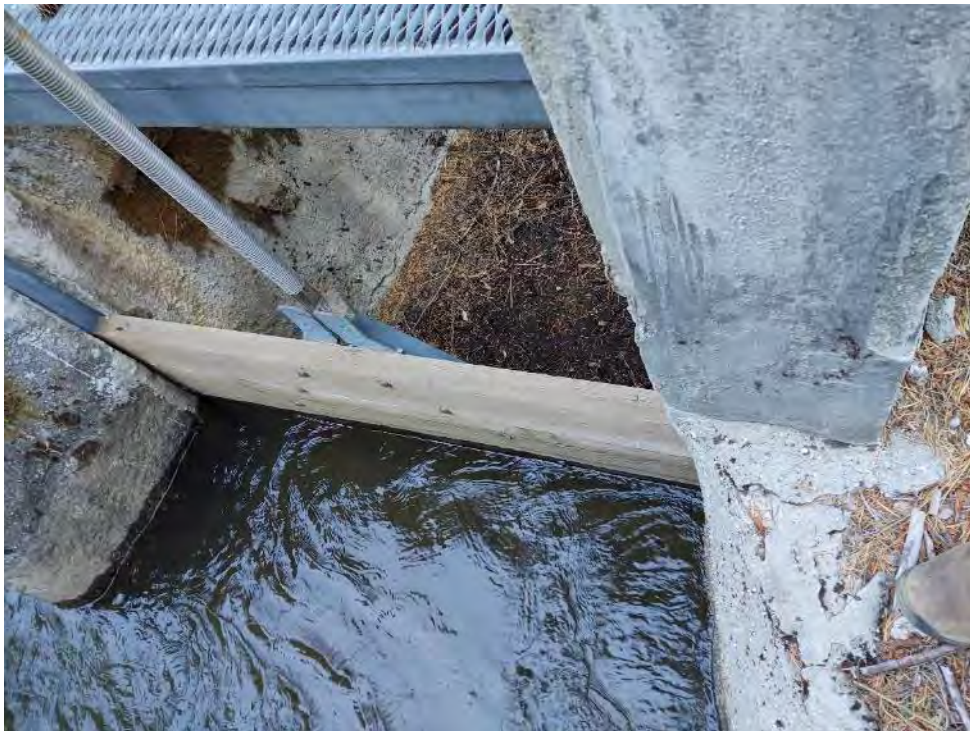
Photo 51 - View of 9 ½ Mile Spill

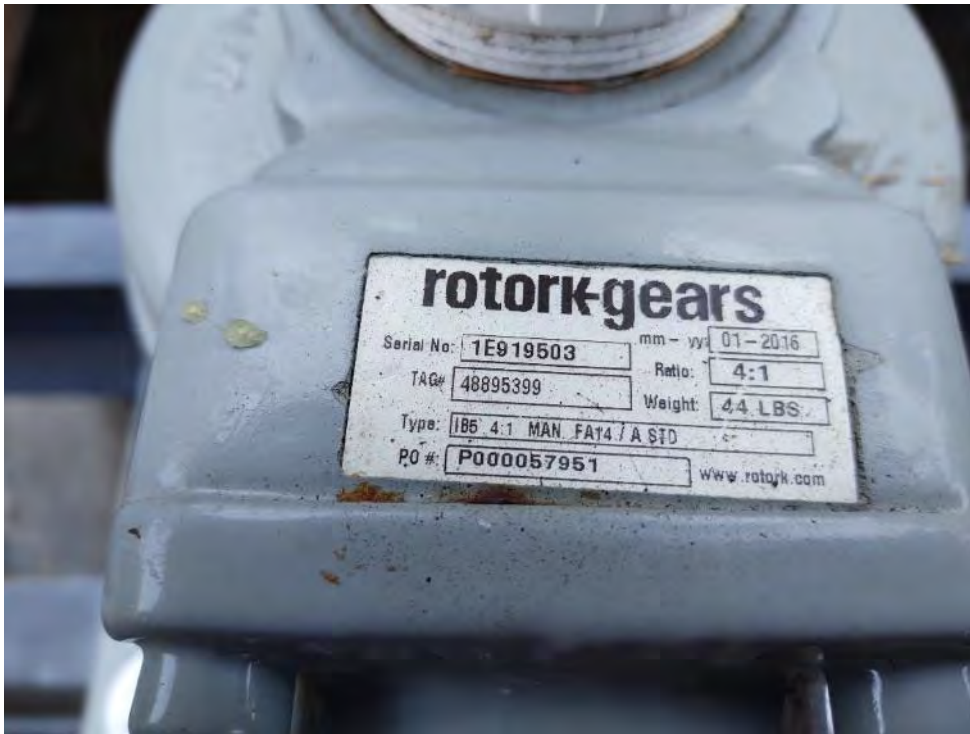
Photo 52 - View of 9 ½ Mile Spill

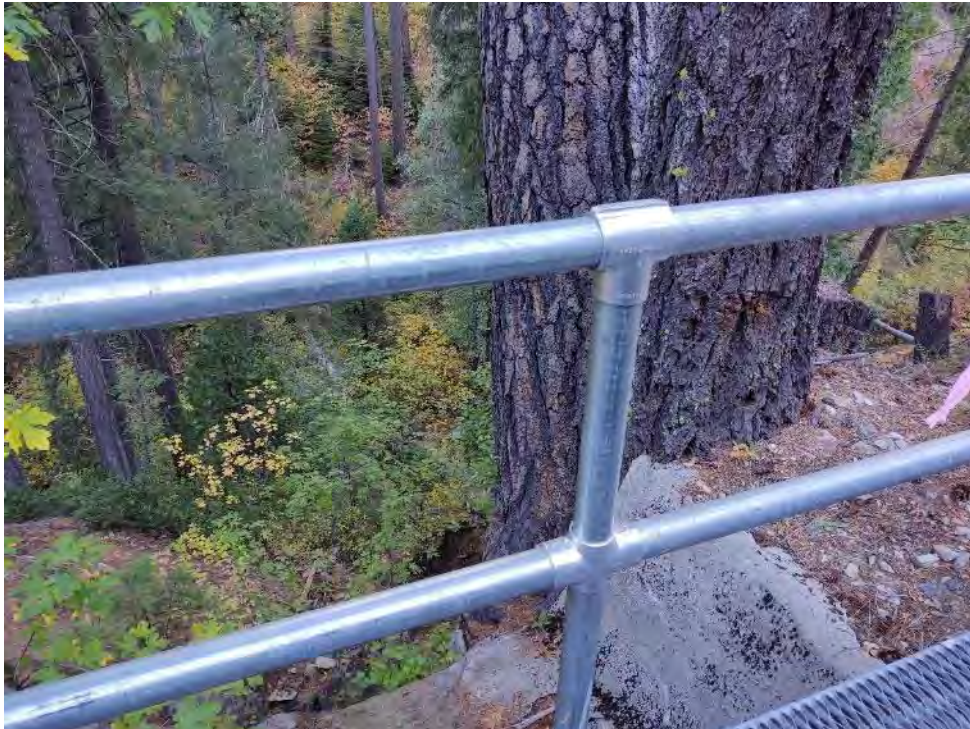
Photo 53 - View of 9 ½ Mile Spill

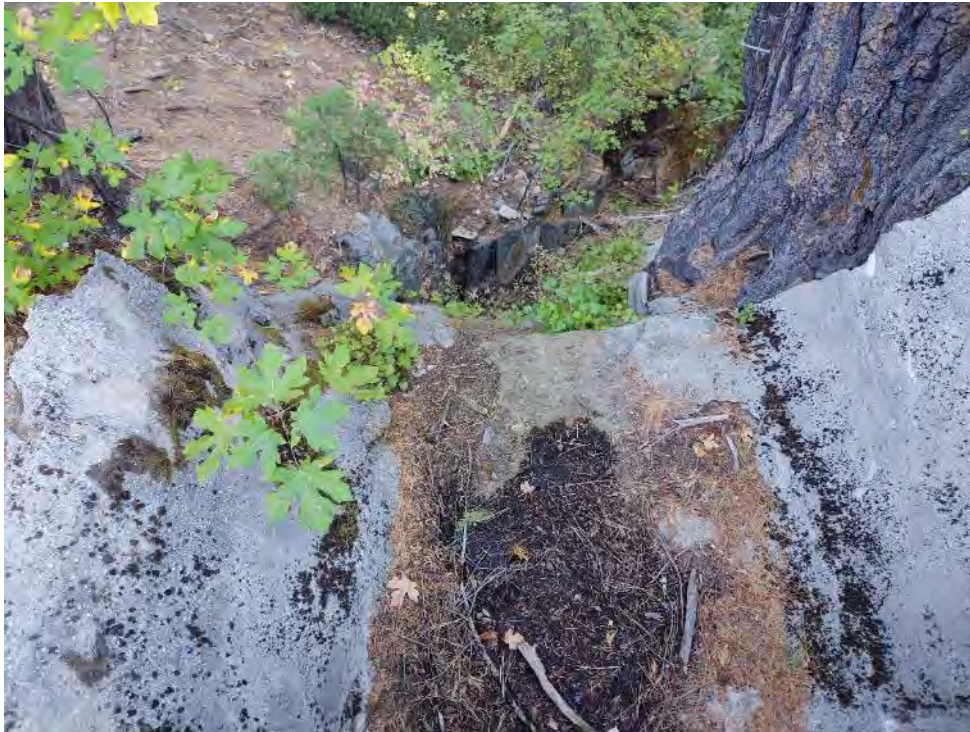
Photo 54 - View of 9 ½ Mile Spill

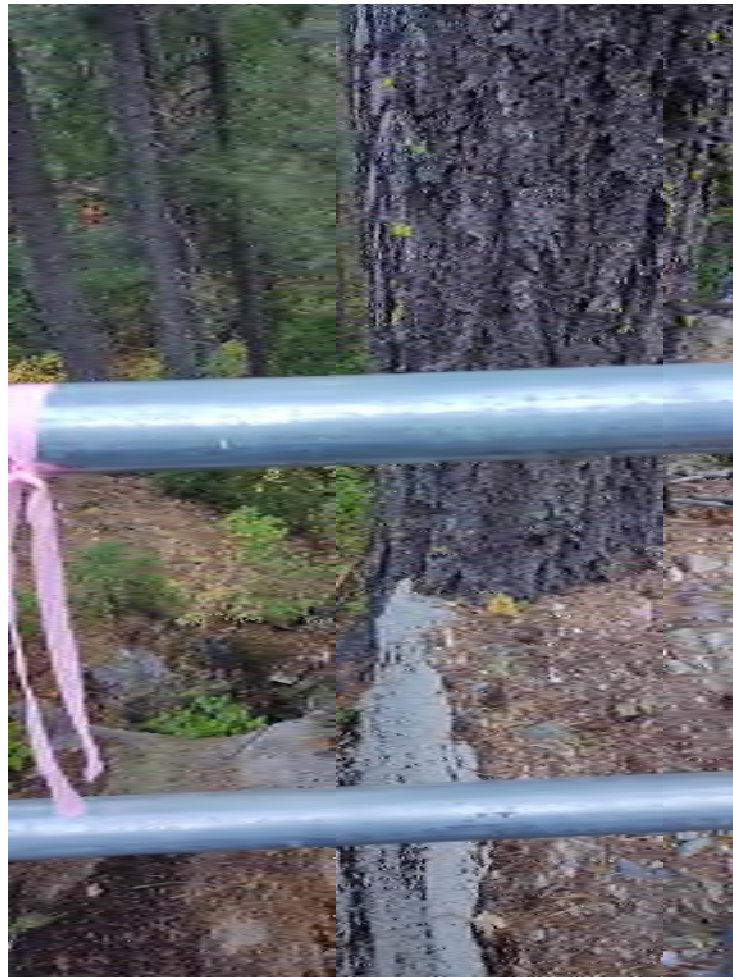
Photo 55 - View of 9 ½ Mile Spill

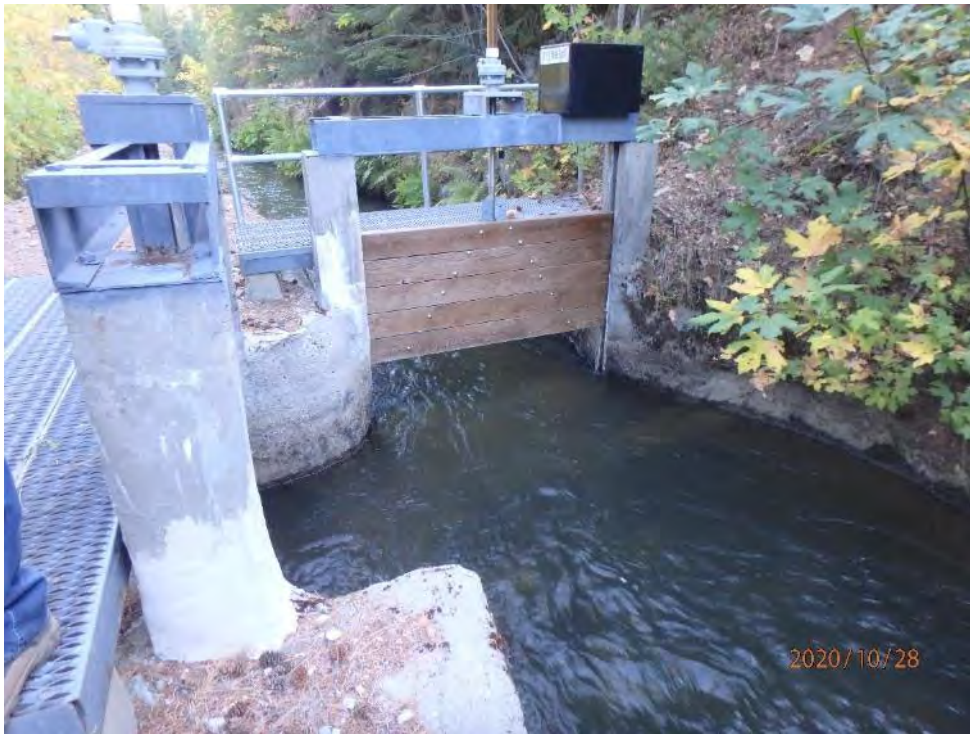
Photo 56 - View of 9 ½ Mile Spill

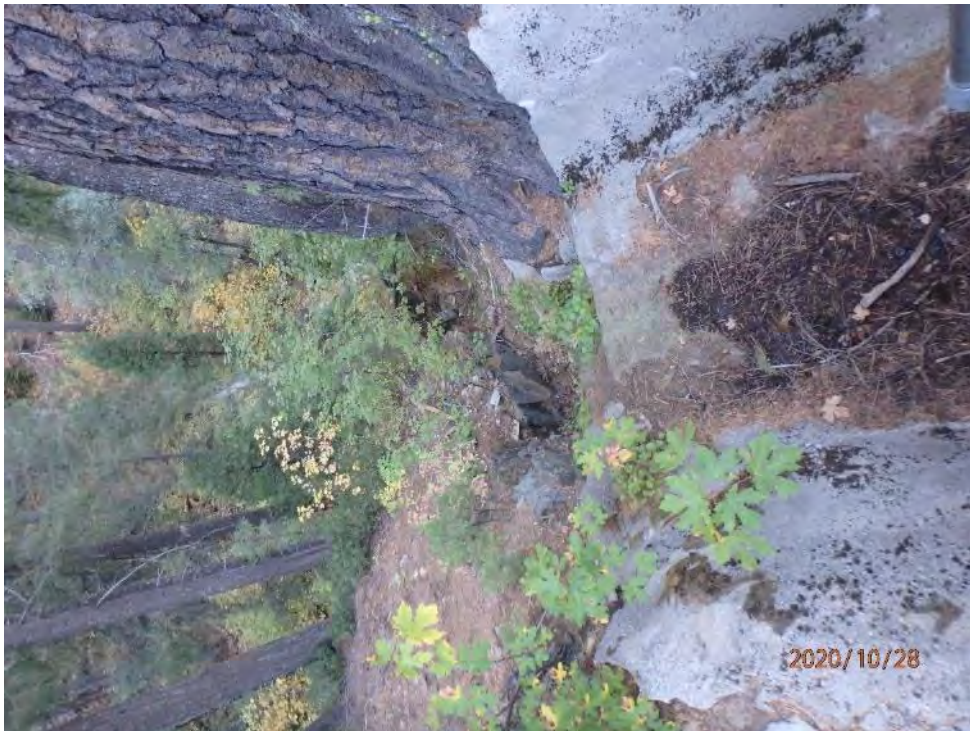
Photo 57 - View of 9 ½ Mile Spill

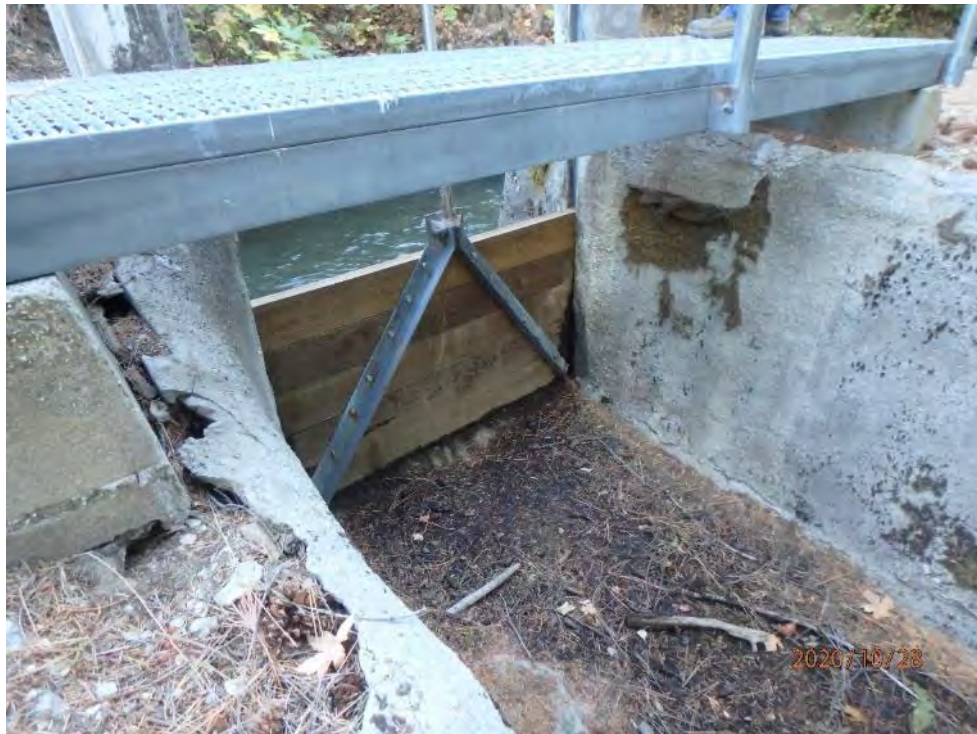
Photo 60 - View of 9 1/2 Mile Spill

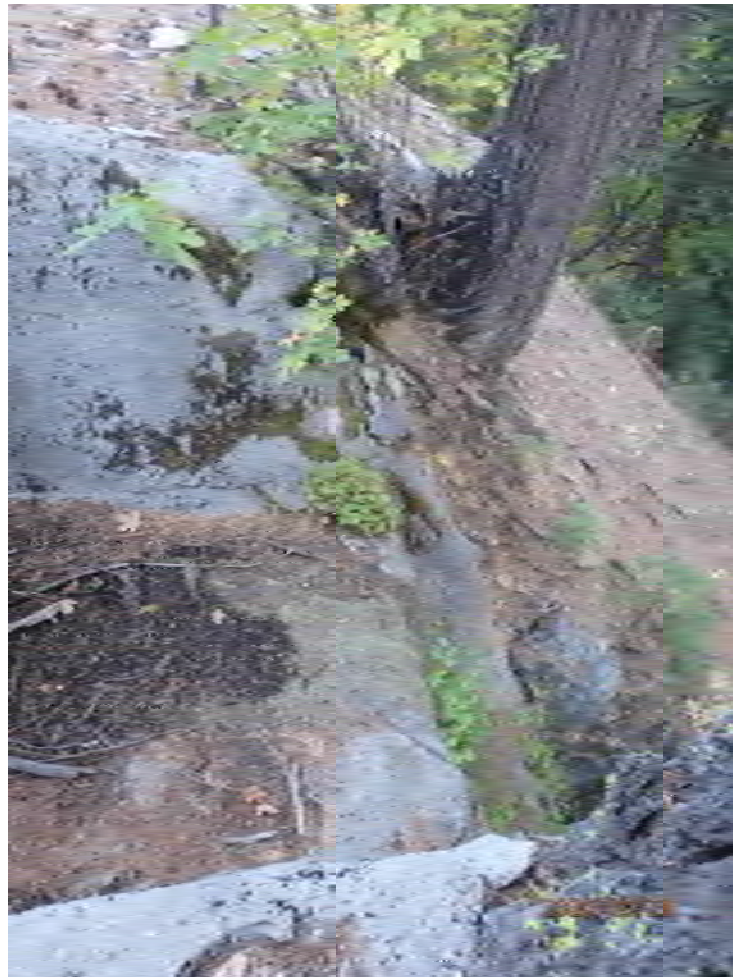
Photo 61 - View of 9 ½ Mile Spill

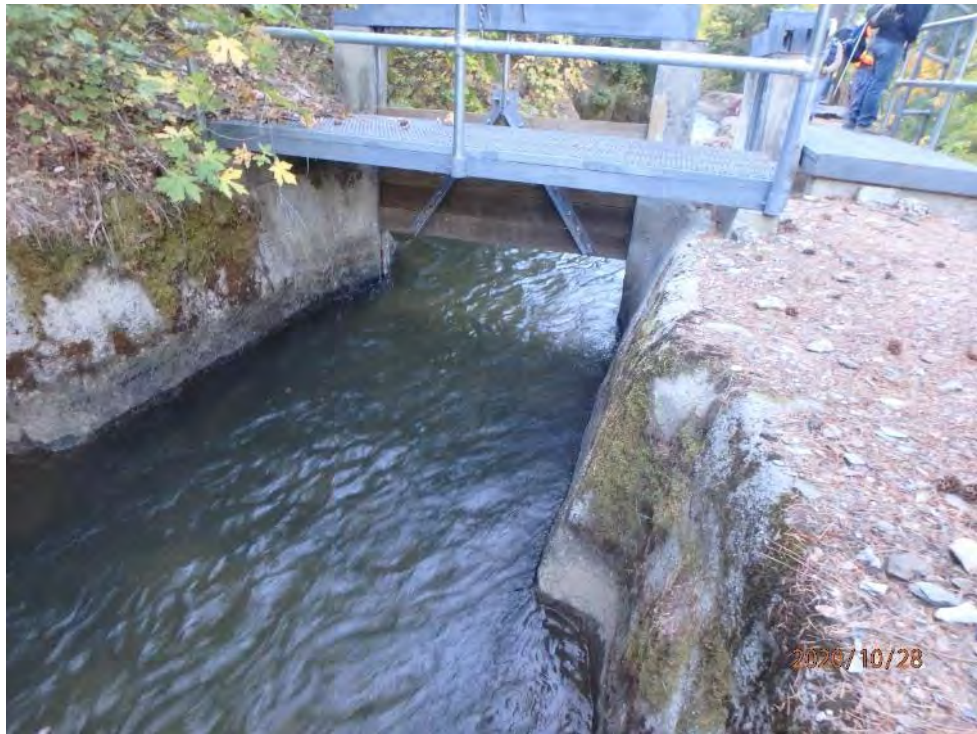
Photo 62 - View of 9 ½ Mile Spill
